# ENGINEERING REPORT

Project:  
**Proposed Subdivision**  
373 Maude Road, Korito, Kaimiro, Taranaki

Client:  
Rachel Broadmore

JOB NUMBER: 24005  
Rev B  
31 January 2024

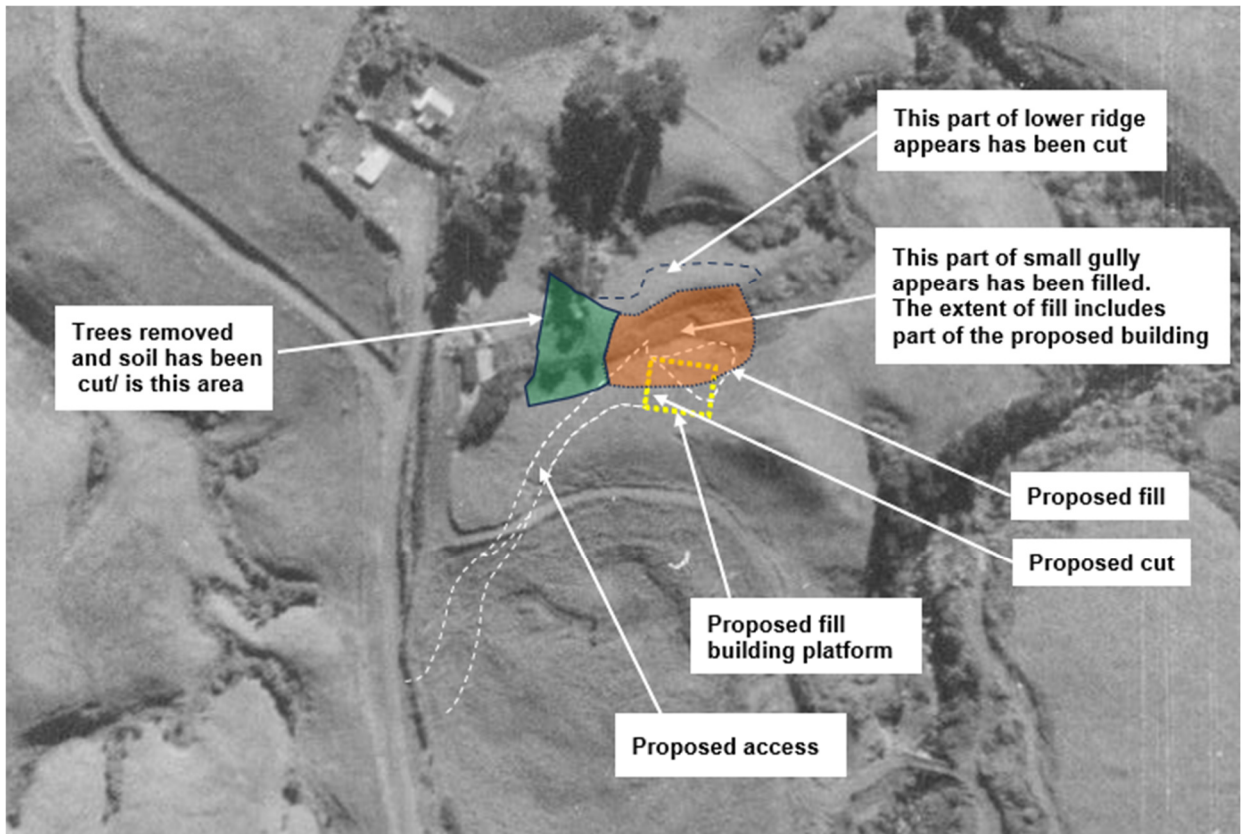
From the above photographs review, we have observed that geotechnical alterations such as site cutting, excavation, backfilling and recontouring occurred in the past. Please refer to Figure 7 and Figure 8 for the location and approximate extent of the observed geotechnical alterations.

Figure 7: Observed geotechnical alterations.

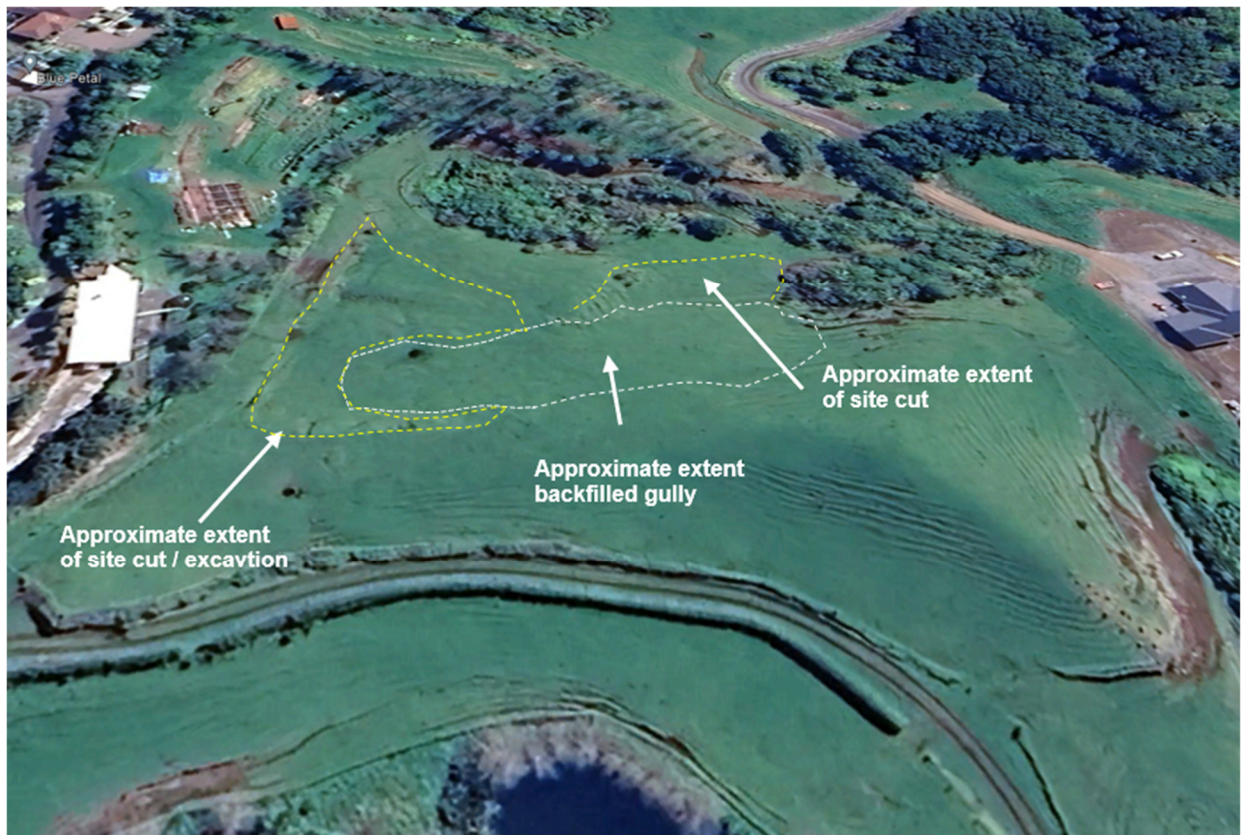
Figure 8: Approximate extent of geotechnical alterations.

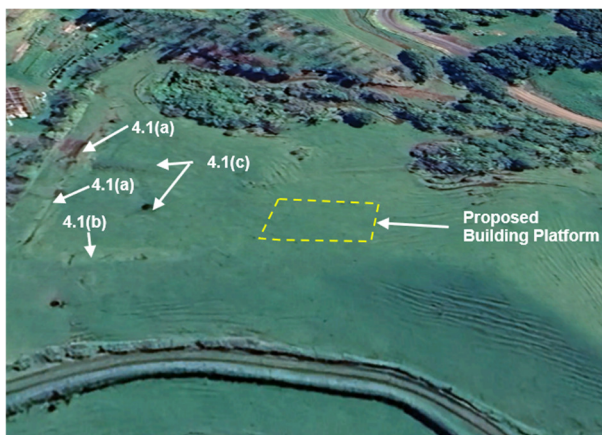
Figure 9: Observation notes location reference

- There is approximately 0.80 to 2.0m historic vertical cut to West property boundary of the proposed Lot 1. Refer to *Figure 9* for the location and *Figure 10* and *Figure 11* for sample photographs.

- Historic cut batter (now mostly covered by grass and soil) is also evident to the Northern side of the Western part of the ridge, West of the proposed building platform. Refer to *Figure 9* and *Figure 12* for the location and sample photograph.

- There is a soil bund like or lower ridge located North-West of the proposed building platform trapping stormwater to *the flat shallow bowl like area*. Refer to *Figure 9* and *Figure 11* for the location and sample photograph of the trapped stormwater.

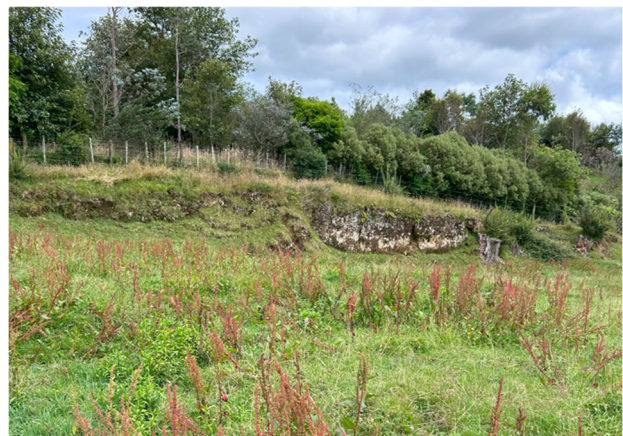
Figure 10: Historic vertical cut

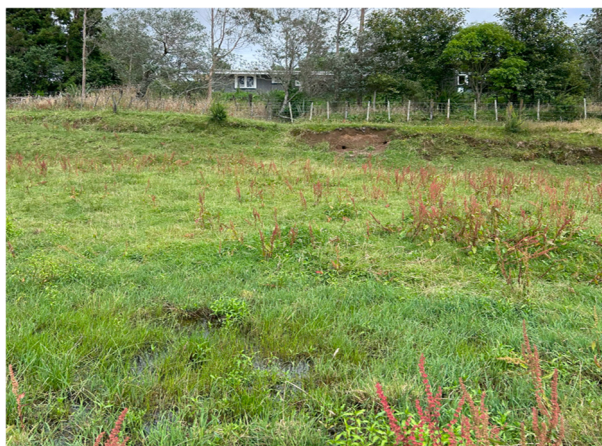
Figure 11: Historic vertical cut and trapped stormwater to the flat shallow bowl like area

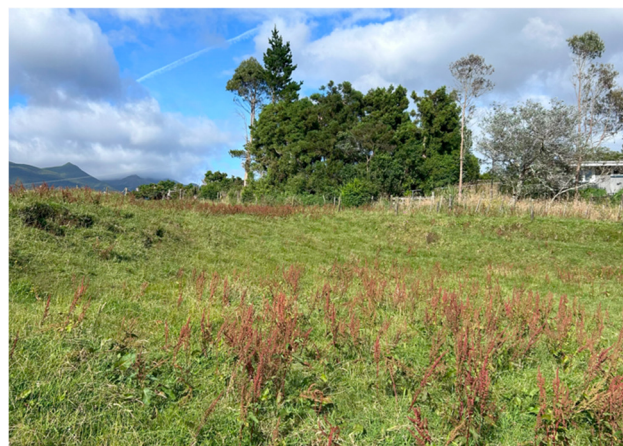
Figure 12: Historic cut batter to the north side of the Western part of the ridge

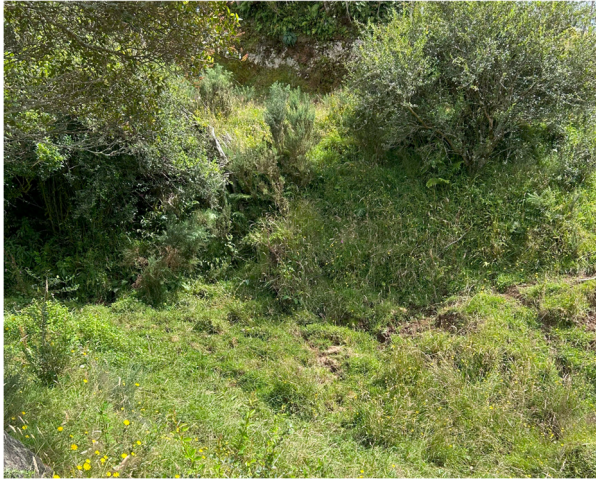
- There is a dry gully to the Northern property boundary of the existing Lot 1.
- The location of the proposed building platform has a moderate slope ranges from 1:5 to 1:4 (11 to 14 degree slope).

Figure 13: Dry gully photo 1,  
North property boundary of existing Lot 1

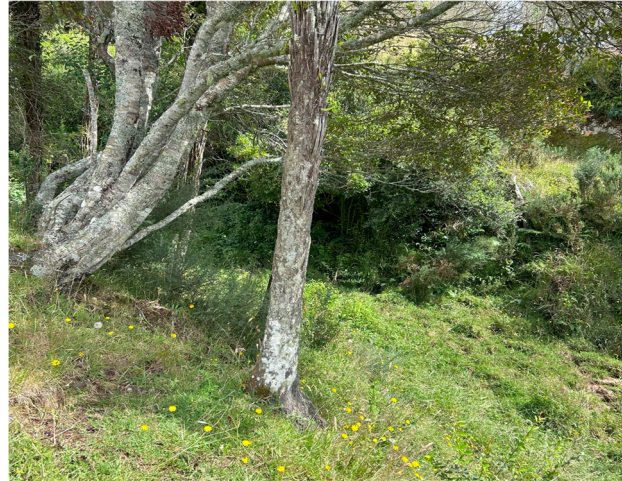
Figure 14: Dry gully photo 2,  
North property boundary of existing Lot 1

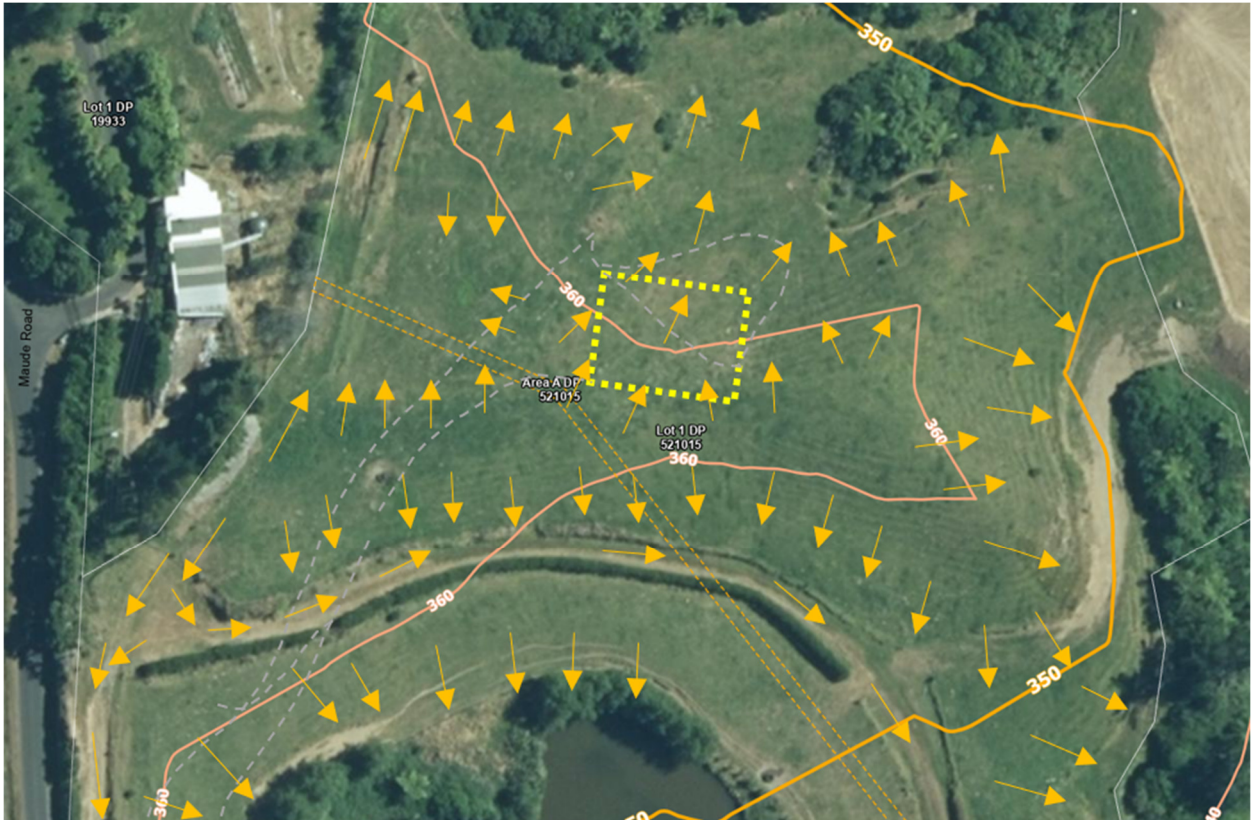
- towards North to the natural dry Gully within the property boundary
- towards East to the natural waterway outside the property boundary
- towards South to the natural watercourse to the proposed Lot 3.

Figure 15: Existing overland flow paths

All overland flow paths in future developments shall be appropriately designed and managed to prevent any water ponding, soil erosion or scouring issues.

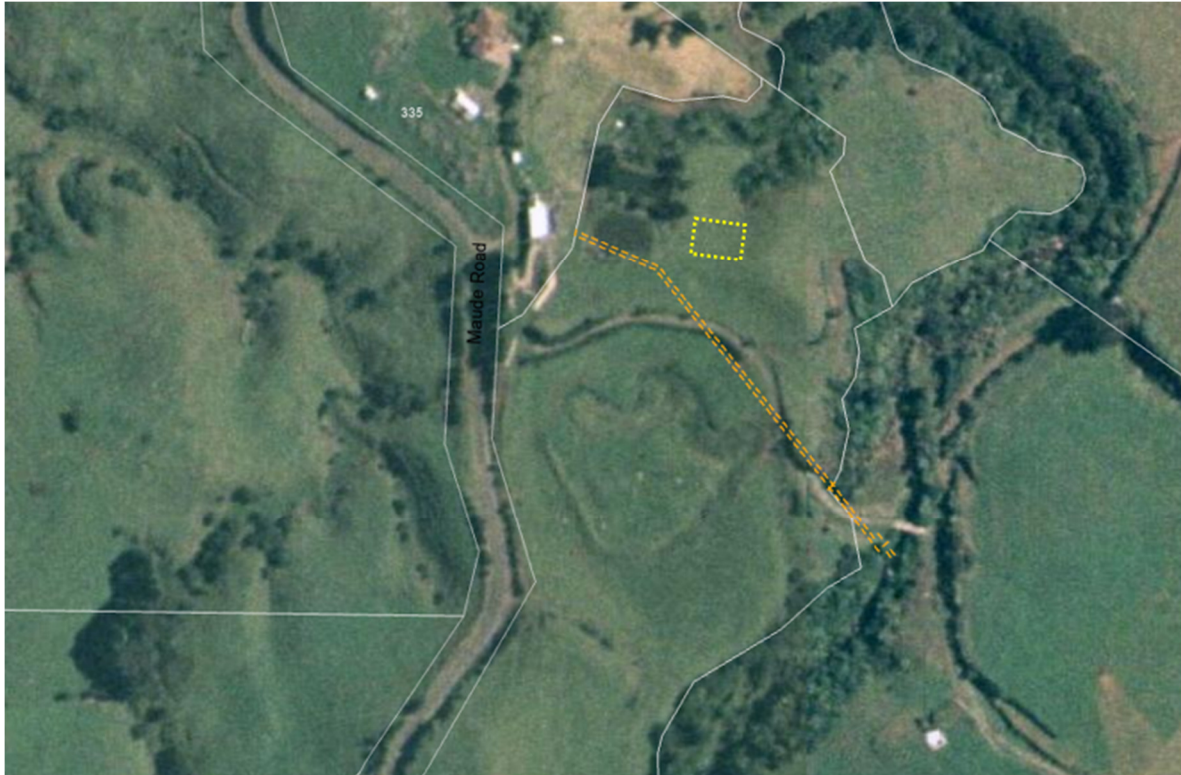
2001 Aerial photo (Source: NPDC GIS) – The upper dry Gully appears has been filled
