# RESOURCE CONSENT APPLICATION AND ASSESSMENT OF ENVIRONMENTAL EFFECTS

Brougham Street Commercial  
Development

for K.D. Holdings Limited

Rev 1 - 29/04/2020

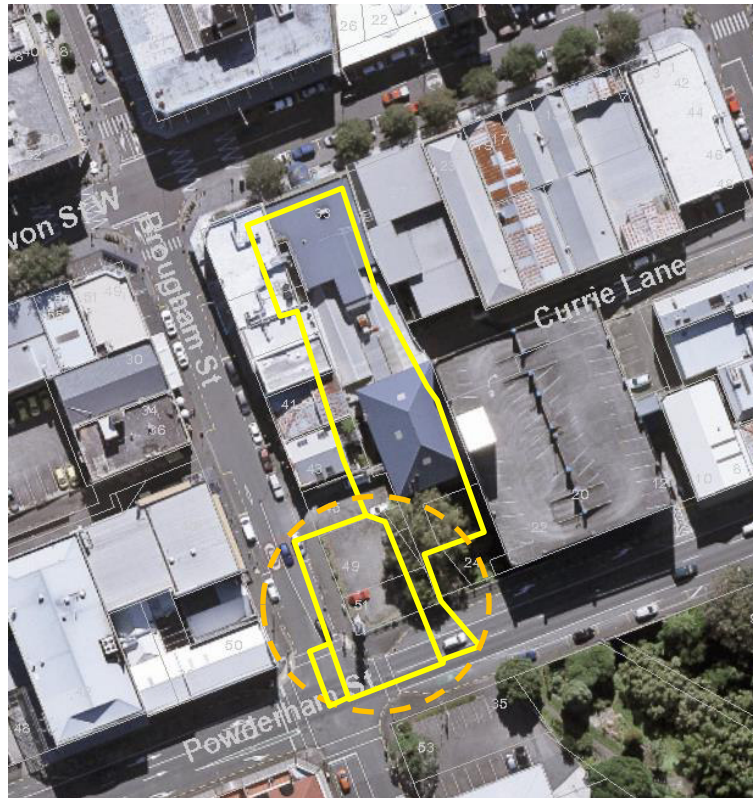
Figure 2.1: Aerial photo of site (outlined) and general area of proposed activities (circled) (Source: LINZ, 2016-17)

The application site is 45-51 Brougham Street (owned by the applicant), a small area of Lot 2 DP 15492 fronting Powderham Street (owned by NPDC), and a small area of footpath in the road reserve of Brougham Street. The site is identified in Figure 2.1 below with the area of proposed activities circled. Descriptions of the subject Lots follows:

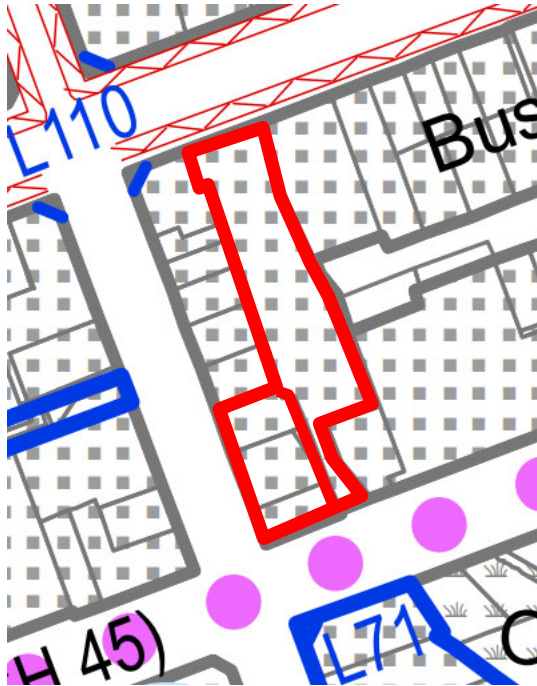
Figure 2.2: Extract from ODP C24a Map (site outlined red)

With regard to the ODP (Figure 2.2 and Figure 2.3), the site is located in:

- The Business A Environment Area;
- Section 2 of both the Cameron Street and Victoria Street Viewshafts;
- Section 3 of the Marsland Hill Viewshaft;
- A Defined Pedestrian Frontage is located along Devon Street;
- Notable Tree 97 is located on Lot 2 DP 15492. In Appendix 13 (Notable Trees) this single tree is categorised as a Willow Myrtle (*Agonis flexuosa*) in Category 2;
- Huatoki Stream is a Priority Waterbody; and
- Powderham Street is identified as State Highway 45 and Brougham Street as a Local Road within the Roding Hierarchy.

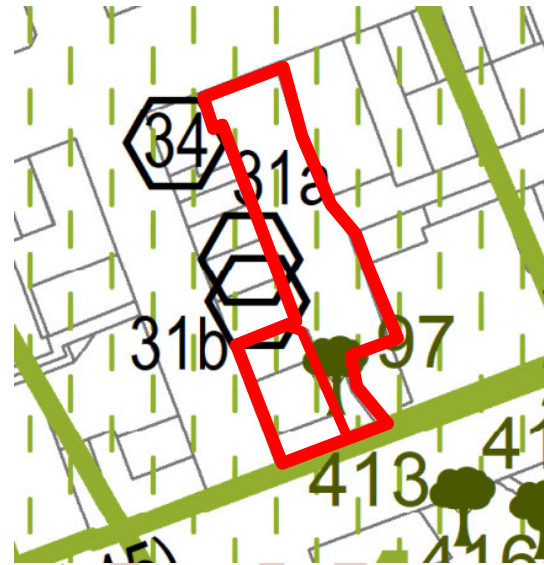
Figure 2.3: Extract from ODP C24b Map (site outlined red)

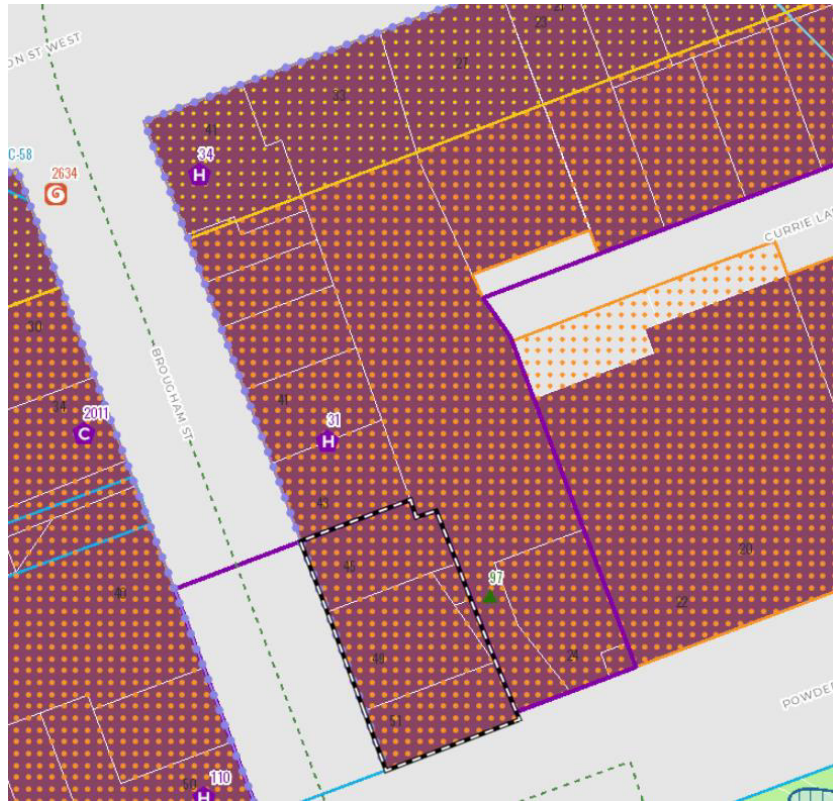
Figure 2.4: Extract from PDP Map

The PDP was notified on 23 September 2019 and the submission period closed on 22 November 2019. The PDP proposes the following provisions for the site (Figure 2.4):

- Height Management Area B (14m) at northern end, majority of site in Height Management Area C (17m);
- Notable Tree Site ID 97; and
- Heritage Character Area.

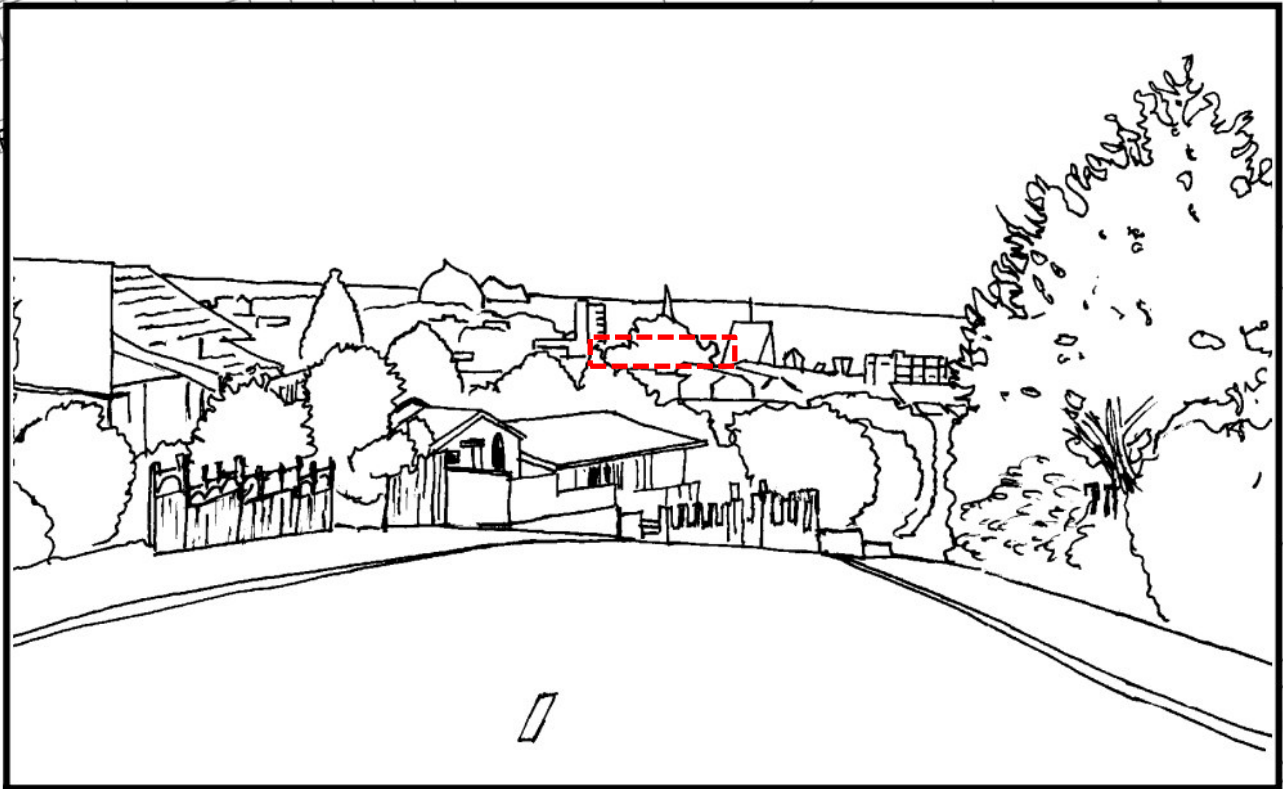
Figure 4.1: ODP Cameron Street Viewshaft Map with approximate building location amongst existing buildings indicated, though building would be behind trees shown (not to scale)

With regard to Cameron Street Viewshaft, the proposed building is considered to have little, if any, visibility due to being located behind the prominent trees of Central School (Figure 4.1 and Figure 4.2, Appendix J). The proposal therefore has less than minor adverse effects on the viewshaft.

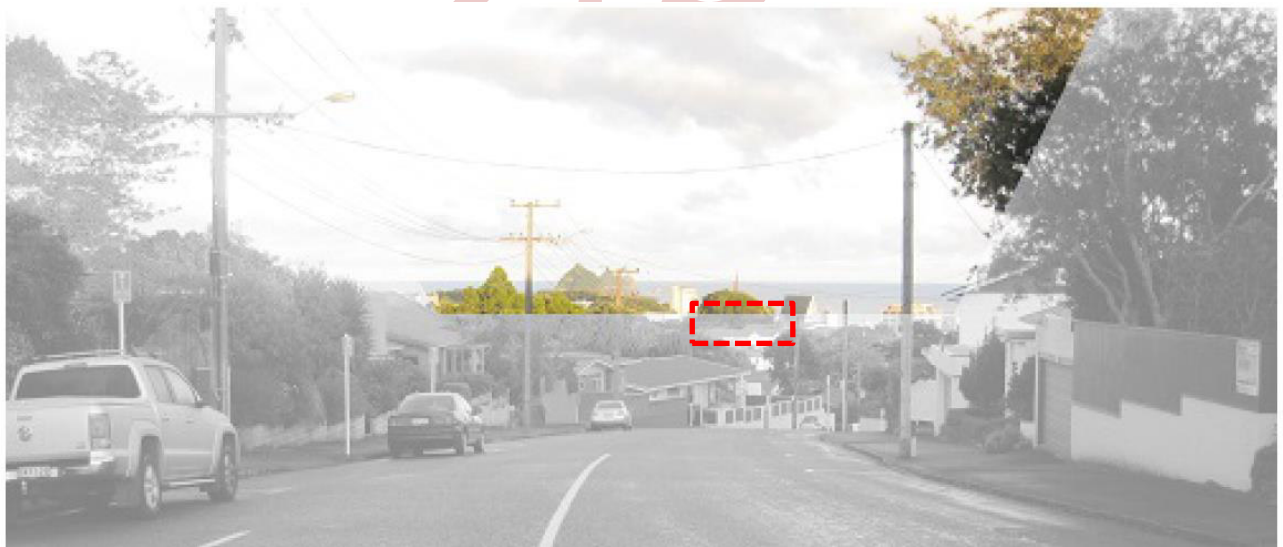
Figure 4.2: Cameron Street Viewshaft from Schedule 5 of PDP, approximate building location indicated (behind trees) (not to scale)

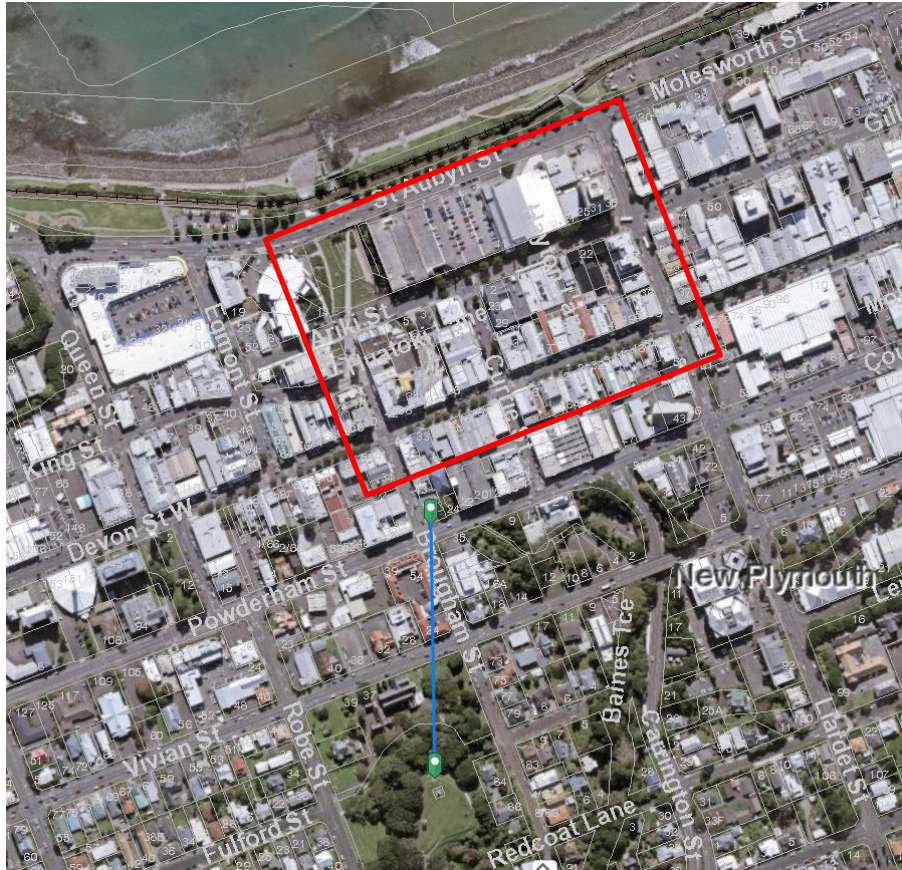
Figure 4.3: Aerial photo indicating view of site from Marsland Hill/Pukaka with background buildings between the site and the sea views (Source: LINZ, 2016-17)

With regard to Marsland Hill/Pukaka Viewshaft, the site is visible from Marsland Hill/Pukaka at a distance of approximately 230m as indicated in Figure 4.3 below and in Appendix J. This results in a significant backdrop of 2-3 further blocks of multi-storeyed buildings between the site and the sea, including the likes of Centre City.

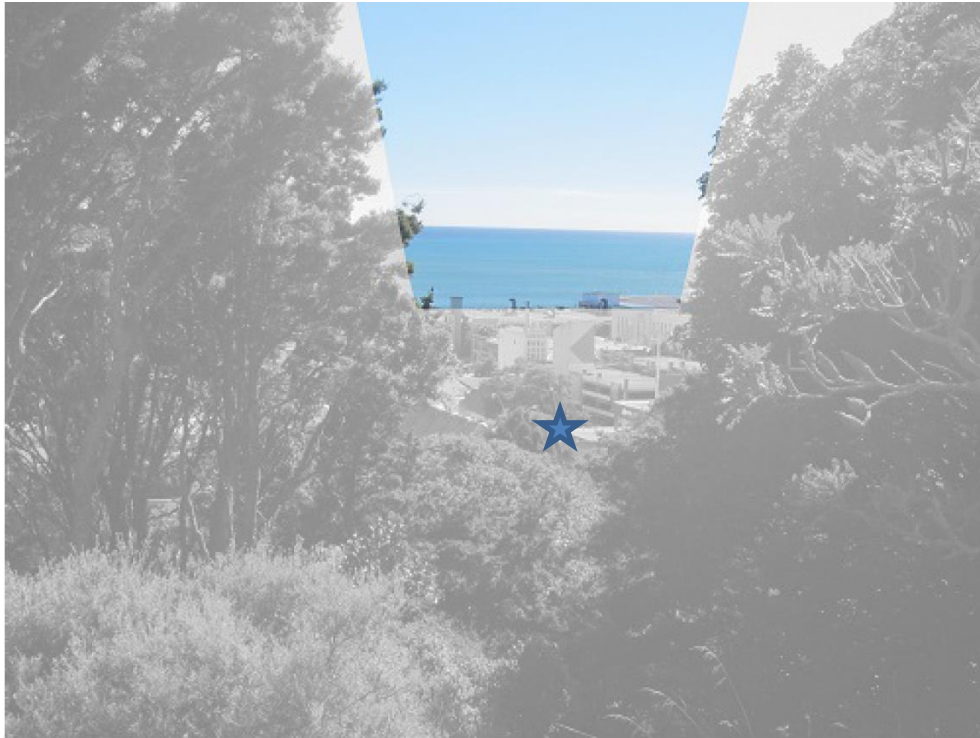
**Figure 4.4: One of Marsland Hill/Pukaka Viewshaft images from Schedule 5 of the PDP, approximate site location indicated with a star, nearby Council-owned carpark building of 20 Powderham Street immediately to the right**

This is further illustrated in Figure 4.4, whereby the proposed building will integrate into this existing high density development backdrop, with no sea view lost. The visibility of the site from Marsland Hill/Pukaka is also just at one point of many as illustrated in Appendix J, and as per Scheduled 5 of the PDP, in this viewshaft “no single viewpoint (is) more significant than another”. Thus, any adverse effects of the proposal on the Marsland Hill/Pukaka viewshaft are considered to be less than minor.

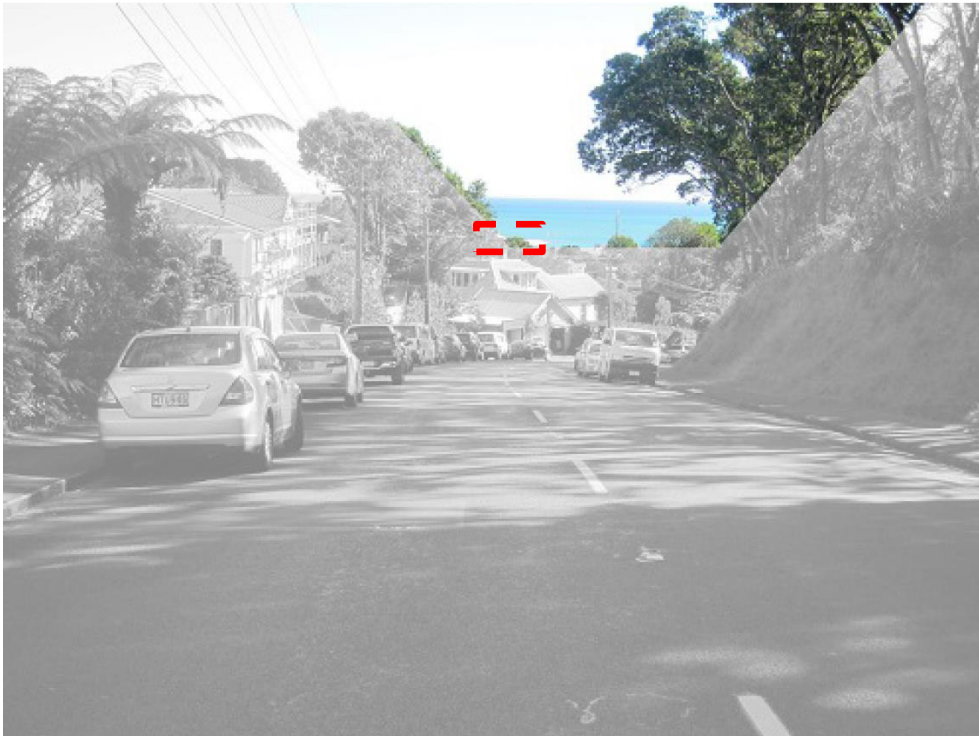
Figure 4.5: Victoria Road Viewshaft image from Schedule 5 of PDP, approximate building location indicated (not to scale)

With regard to Victoria Road viewshaft (Figure 4.5 and Appendix J), the exact proposed building location is unclear from a distance of some 500m+ but it will be located within a mix of other multi-storeyed buildings, several tall trees and the many layers of buildings visible from the Victoria Road Hill down to the sea. The building may obscure a minority area of sea however the sea will remain the dominant feature of the viewshaft, with the Wind Wand remaining the tallest feature after the addition of the proposed building. The building also represents a very small portion of the greater Victoria Road viewshaft. Altogether, potential adverse effects on the Victoria Road viewshaft are considered to be less than minor.

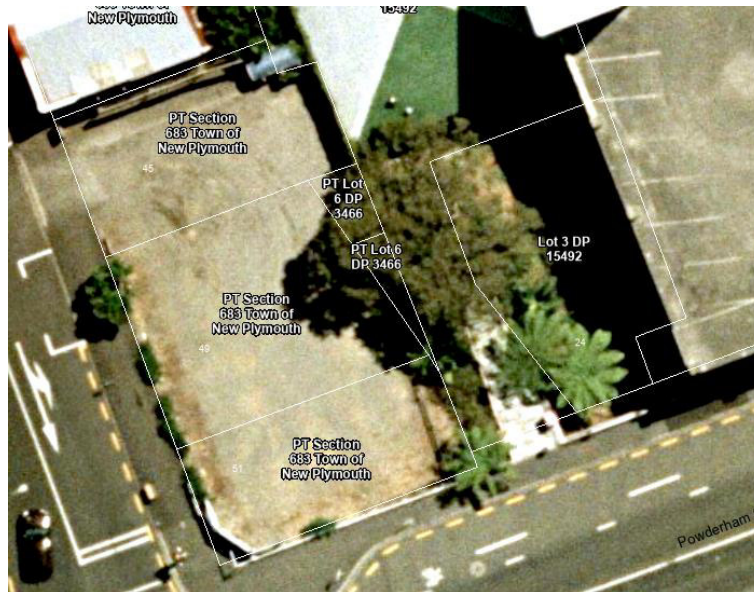
Figure 4.6: Aerial photo of site and Notable Tree (Source: NPDC, 2001)

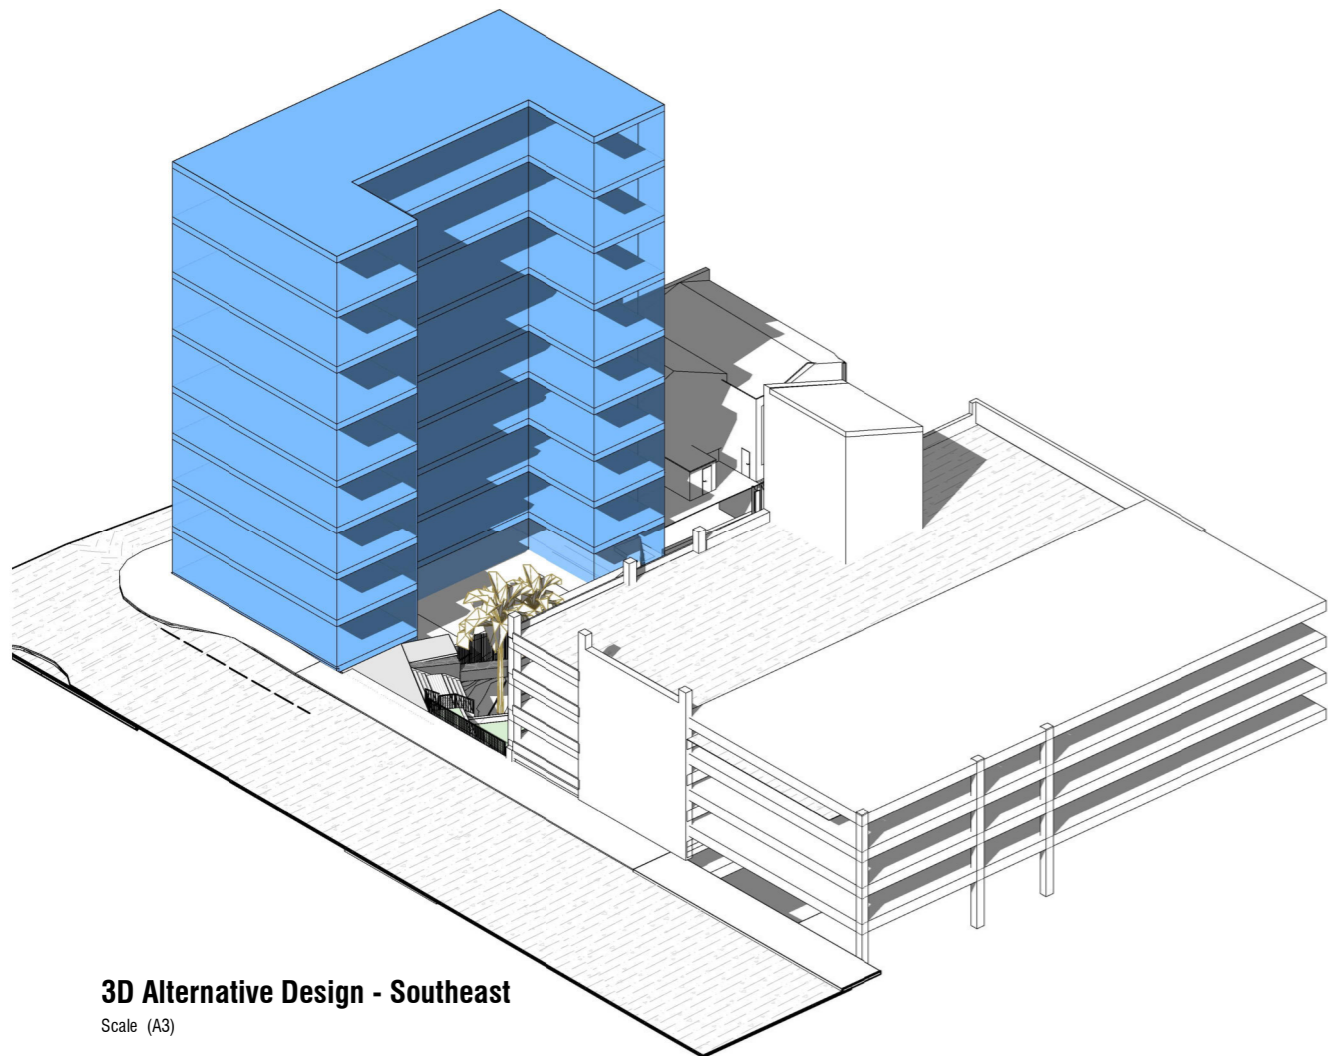
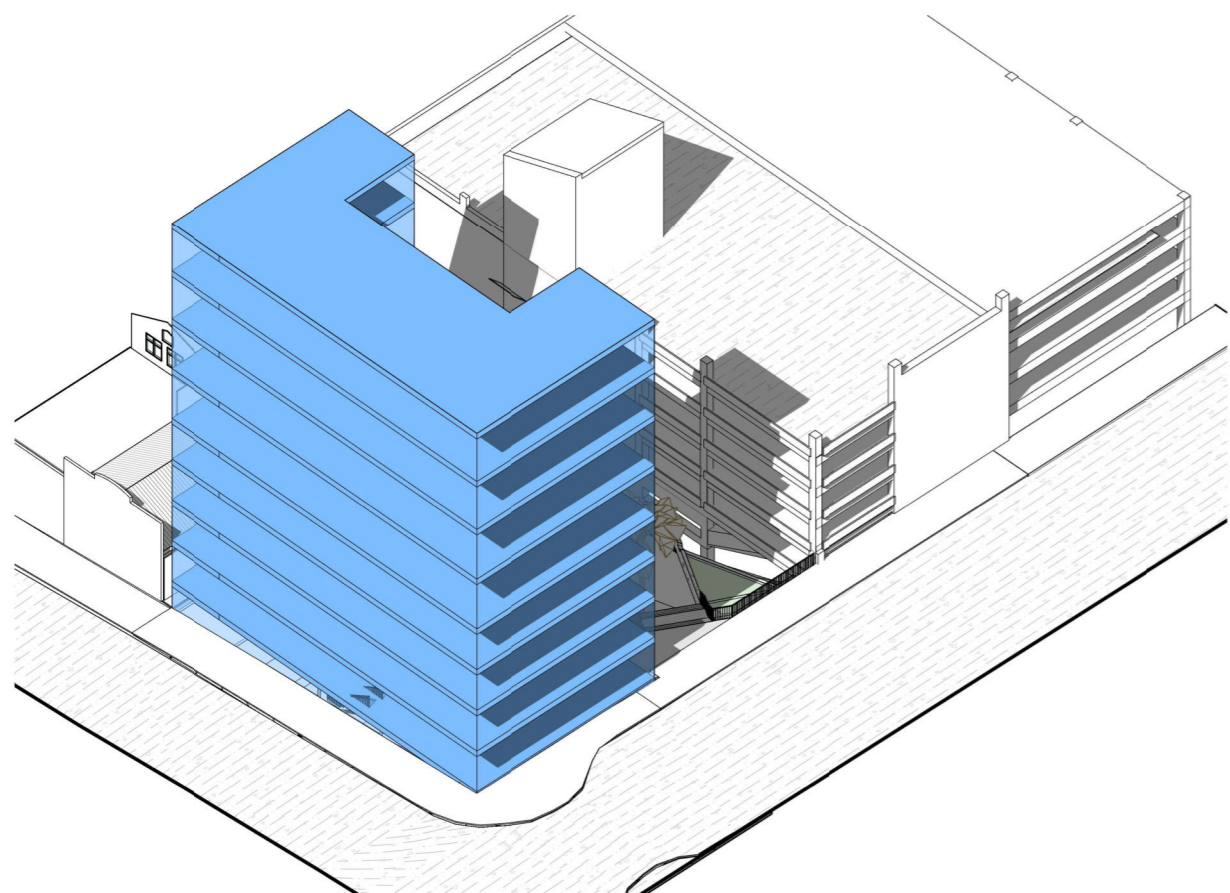
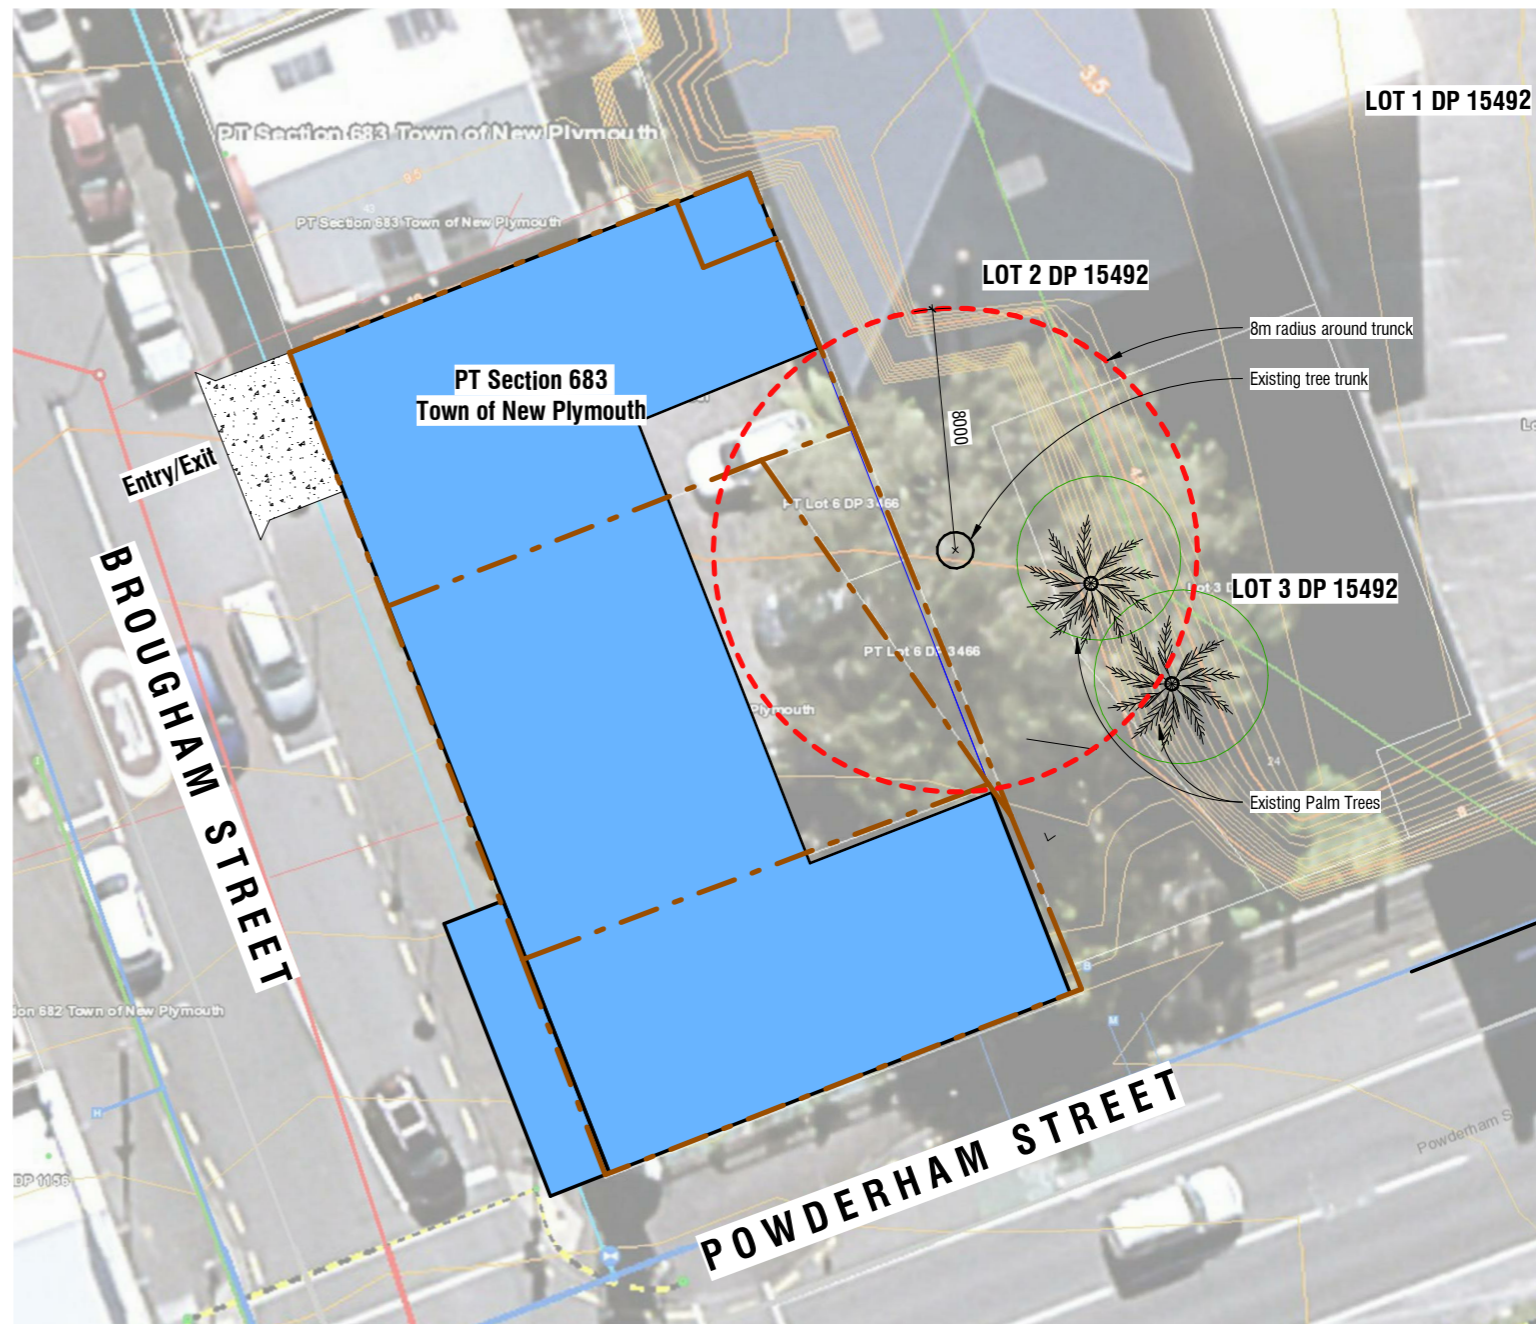
**Site Plan - Alternative with Tree Preserved**  
Scale 1 : 250 (A3)

**Areas**  
Original Proposal = 490m<sup>2</sup> per pavement x 7 = 3230m<sup>2</sup>  
Alternative Proposal = 375m<sup>2</sup> per pavement x 9 = 3375m<sup>2</sup>

The option of building construction within the dripline while retaining the tree (as aided by trimming the tree) was also considered. As per the assessment of Appendix M, driven pile foundations and a concrete basement slab are necessary. As per the same report, the nature of the building design proposed dictates driven piles at regular locations under the building, therefore piles are unable to be located away from roots and, as per the Arboricultural Assessment (Appendix E), *“it is likely that pile holes will damage large anchoring roots resulting in heightened chance of tree failure and possible health decline due to root damage”*. Considering that the tree is anchored on a steep bank, the Appendix M report concludes that:

Alternative shallow concrete foundations to minimise disturbance of the roots, would be unable to support a multi-storeyed building. Similarly, a building on raised piles may practically be only one to two storeys high and this foundation design does not adequately provide for ground stability within the site. Due to the relatively small size of the Brougham Street site at 478m<sup>2</sup> and other market-driven factors with regard to leasable commercial space in the inner-city, a building on the site is required to be multi-storeyed to be commercially feasible to construct, lease and thereafter maintain. Shallow or raised pile foundations for a one or two-storey building are therefore not feasible options.

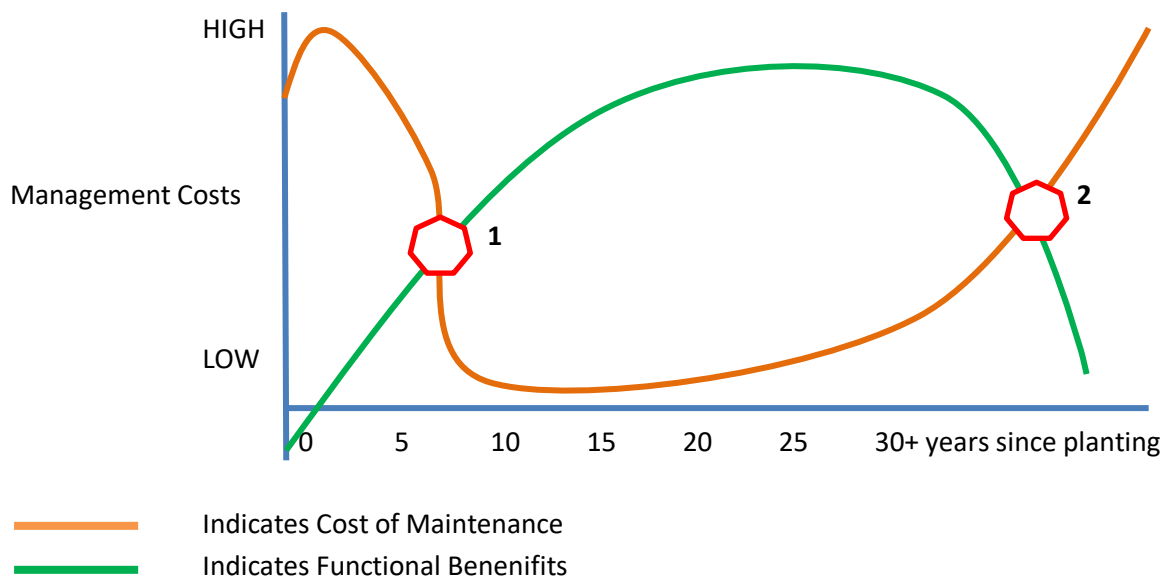
The relationship between functional (aesthetic) benefits and management costs is shown in the following table (indicative only):

**Area 1:** is the point where the tree becomes an asset as the functional (aesthetic) benefit becomes greater than the cost of management.

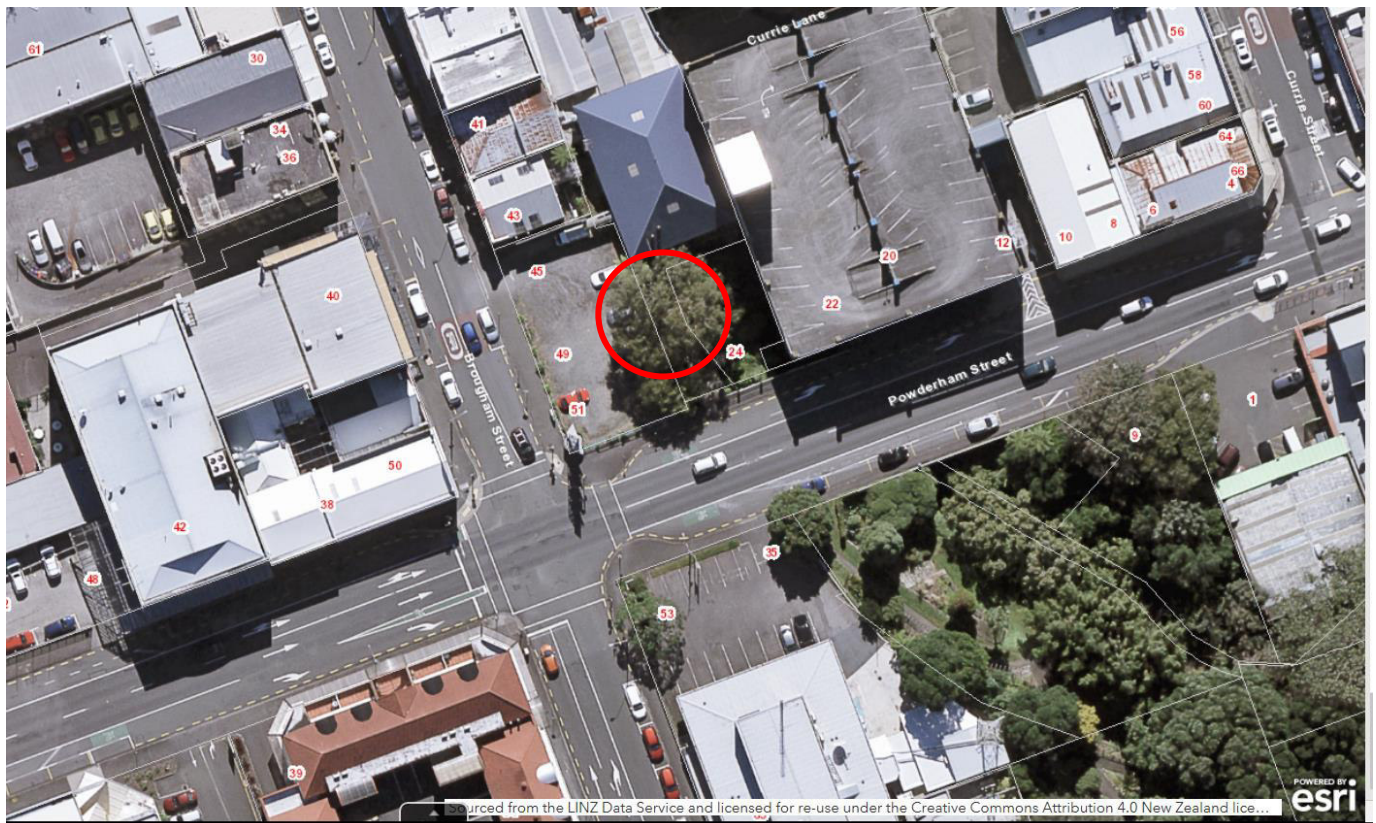
**Aerial Image.** The aerial image above depicts the location of the protected Agonis (within red circle) and the proposed development site on the immediate left (west-side). The tree is a prominent feature when approaching the Brougham Street intersection from the west, and from the south along Brougham Street.

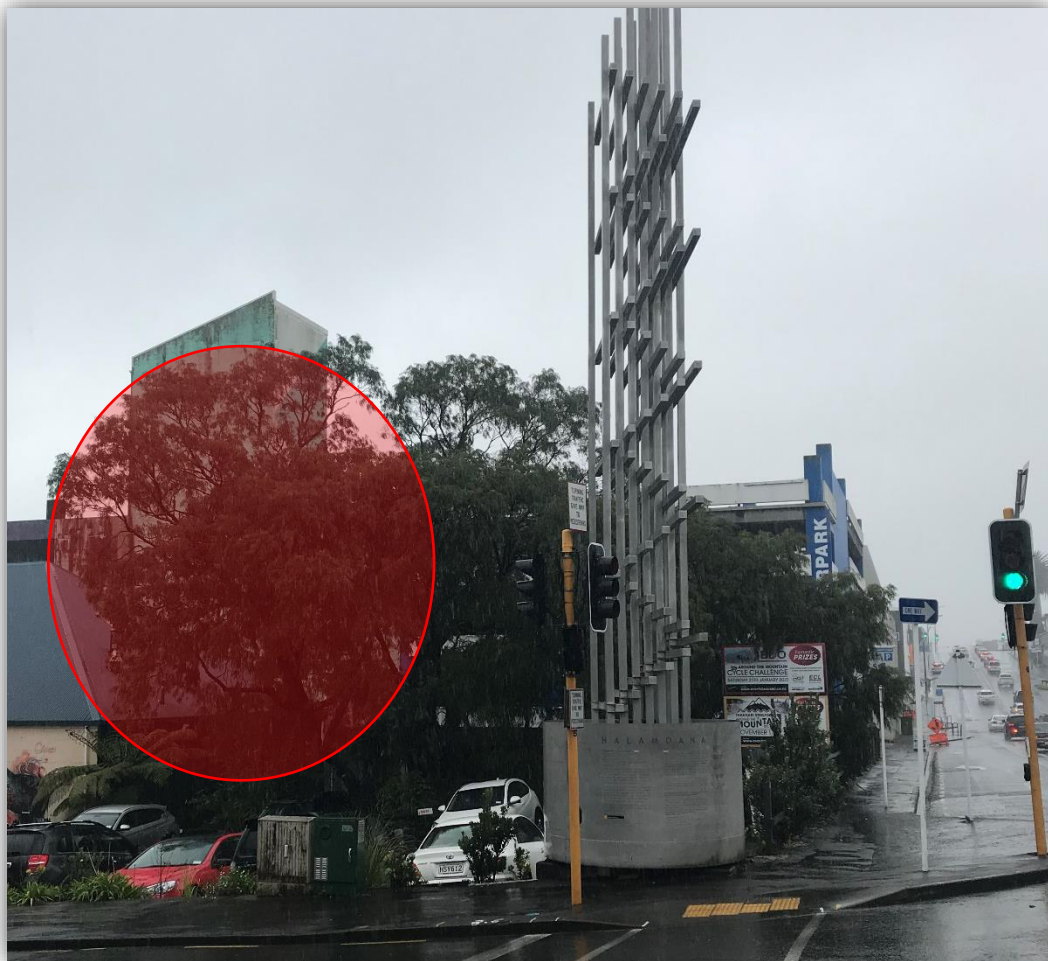
**Image 1.** The protected agonis as seen when approaching from Powderham St. The main section of the protected agonis is highlighted within the red circle, the vegetation to right is predominately self-seeded agonis with the parent tree likely being the protected agonis.

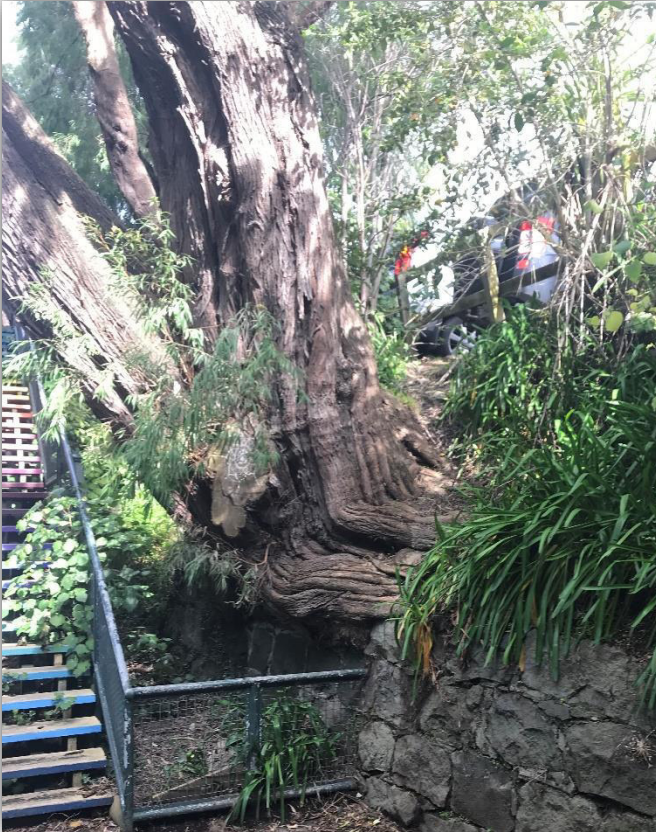
**Image 2 (left).** The base of the tree growing out of the embankment is larger than normal. It is the size of the lower stems and the trees prominence that merit the tree to be a Category 2 protected item.

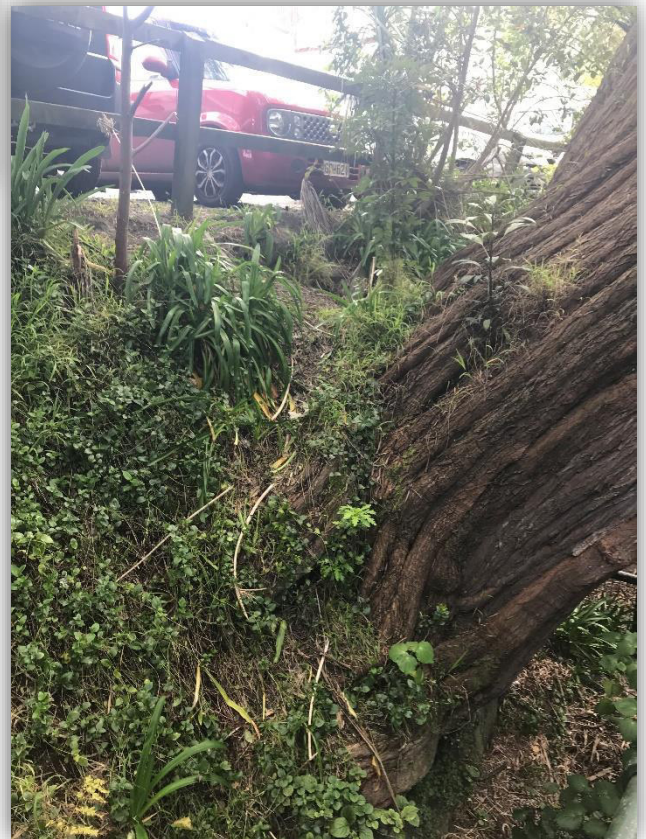
**Image 3 (right).** The rooting structure of the tree extends into the bank with numerous small feeder roots growing up towards the carpark surface. The weight loading of the tree away from the carpark, is expected to be counteracted by anchoring roots also extending below the carpark at a deeper level.

After meeting with geotechnical expertise and having a better understanding of the geotech requirements I can confirm that the foundation piles set in a gridline will likely affect the tree roots. The close proximity of the piles to the base of the tree and the gridline pattern of piles, it is likely that pile holes will damage large anchoring roots resulting in heightened chance of tree failure and possible health decline due to root damage.

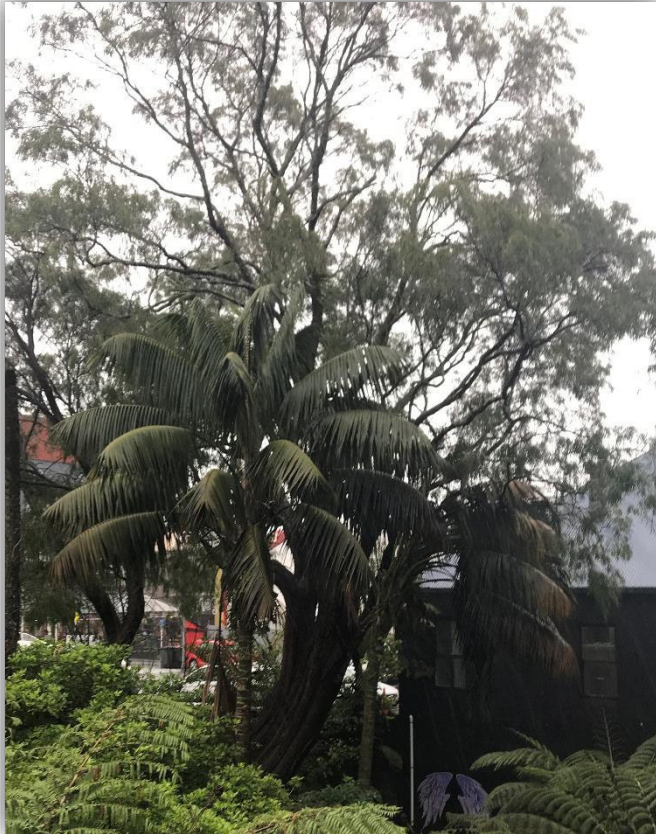
**Image 4 (left).** Growing below the agonis on the embankment are two kentia palms, these palms are not considered common and should be preserved within their current location. The palms may be considered an extension of the wider Huatoki Plaza and associate with the Puke Ariki greenspace theme.

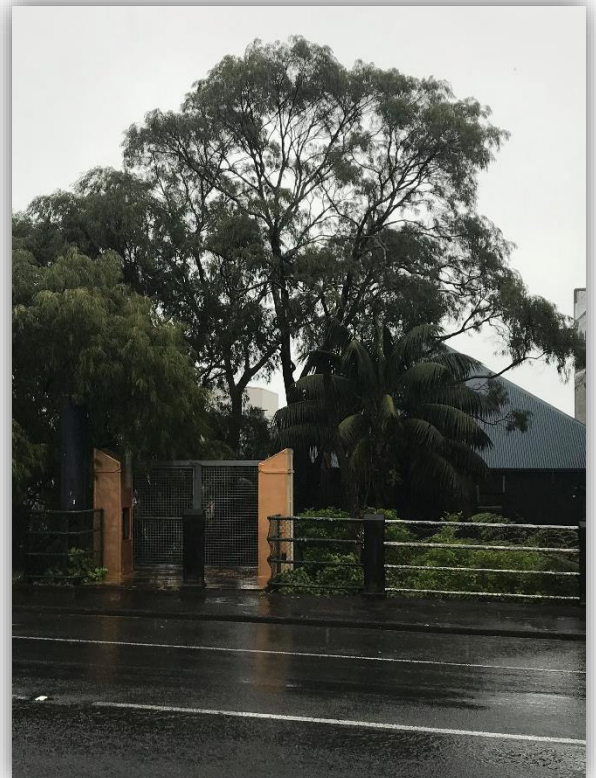
**Image 5 (right).** This image depicts the protected agonis and adjacent vegetation when viewed across Powderham Street, (looking north).

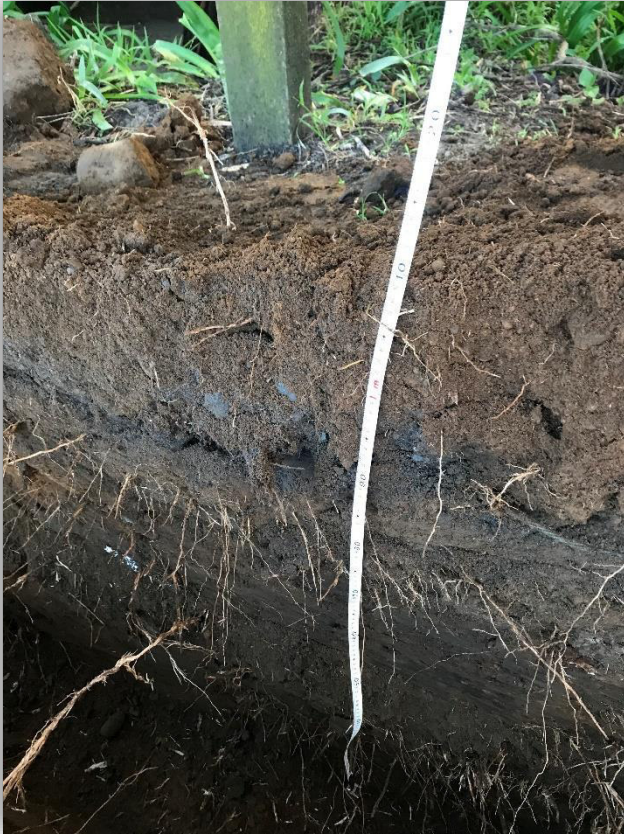
**Image 6 (left).** The exploratory excavation confirmed the presence of both small feeder roots and larger anchoring roots. Most feeder roots were found within the top 30cm of soil below the gravel basecourse. Larger anchor roots were encountered at about a depth of 1.0m. To minimise root disturbance the excavation did not proceed beyond this depth .

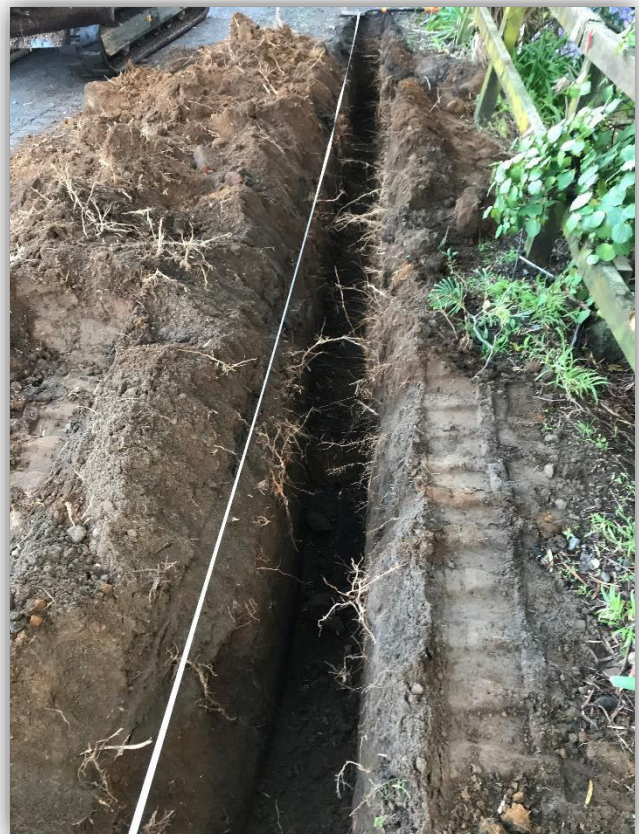
**Image 7 (right).** The exploratory excavation found most roots were radiating from the base of the tree within the central part of the excavation trench. The larger and deeper roots were found either side of the tree.

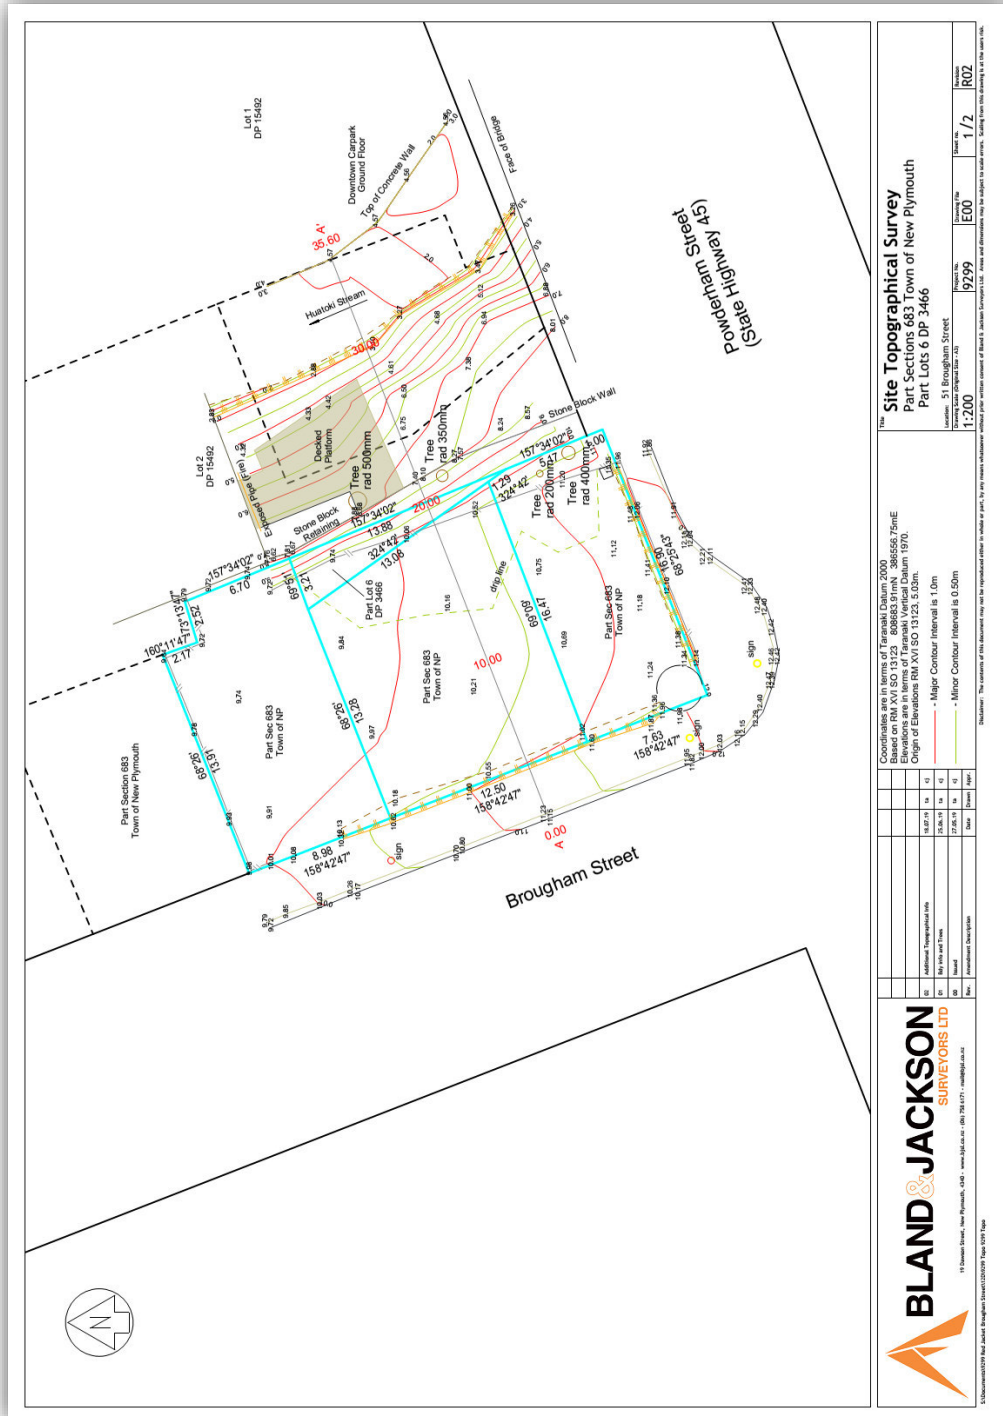
**Site Topographical Survey**  
 Part Sections 883 Town of New Plymouth  
 Part Lots 6 DP 3466  
 Location: 51 Brougham Street  
 Scale: 1:200  
 Elevation: 9299  
 Date: 1/2  
 No: R02

Coordinates are in terms of Tasmanian Datum 2000  
 Elevation is in terms of Mean Sea Level  
 Elevation is in terms of Tasmanian Vertical Datum 1970  
 Origin of Elevations RM XVI SO 13123, 5.03m.  
 - Major Contour Interval is 1.0m  
 - Minor Contour Interval is 0.50m

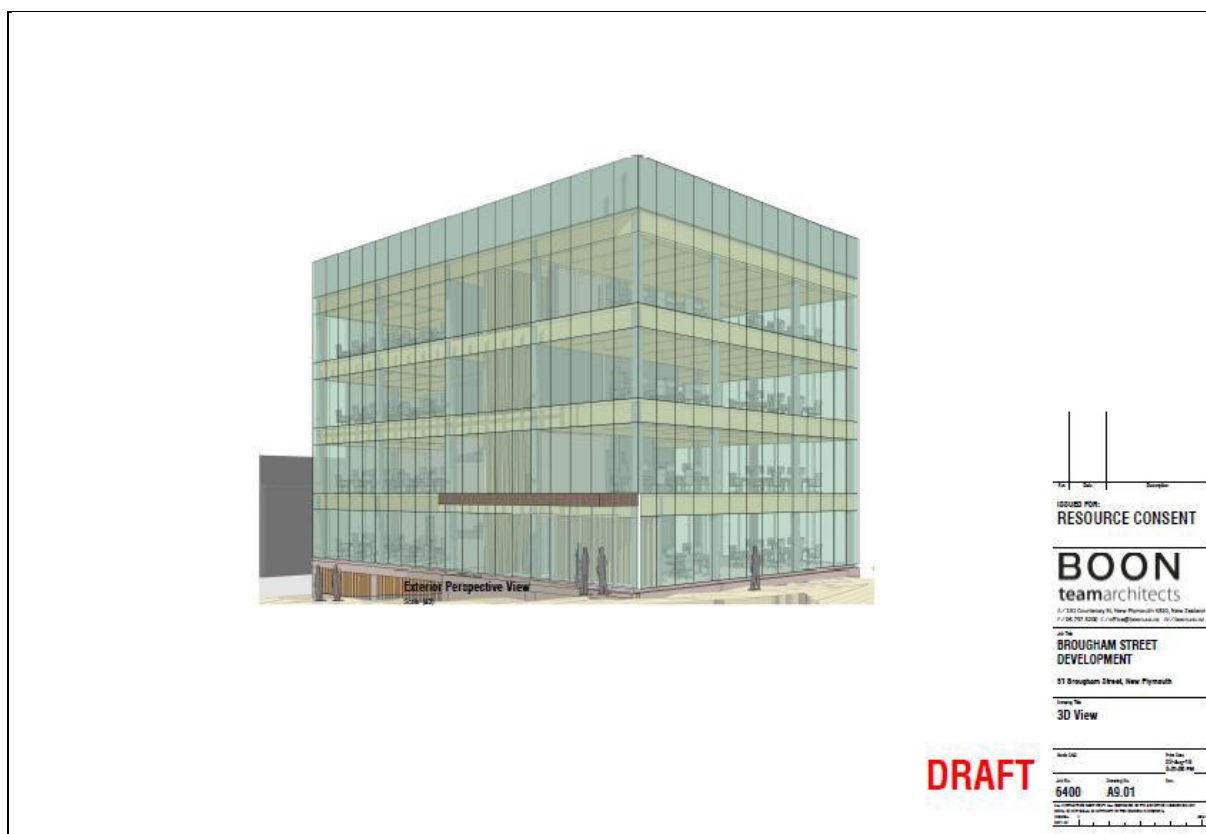
Figure 1: Concept drawing of the proposed building.

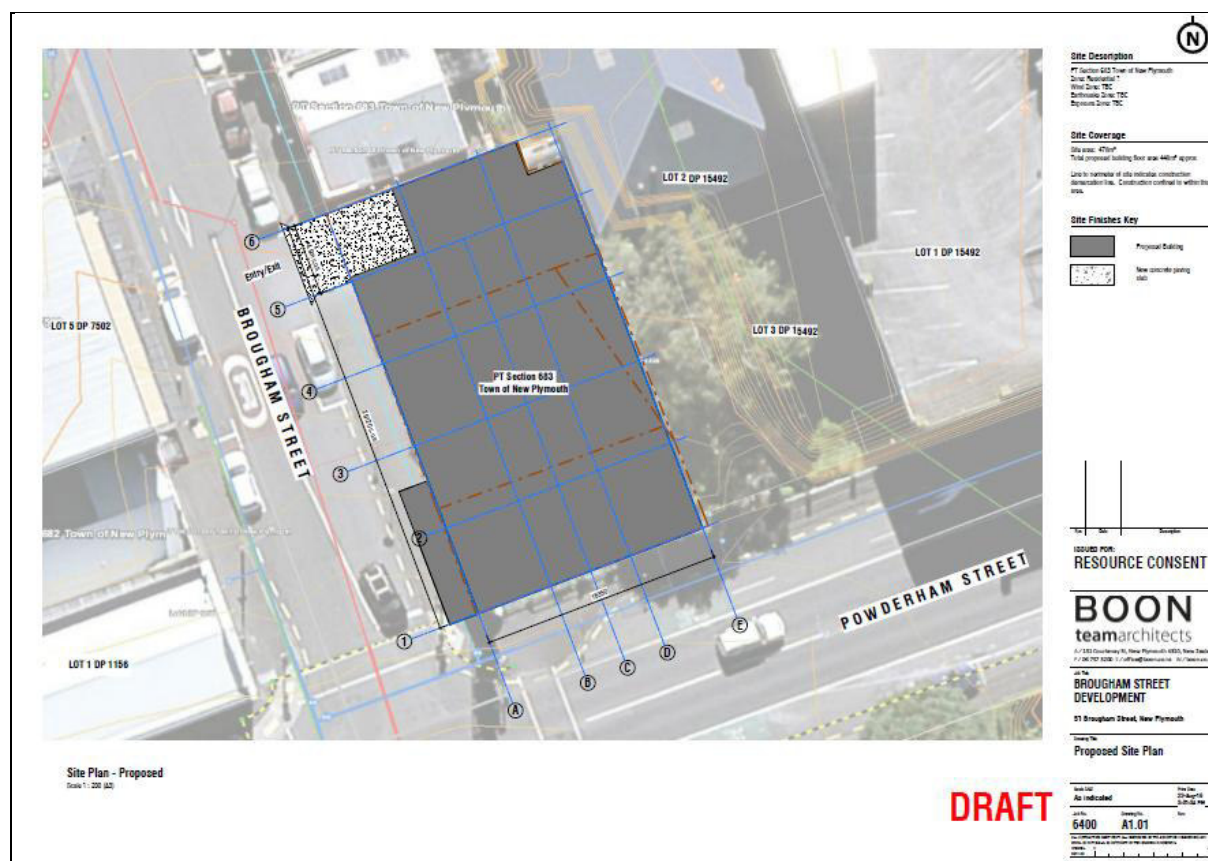
Figure 2: Footprint of the proposed building.
