# RESOURCE CONSENT APPLICATION AND ASSESSMENT OF ENVIRONMENTAL EFFECTS

Brougham Street Commercial  
Development

for K.D. Holdings Limited

Rev 1 - 29/04/2020

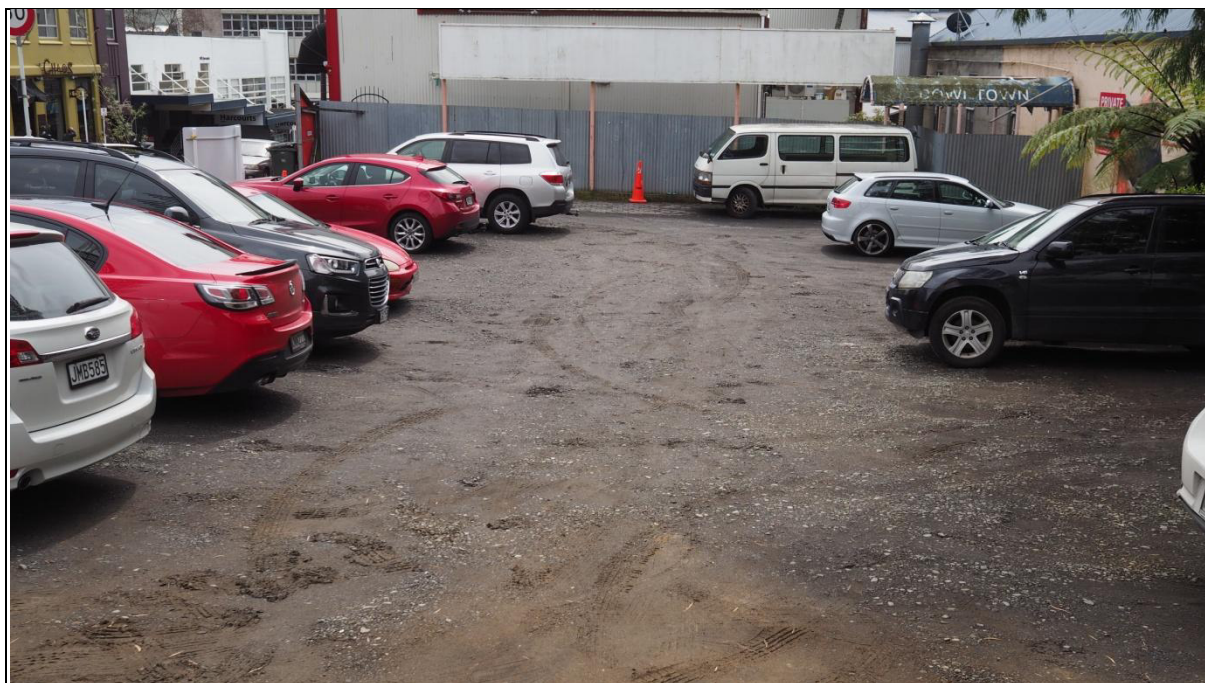
Figure 12: Project area, photo taken looking north (Image: Ivan Bruce, 2019).

9.1 The project area presents a heavily modified surface, consisting of a gravelled car park, sloping slightly to the north and east. There are no surface indications of the former historic structures that stood here.

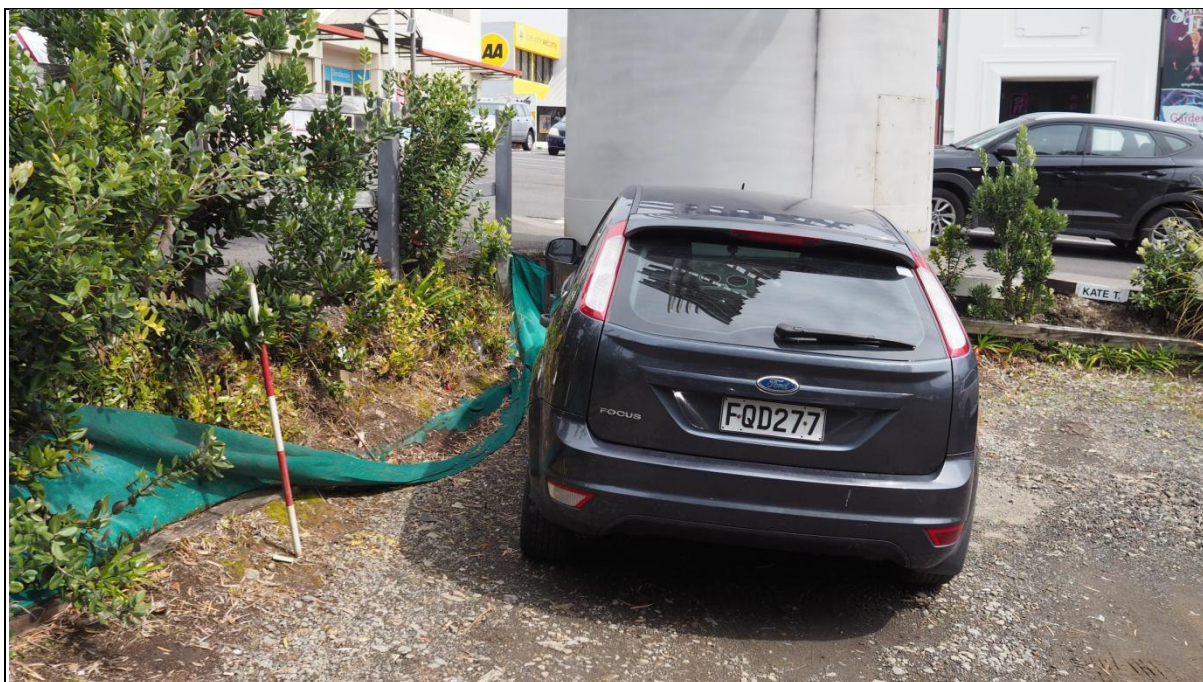
Figure 13: Powderham St profile to the left of shot (Image: Ivan Bruce, 2019).

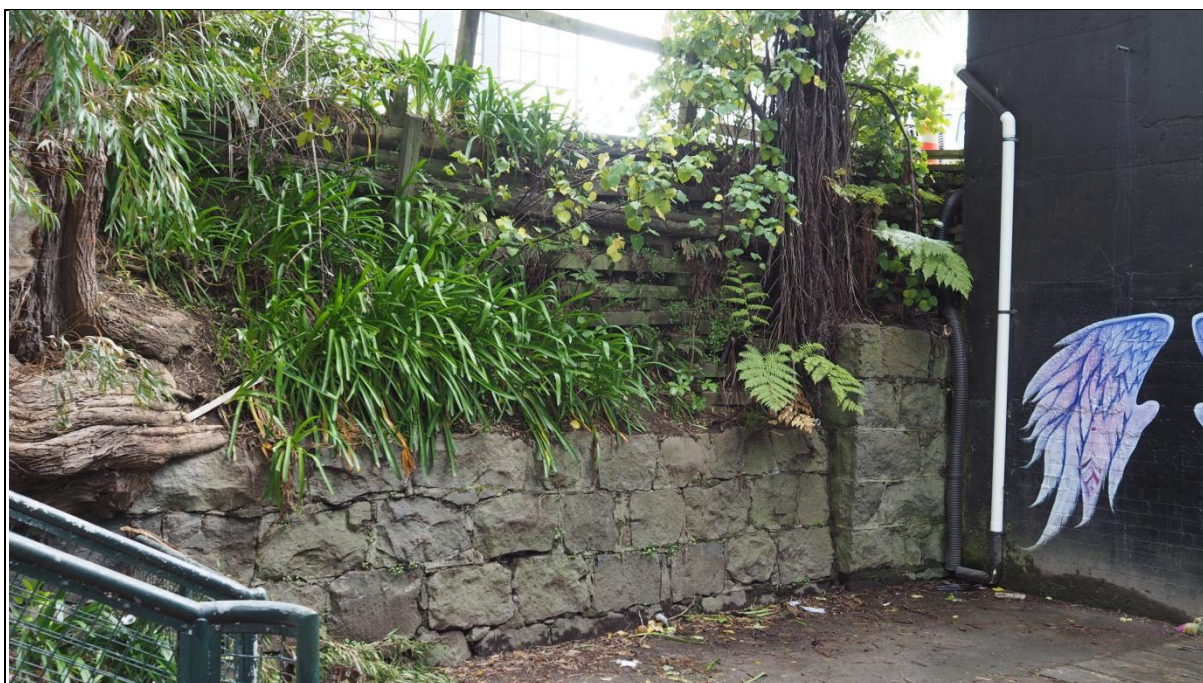
Figure 14: Remnant section of stone railway embankment, retained eastern boundary of project area above (Image: Ivan Bruce, 2019).

9.3 The eastern section has been retained and backfilled with relatively recent material, as stated in section 3.2. The retaining is supported by the former railway embankment,

10.2 It is possible that the removal of the large *Agonis Flexuosa* will destabilise the stone railway embankment, which may in turn require demolition and/or replacement of that wall. This structure predates 1900 and is by definition part of an archaeological site and will require an archaeological authority to damage destroy or modify this feature.

12.2 No modification of the stone railway embankment should occur if possible. However if the preservation of the surviving section of embankment cannot be practically achieved I recommend that K.D. Holdings Limited make an application for a general archaeological authority to modify, damage or destroy this embankment, and any unrecorded archaeological features contained within the entirety of the project area.

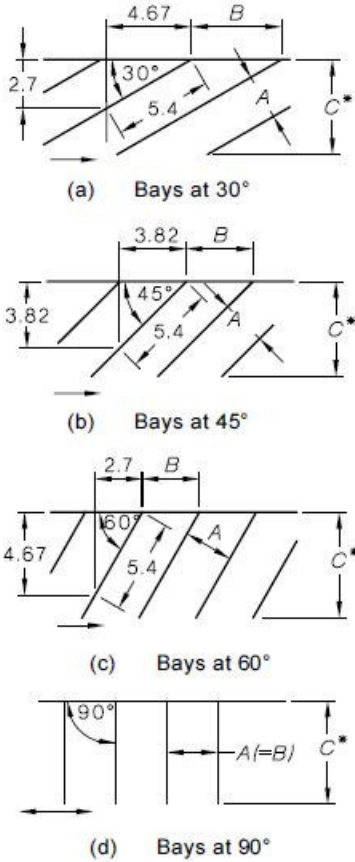
User class (Note 1)	A (Notes 2 & 3)	B	C <sub>1</sub>	C <sub>2</sub>	C <sub>3</sub>	Aisle width
1,1A	2.1	4.2	4.4	4.1	4.5	3.1
2	2.3	4.6	4.4	4.1	4.7	3.0
3	2.5	5.0	4.4	4.1	4.9	2.9
3A	2.5	5.0	4.4	4.1	4.9	3.45

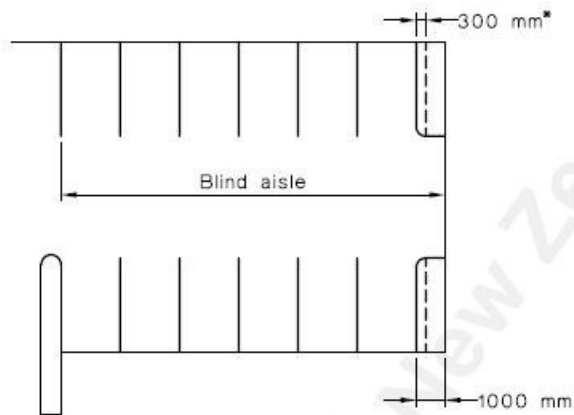
\*Additional widening required if there is a wall or fence at the side of the last space, see Clause 2.4.1(b)(ii).

DIMENSIONS IN MILLIMETRES

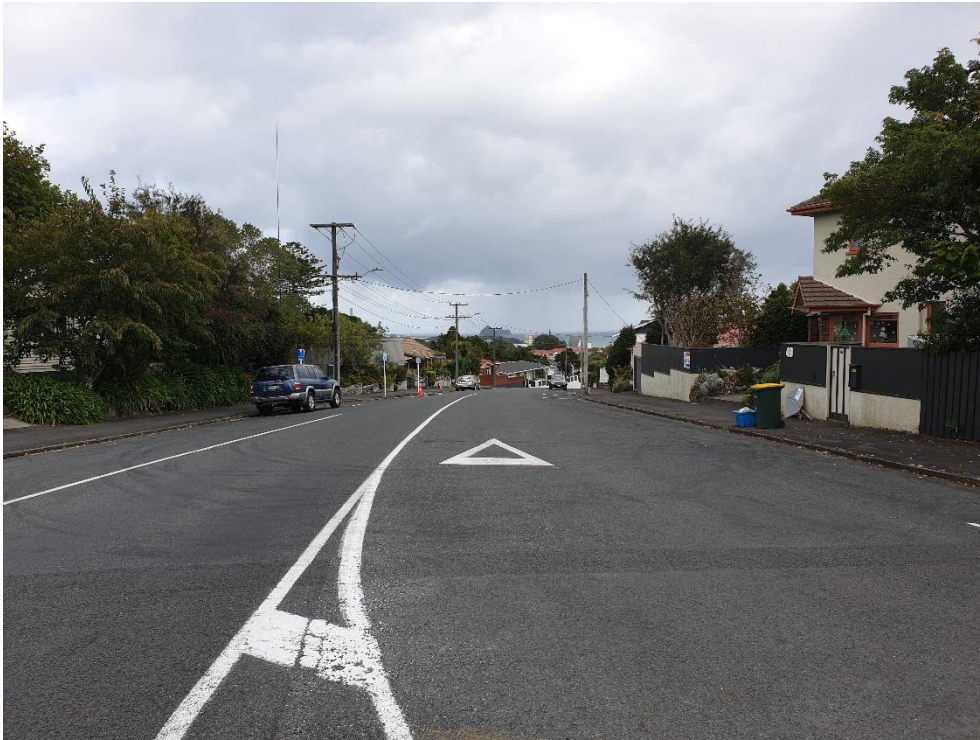
Figure J 1: Photo from top of Cameron Street Viewshaft (Source: BTW)

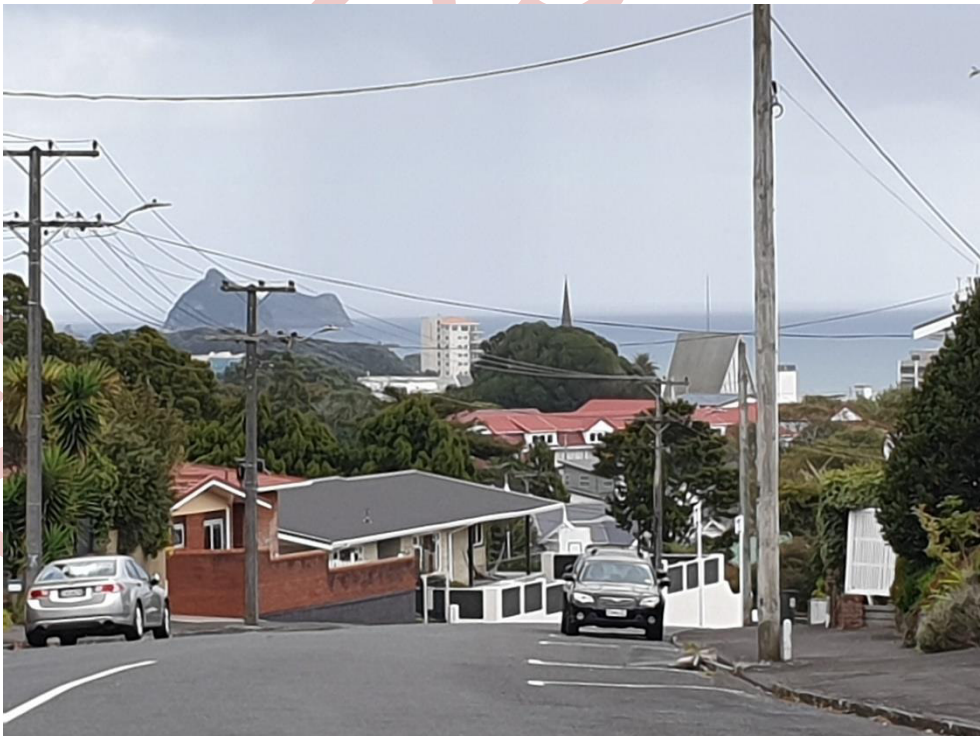
Figure J 2: Zoomed in photo from top of Cameron Street viewshaft (Source: BTW)

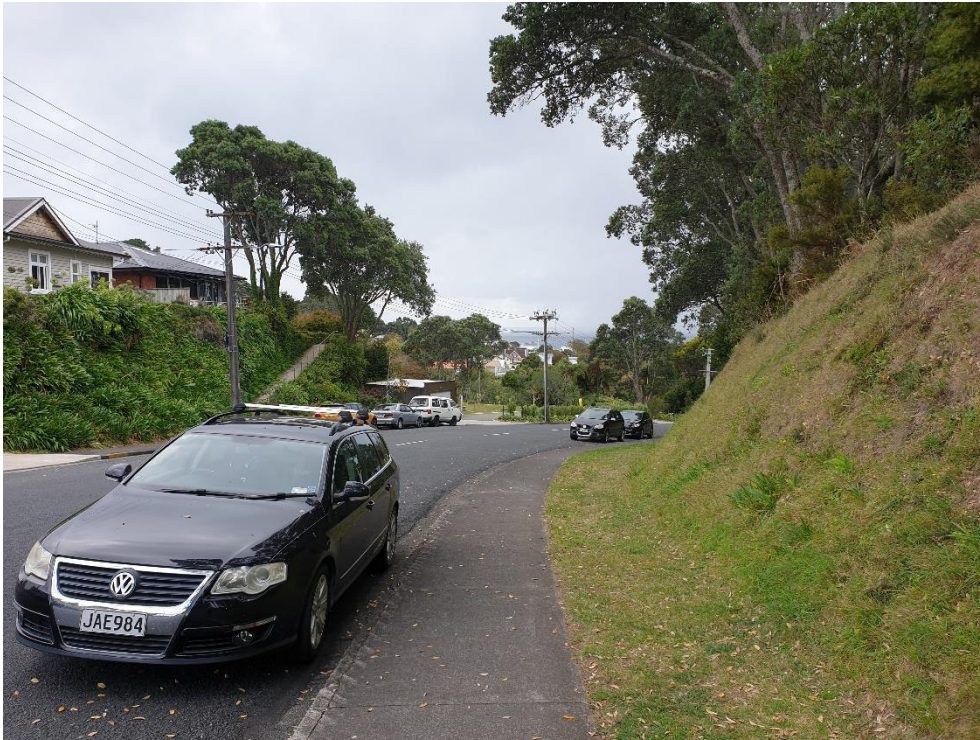
Figure J 3: Photo from Victoria Road viewshaft (Source BTW)

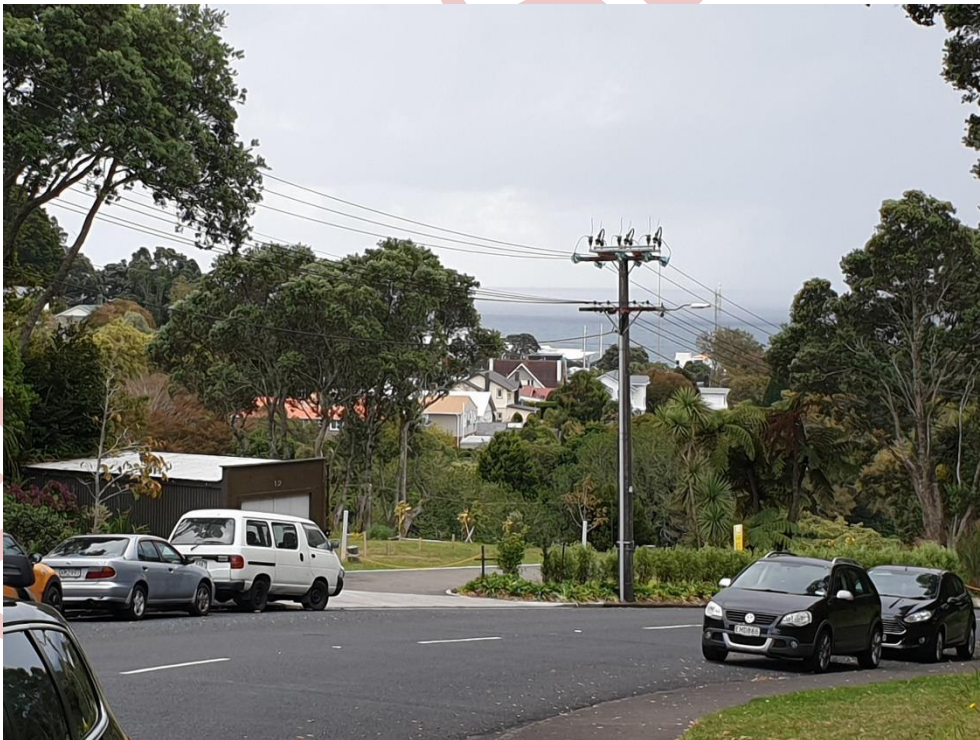
Figure J 4: Zoomed in photo from Victoria Road viewshaft, site location not clear (Source: BTW)

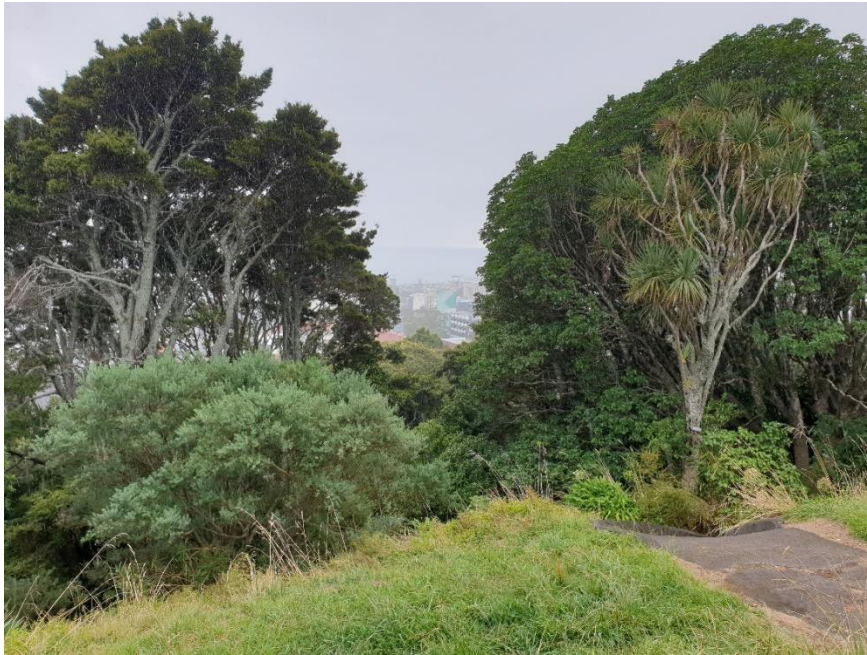
Figure J 5: Photo from Marsland Hill/Pukaka viewshaft (Source: BTW)

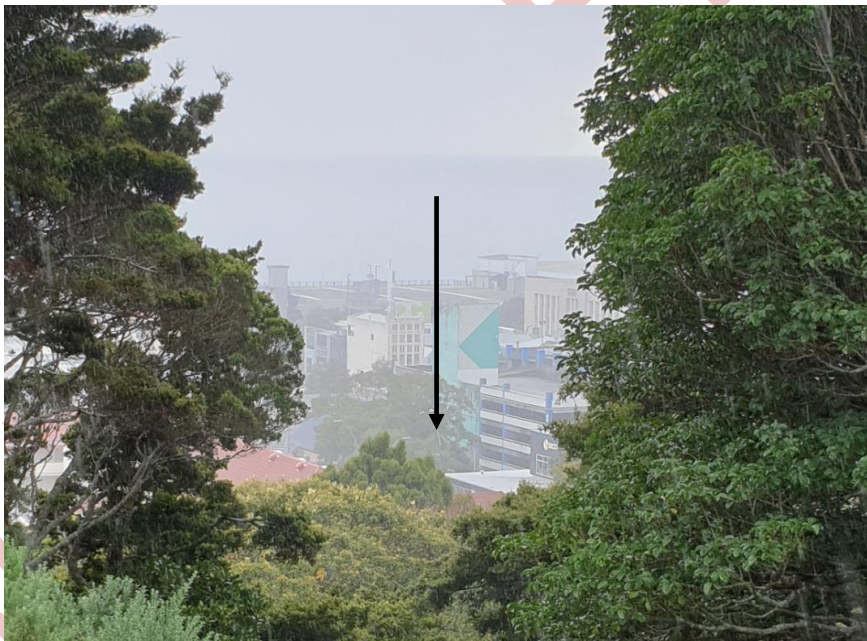
Figure J 6: Zoomed in photo from Marsland Hill/Pukaka, site indicated (Source: BTW)

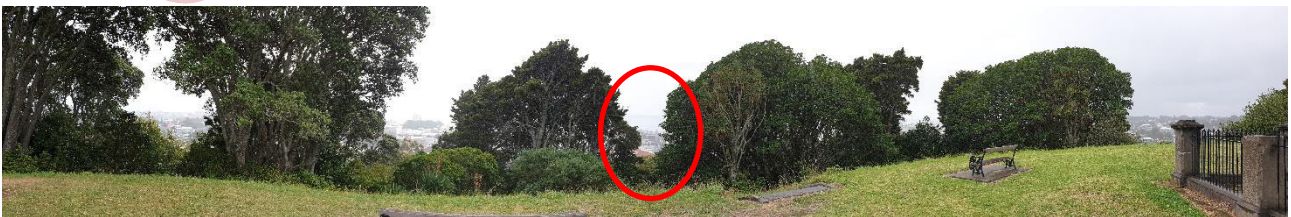
Figure J 7: Panorama of the view from Marsland Hill/Pukaka viewshaft facing the site in context with other available viewpoints (Source: BTW)

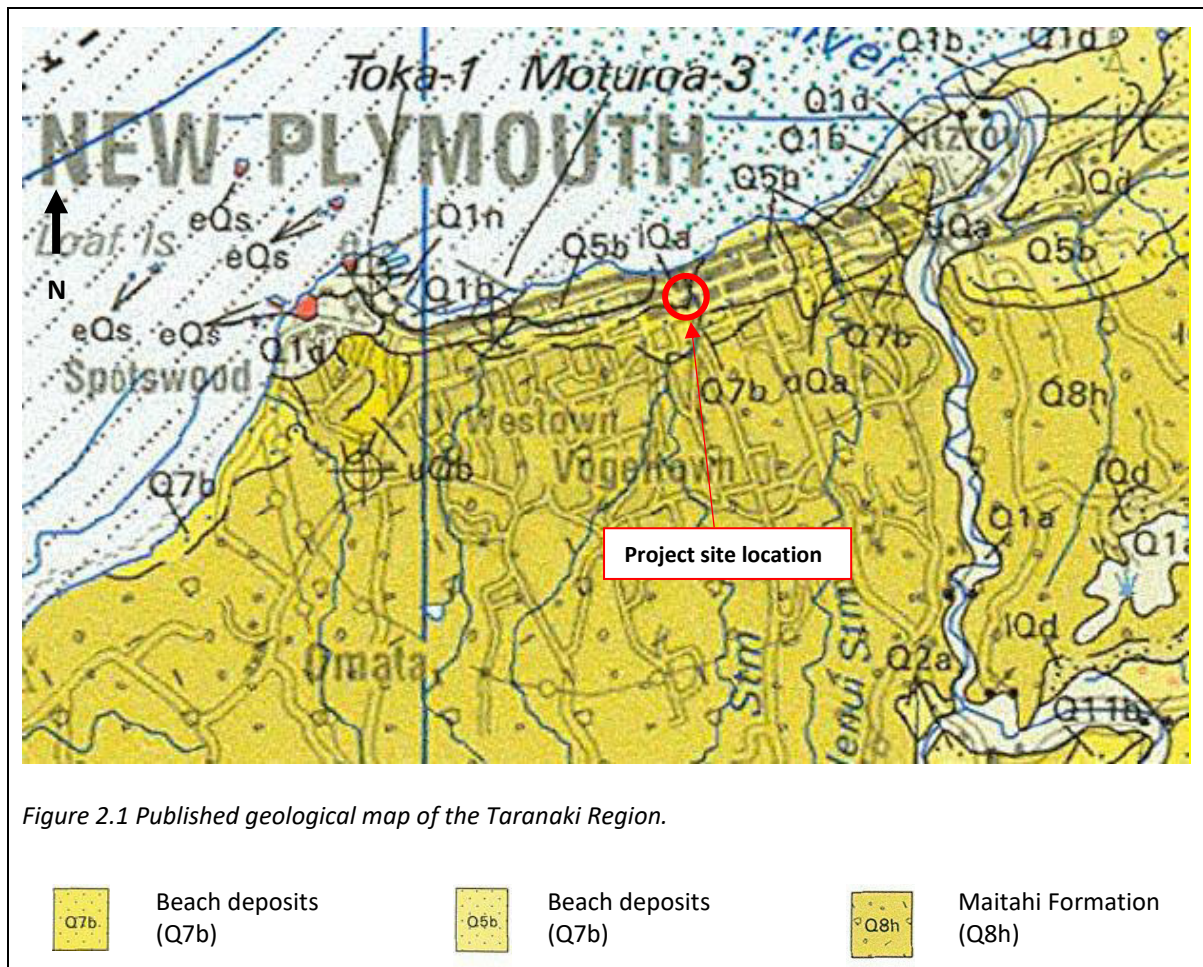
The published geological map of the area<sup>5</sup> indicates that the site is underlain by the Pouakai Group (marine terraces/ beach deposits), and bound to the coastline by the Maitahi Formation (debris avalanche) to the south. The site is overlain by a small covering of Holocene age Taranaki Brown Ash. New Plymouth is located 30km north of Mt Taranaki on the Pouakai volcanic ring plain, which consists of radiating and coalescing fans of laharic, pyroclastic and alluvial volcanoclastic detritus. The location of the site in the context of the regional geology is presented below on Figure 2.1.

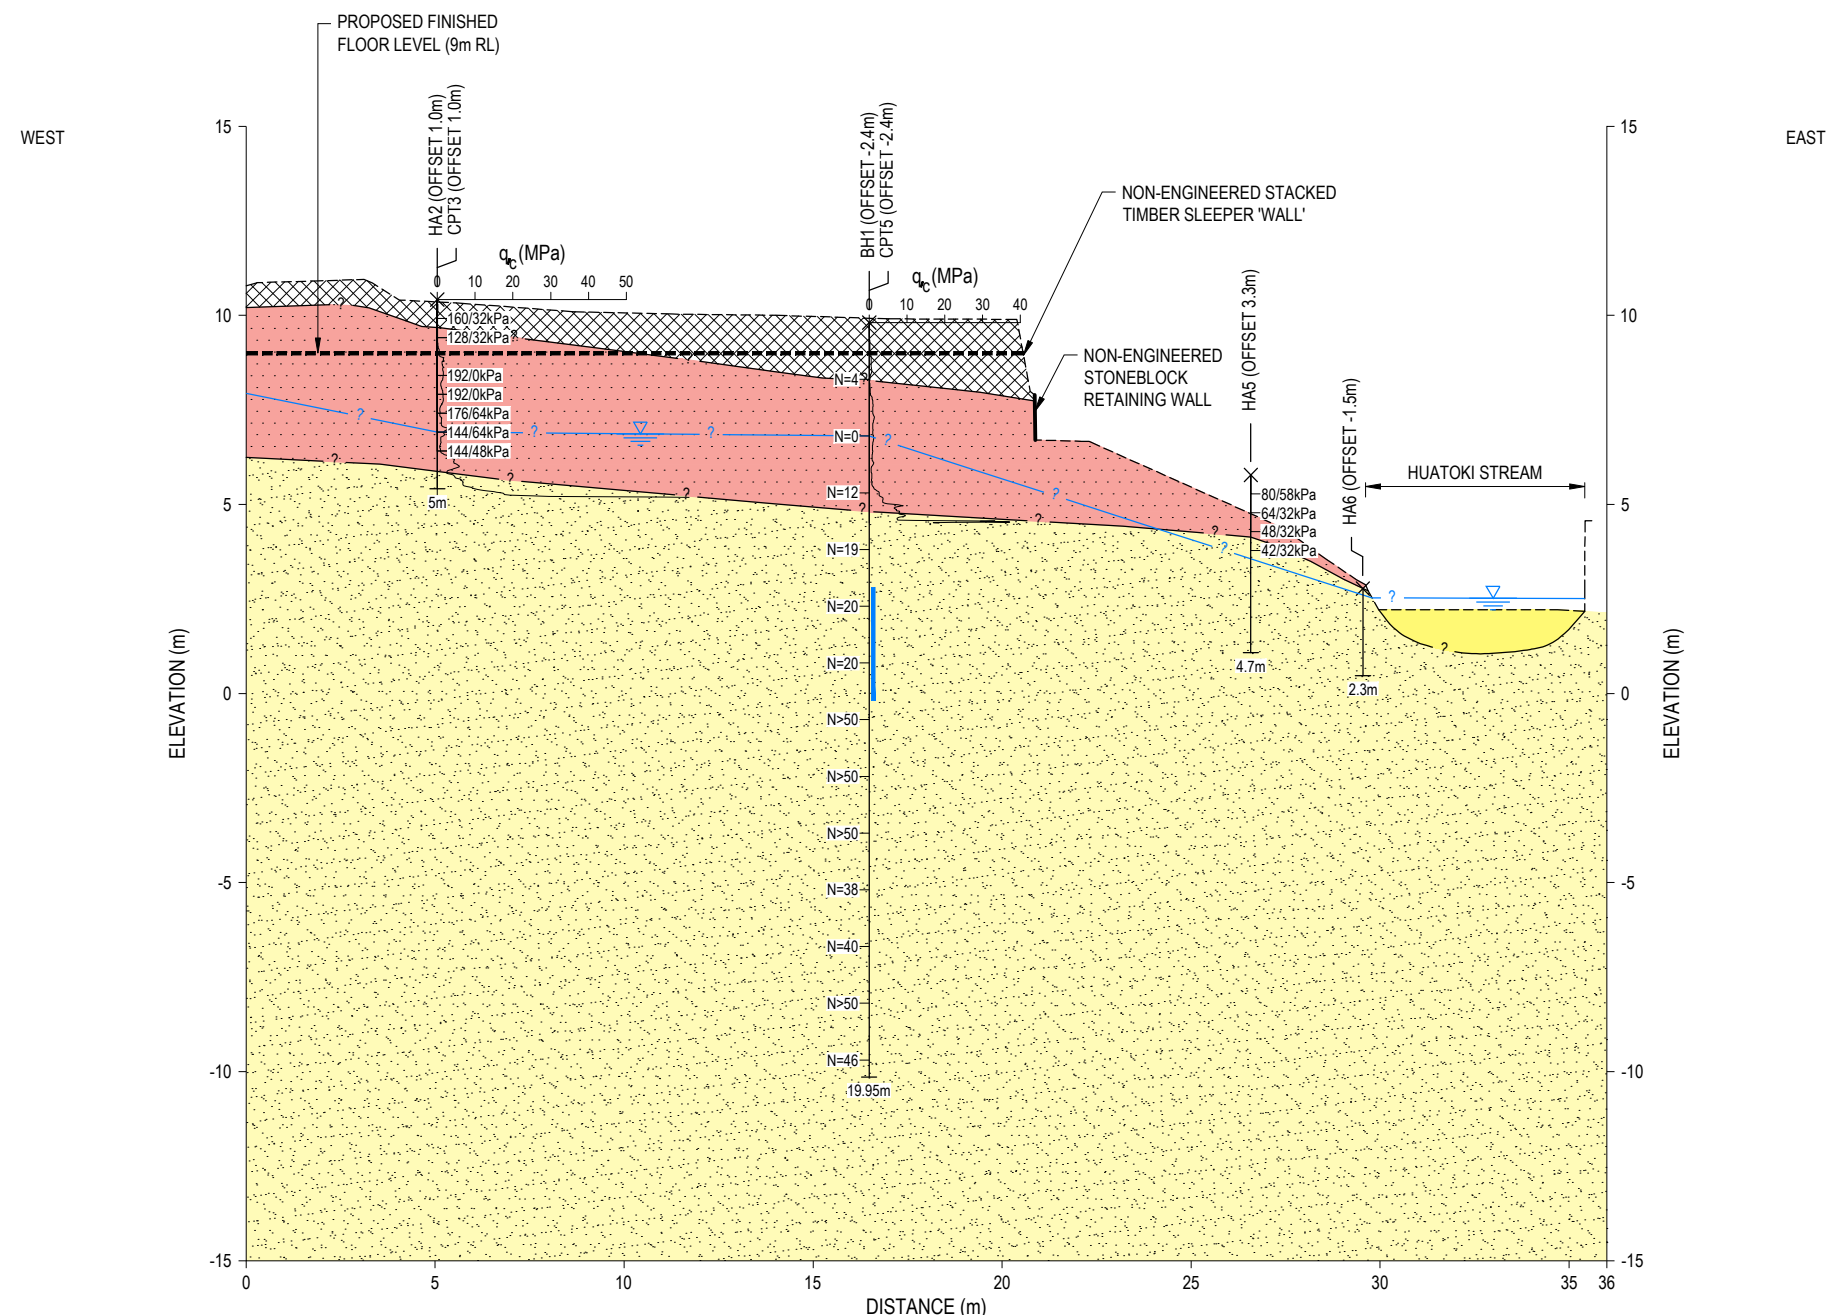
SECTION 1 F1  
SCALE 1:200

CLIENT	<b>RED JACKET LIMITED</b>	
PROJECT	<b>51 BROUGHAM STREET, NEW PLYMOUTH</b>	
TITLE	GEOTECHNICAL INVESTIGATION GEOLOGICAL CROSS SECTION 1	
SCALE (A3)	1:200	FIG No. FIGURE 2
REV	1

The groundwater level was measured at 3.2 m below ground level (6.3 RL m) within BH1. Seasonal fluctuation is expected. For the purpose of foundation design and construction, we recommend a design groundwater level that is shown in the cross section in Appendix A. Table 2-3 show a summary of the piezometer details.

Slope stability analysis software SLOPE/W by Geostudio was used to assess a critical section of the existing slope. A cross section (Figure 1, Appendix A) was developed using site survey, geological information and measured groundwater levels.

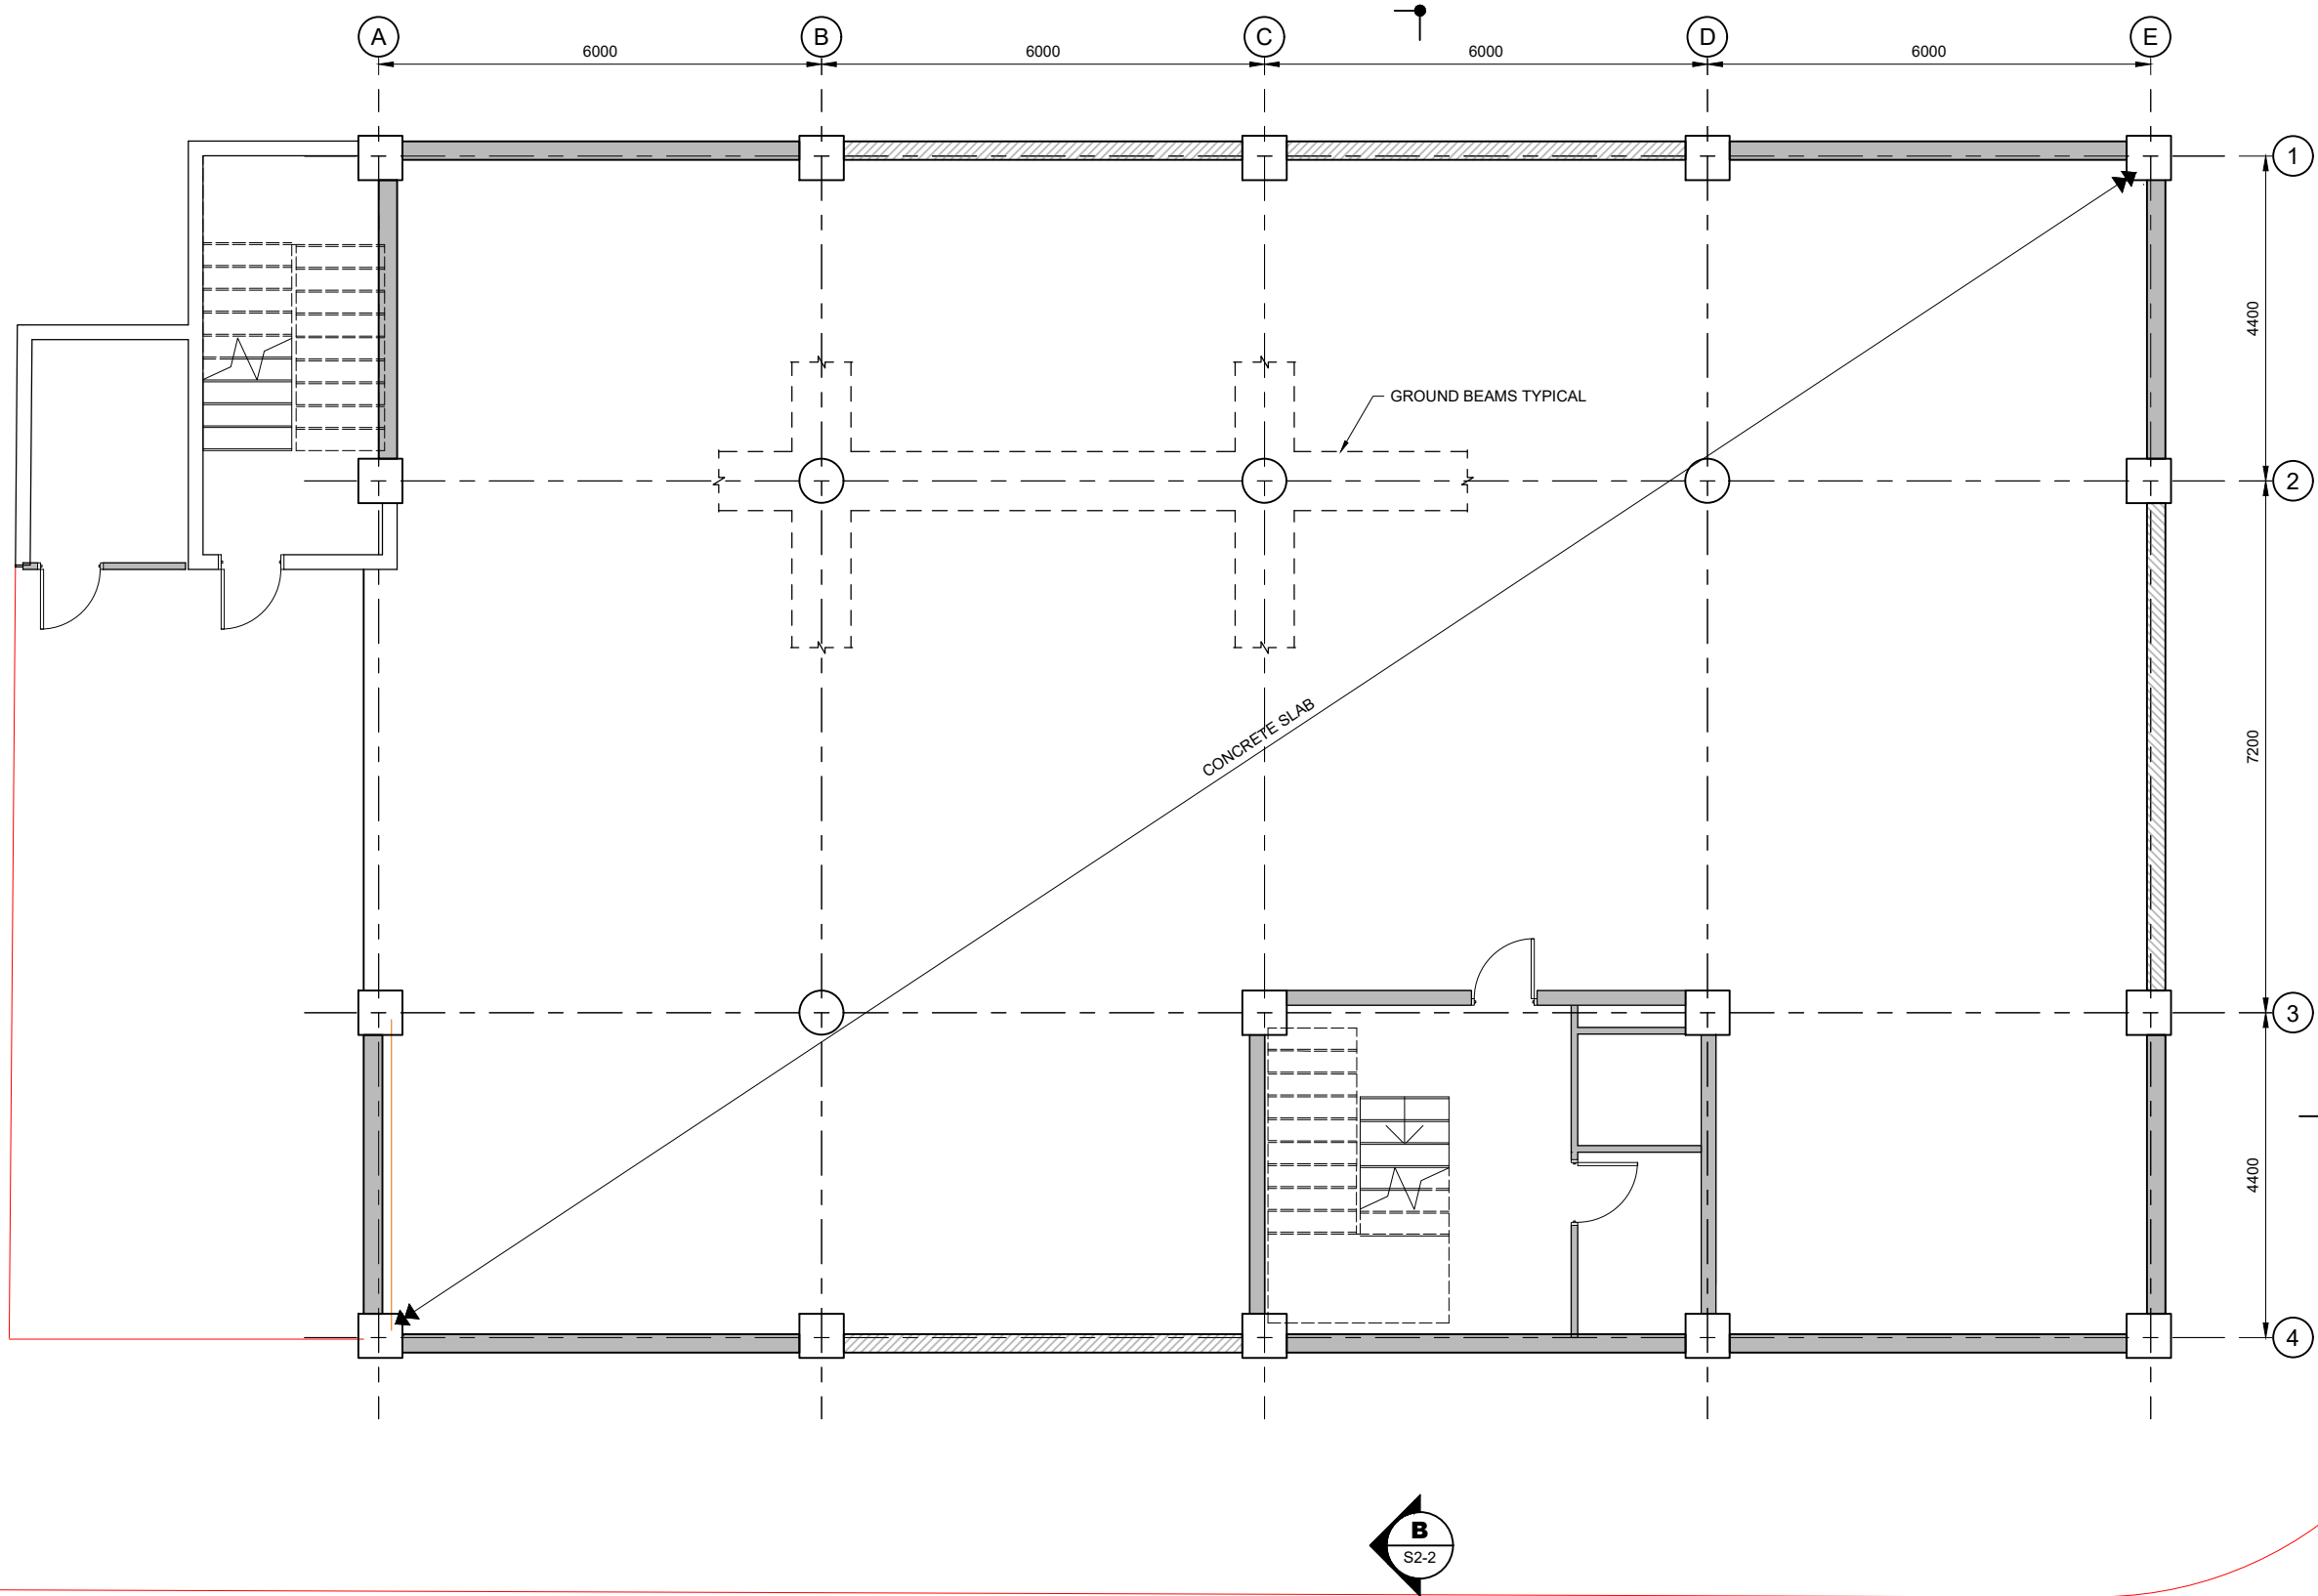
**BASEMENT PLAN**  
1:100

- LEGEND**
- FULL HEIGHT WALL
  - PART HEIGHT WALL
  - 600 SQUARE INSITU CONCRETE COLUMN
  - 600 CIRCULAR INSITU CONCRETE COLUMN

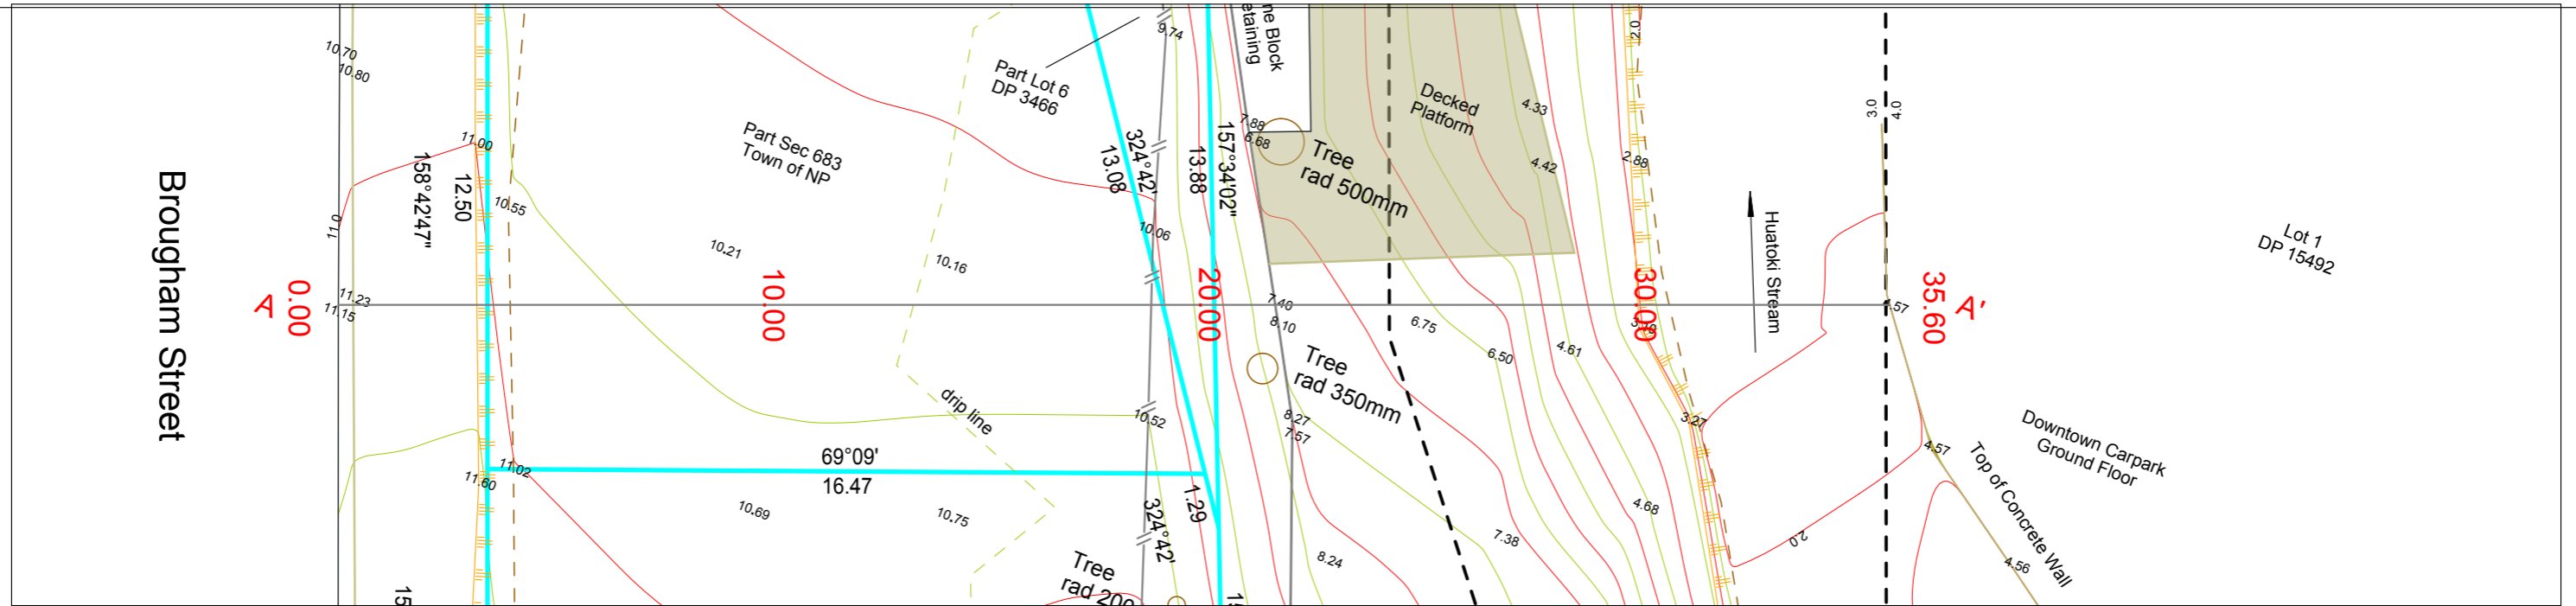
Profile A - A'	11.14	11.22	11.29	10.92	10.72	10.40	10.31	10.29	10.24	10.25	10.25	10.23	9.23	8.57	8.07	7.31	6.74	6.43	5.91	4.56	3.29	3.07	2.80	2.14	1.96	1.95
Ground Level	11.14	11.22	11.29	10.92	10.72	10.40	10.31	10.29	10.24	10.25	10.25	10.23	9.23	8.57	8.07	7.31	6.74	6.43	5.91	4.56	3.29	3.07	2.80	2.14	1.96	1.95
Chainage	0.00	0.34	3.18	3.66	3.94	7.70	8.98	10.00	13.33	14.03	15.13	18.65	20.00	20.88	21.49	21.66	24.52	25.18	26.84	28.00	29.52	29.82	30.00	30.54	35.06	35.59

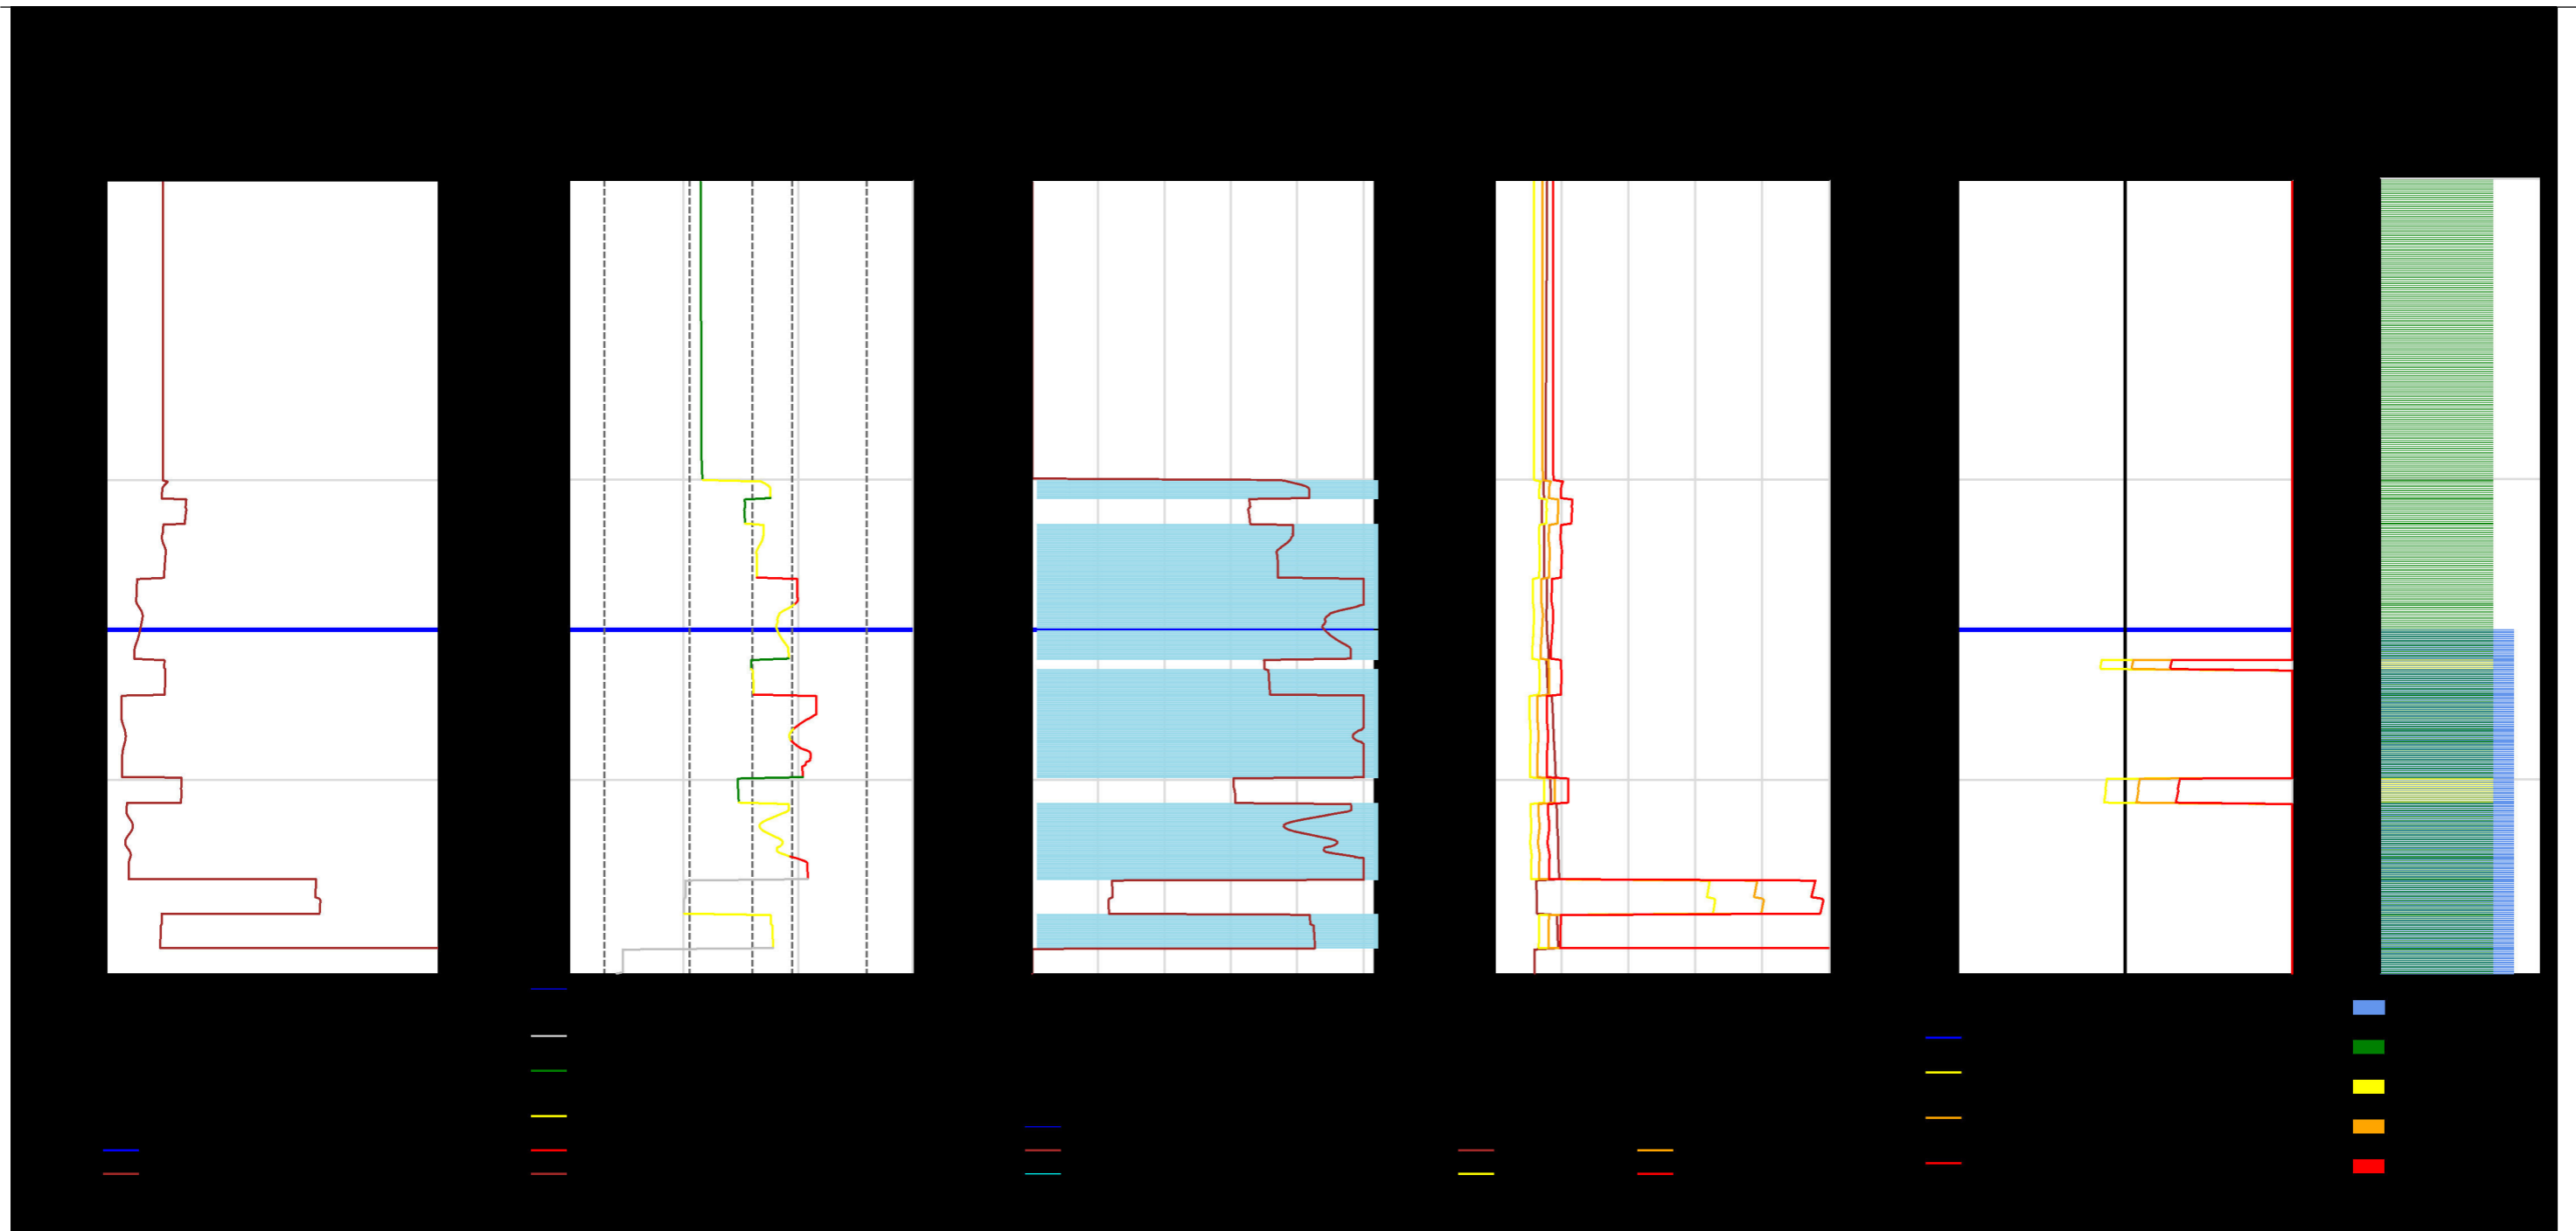
Note: Inverse filtered  $Q_c/F_s$  data ( $10\text{ cm}^2$ ) used.

Run Description	TTGD ID	Investigation Date	Pre-drill (m)	Magnitude	PGA (g)	Trigger Method	Settlement Method	$\gamma$ (kN/m <sup>3</sup> )	Surcharge/Cut/Fill	Surcharge (kPa)	Cut/Fill Height (m)
INPUT CPT01	140508	30/07/2019	2	6	0.29	BI-2014	ZRB-2002	18		0	
PL	SV1D (mm)	CTL (m)	LPI	LSN	CT (m)	LPlish					
OUTPUT 15%	4	0.2	0	1	4	0					
50%	2	0	0	0	5.3	0					
85%	1	0	0	0	5.3	0
