# RESOURCE CONSENT APPLICATION AND ASSESSMENT OF ENVIRONMENTAL EFFECTS

Brougham Street Commercial  
Development

for K.D. Holdings Limited

Rev 1 - 29/04/2020

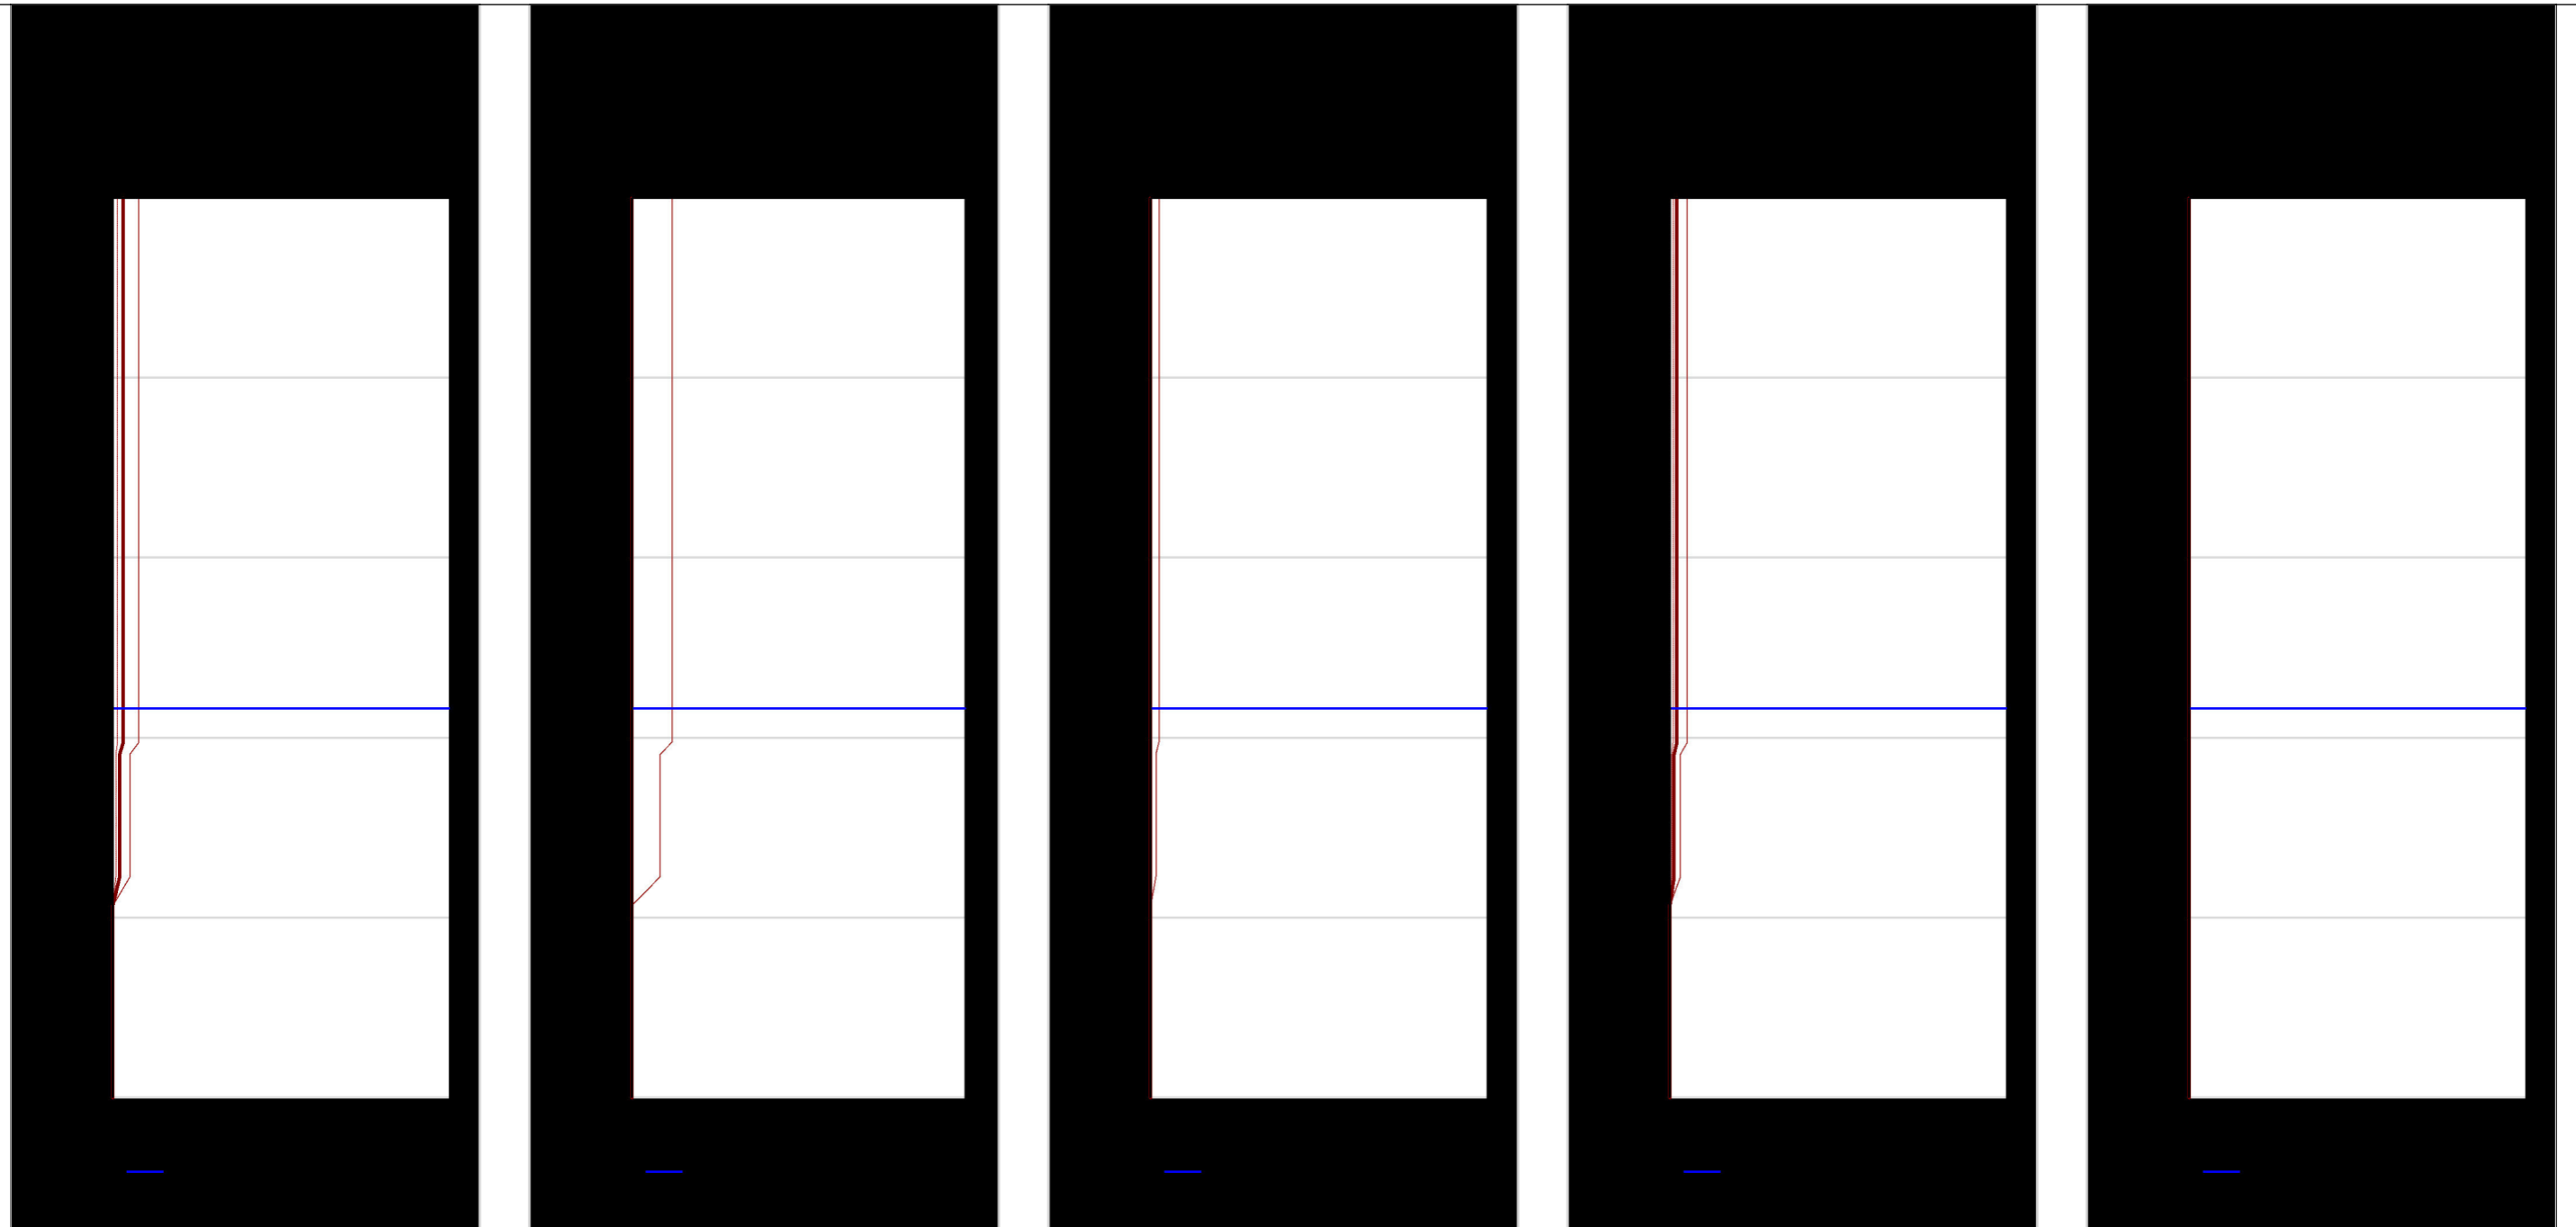
Run Description	TTGD ID	Investigation Date	Pre-drill (m)	Magnitude	PGA (g)	Trigger Method	Settlement Method	$\gamma$ (kN/m <sup>3</sup> )	Surcharge/Cut/Fill	Surcharge (kPa)	Cut/Fill Height (m)
INPUT CPT01	140508	30/07/2019	2	6	0.29	BI-2014	ZRB-2002	18		0

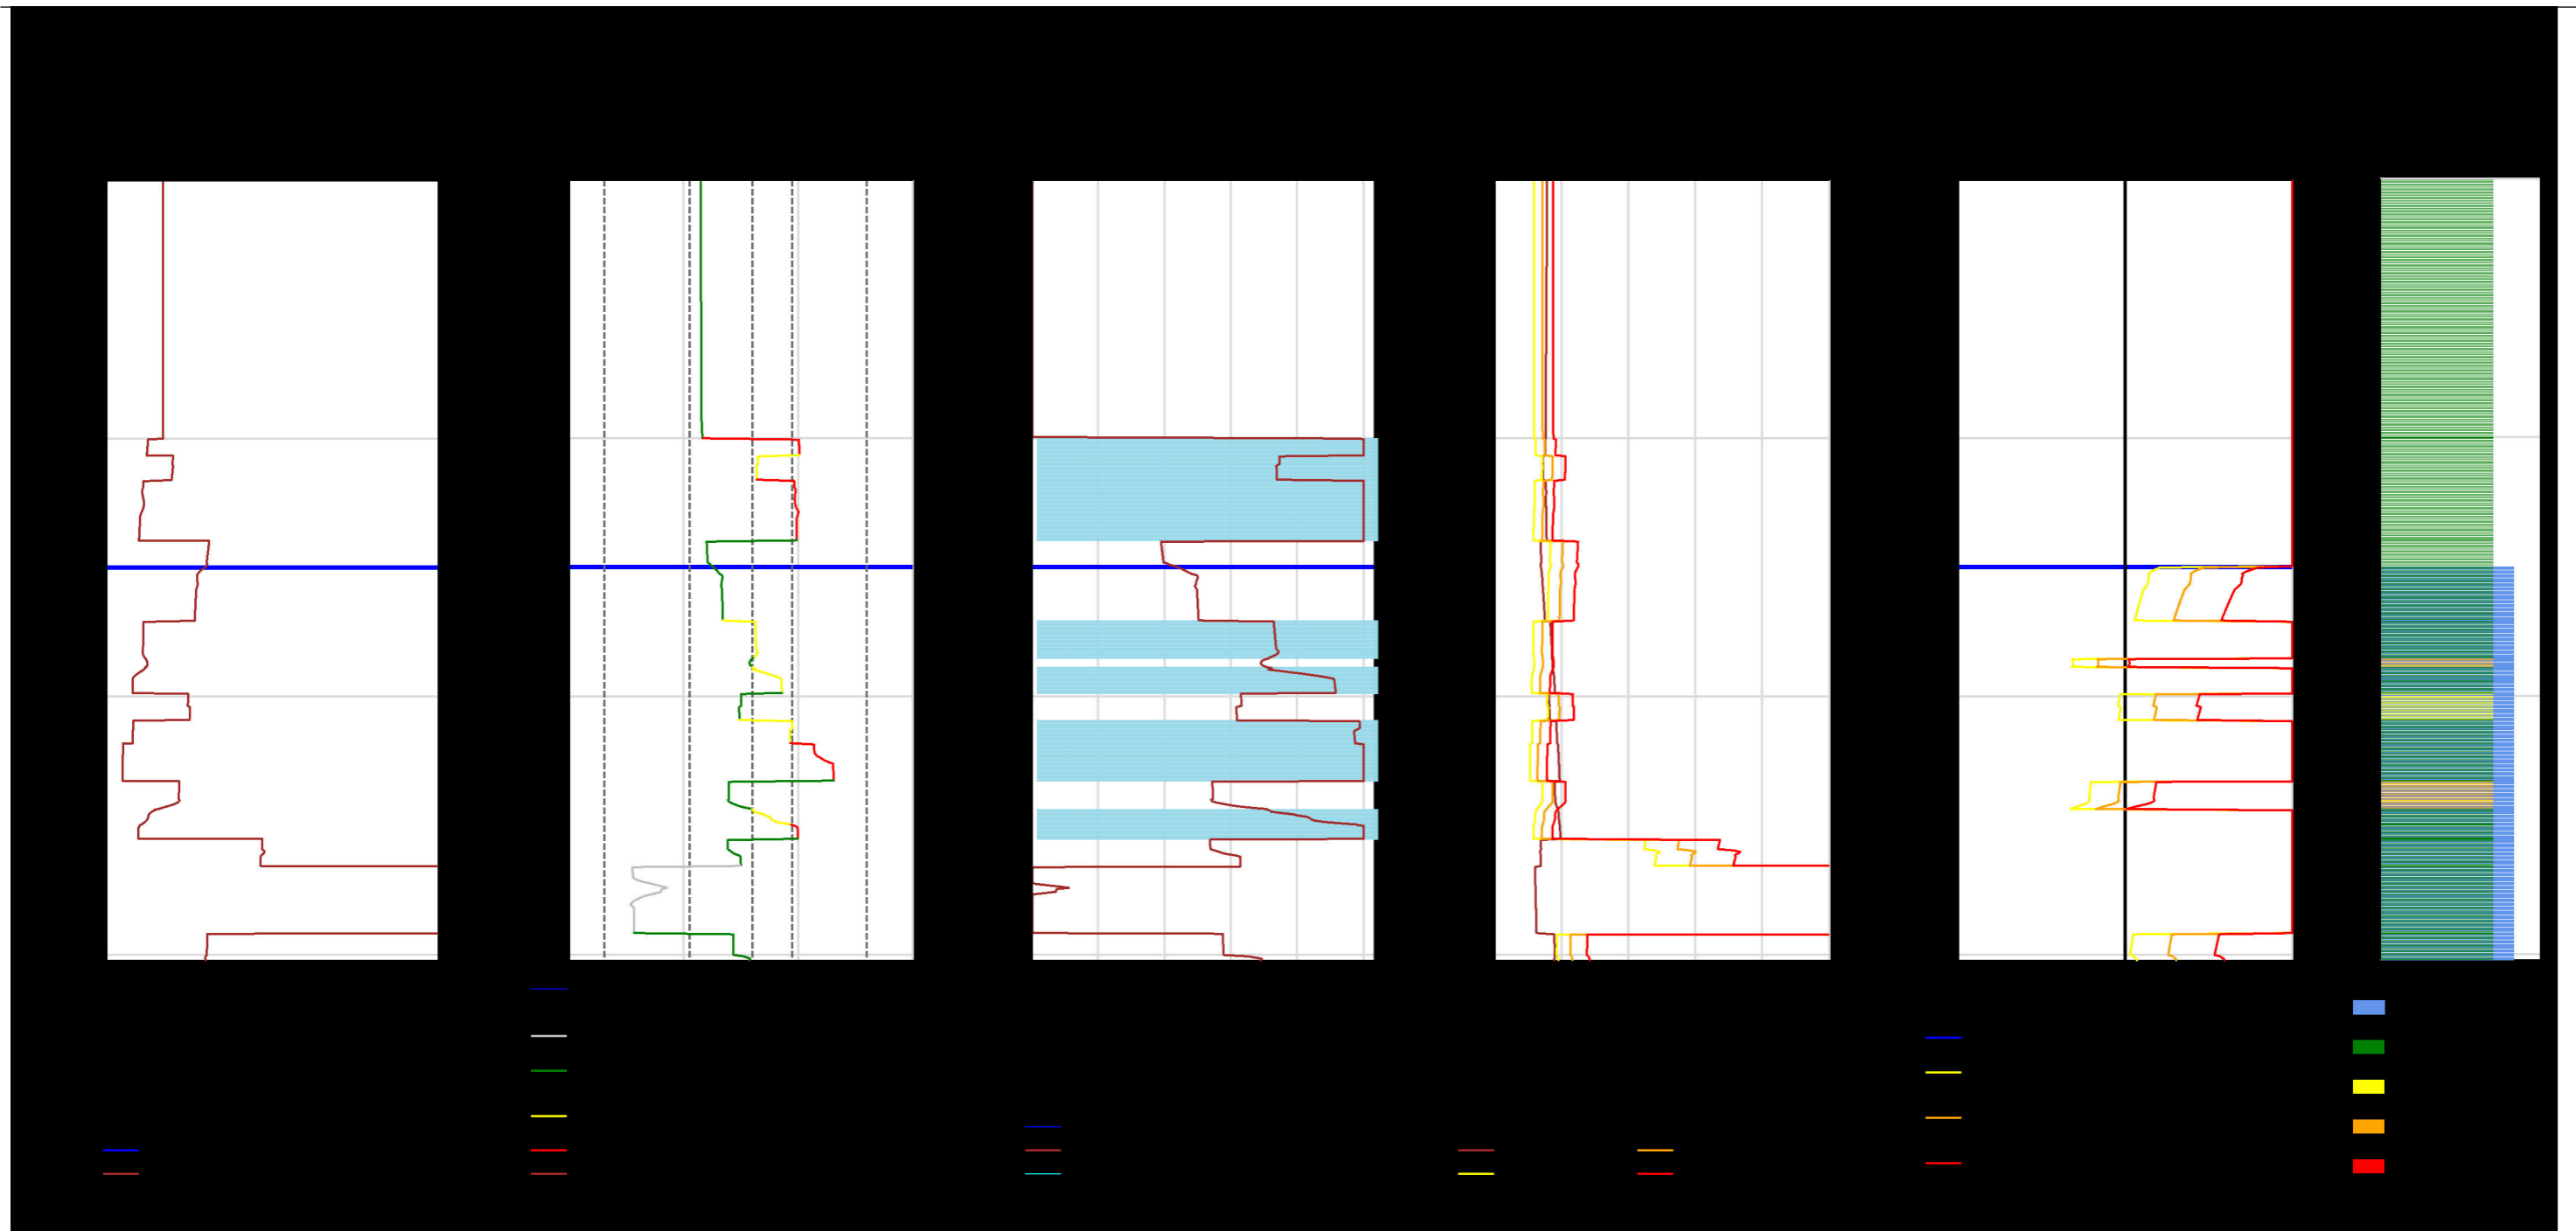
Note: Inverse filtered Qc/Fs data (10 cm<sup>2</sup>) used.

Run Description	TTGD ID	Investigation Date	Pre-drill (m)	Magnitude	PGA (g)	Trigger Method	Settlement Method	$\gamma$ (kN/m <sup>3</sup> )	Surcharge/Cut/Fill	Surcharge (kPa)	Cut/Fill Height (m)
INPUT CPT01A	140510	30/07/2019	2	6	0.29	BI-2014	ZRB-2002	18		0	
PL	SV1D (mm)	CTL (m)	LPI	LSN	CT (m)	LPlish					
OUTPUT 15%	12	0.5	1	3	4	0					
50%	7	0.3	0	2	4.7	0					
85%	3	0	0	1	6	0

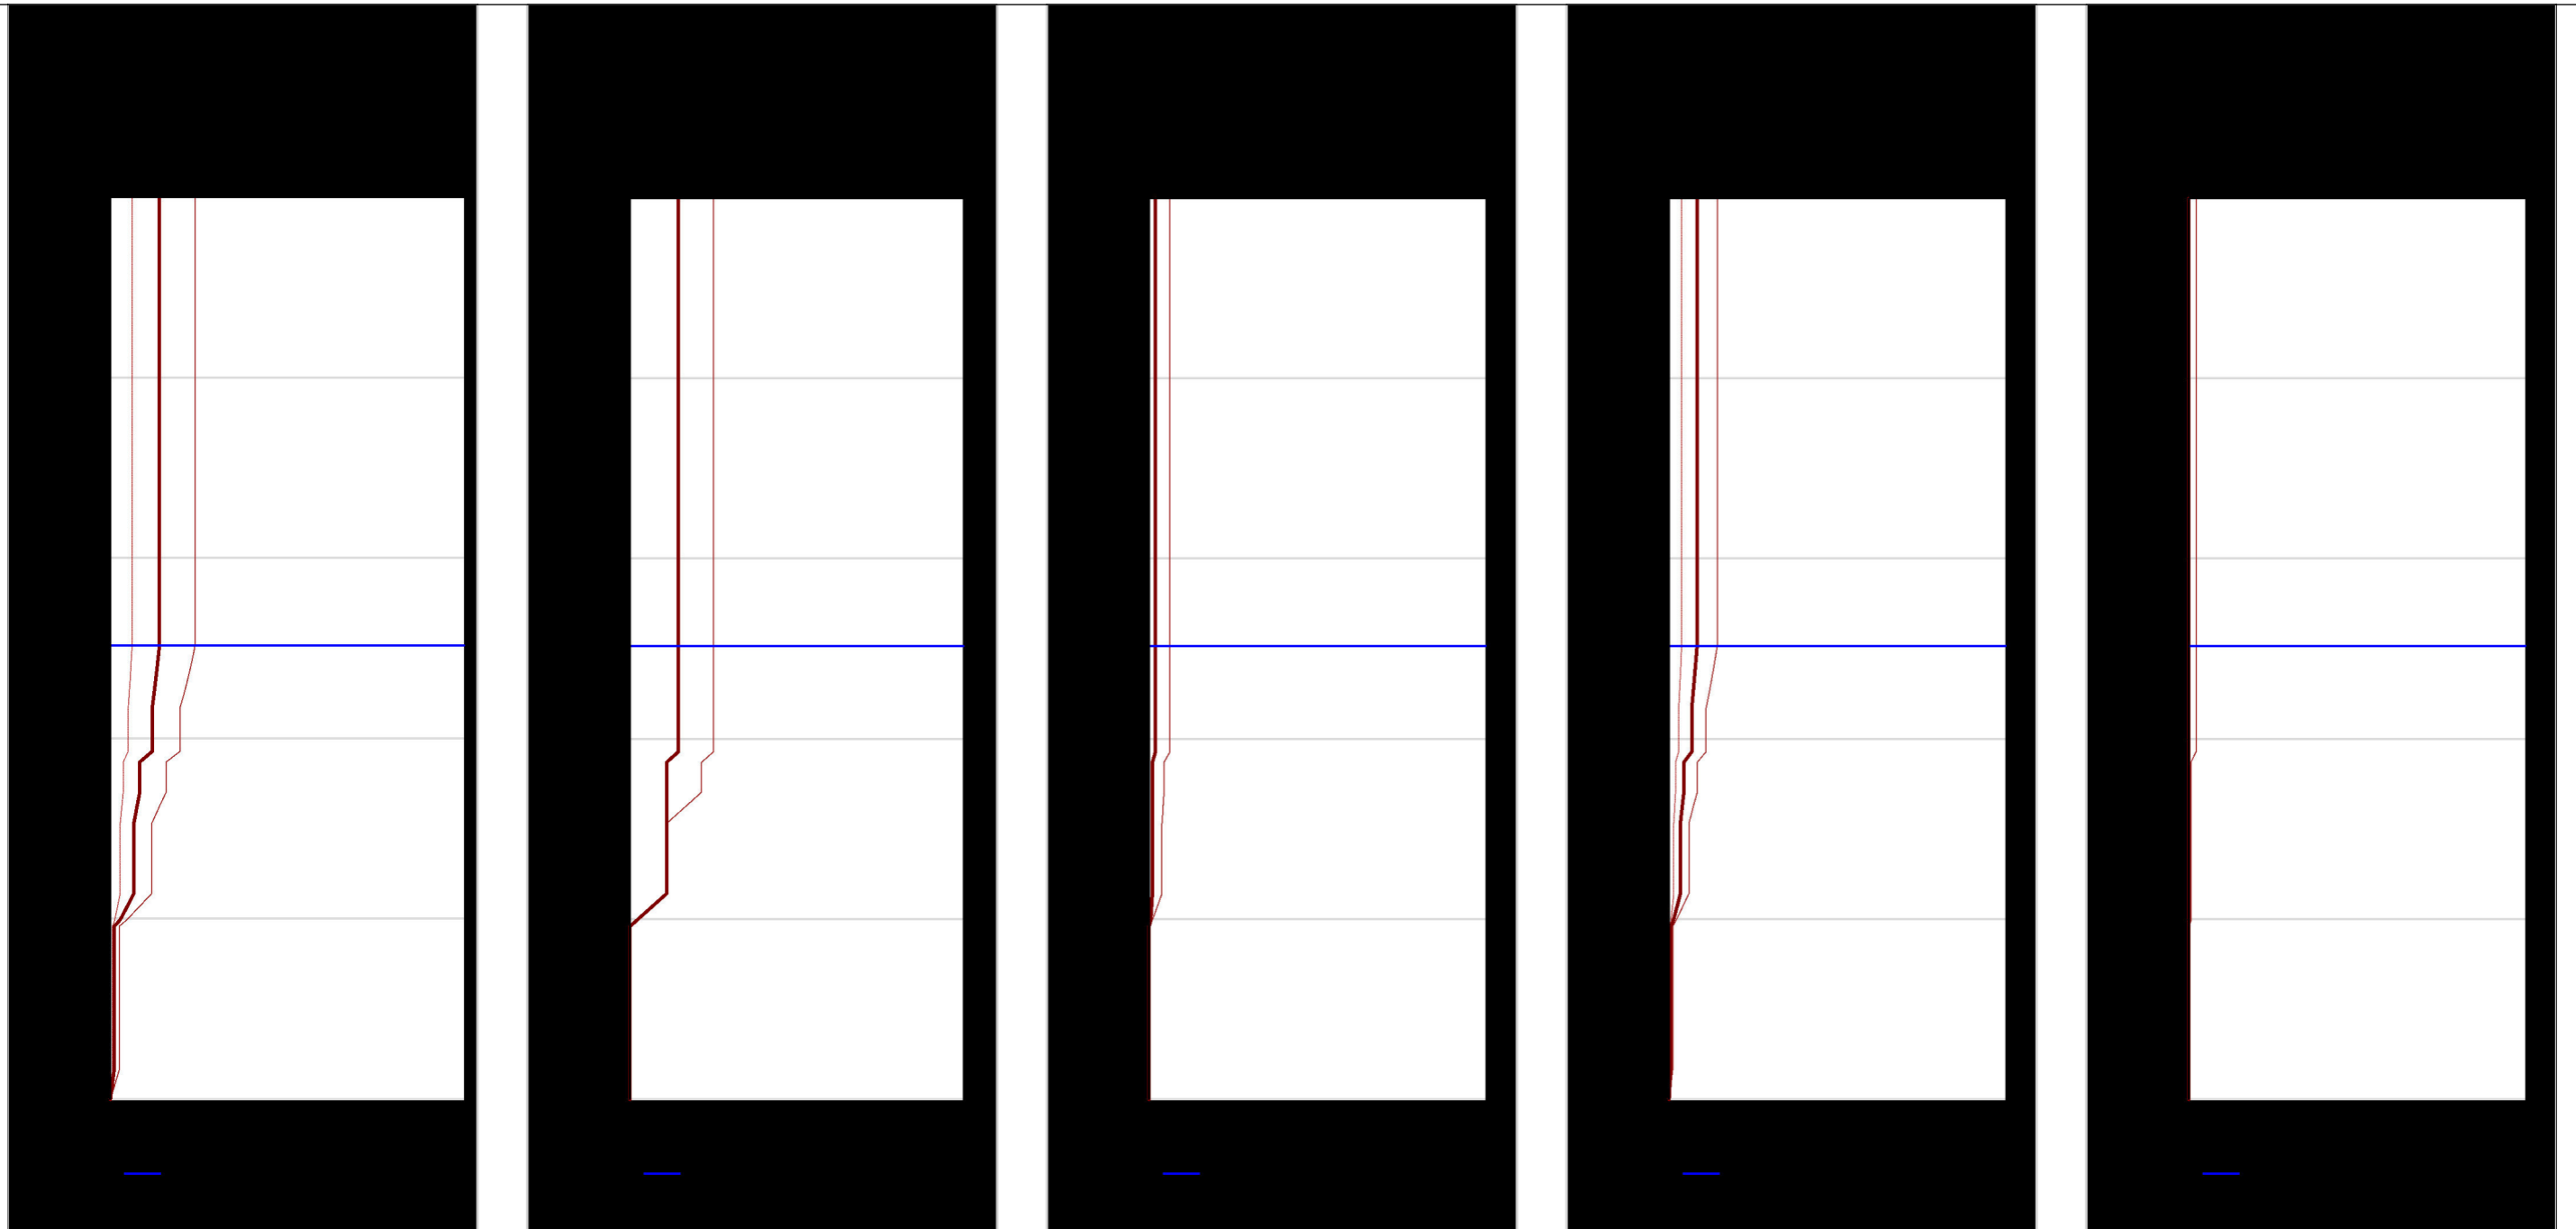
Run Description	TTGD ID	Investigation Date	Pre-drill (m)	Magnitude	PGA (g)	Trigger Method	Settlement Method	$\gamma$ (kN/m <sup>3</sup> )	Surcharge/Cut/Fill	Surcharge (kPa)	Cut/Fill Height (m)
INPUT CPT01A	140510	30/07/2019	2	6	0.29	BI-2014	ZRB-2002	18		0

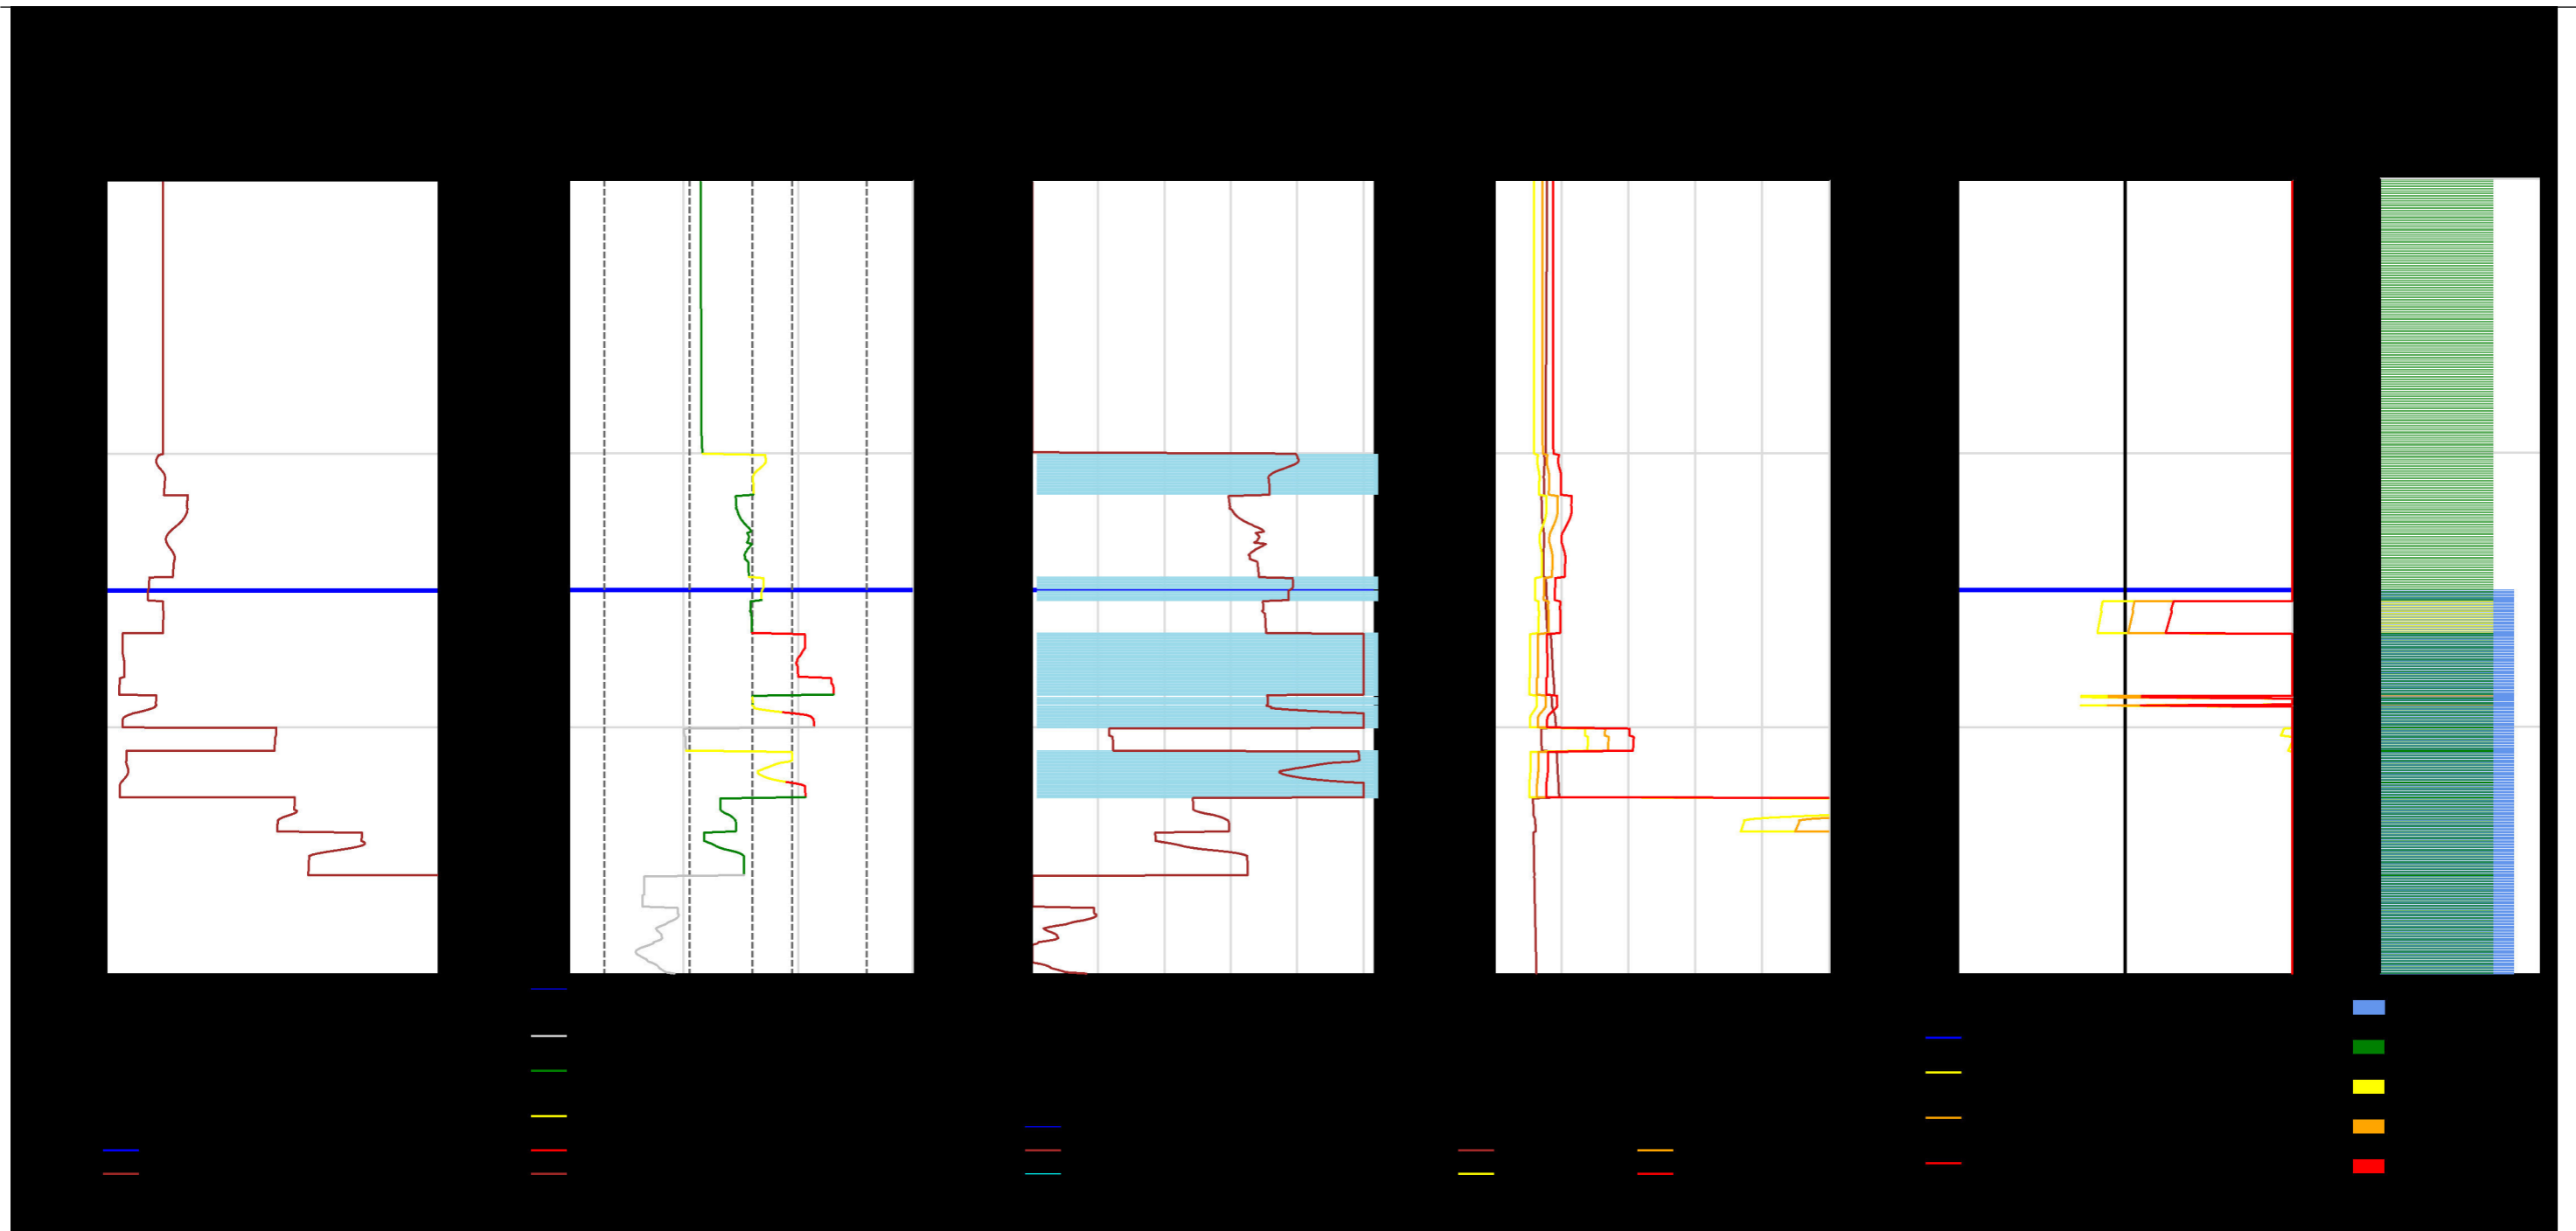
Note: Inverse filtered  $Q_c/F_s$  data ( $10\text{ cm}^2$ ) used.

Run Description	TTGD ID	Investigation Date	Pre-drill (m)	Magnitude	PGA (g)	Trigger Method	Settlement Method	$\gamma$ (kN/m <sup>3</sup> )	Surcharge/Cut/Fill	Surcharge (kPa)	Cut/Fill Height (m)
INPUT CPT02	140509	30/07/2019	2	6	0.29	BI-2014	ZRB-2002	18		0	
PL	SV1D (mm)	CTL (m)	LPI	LSN	CT (m)	LPlish					
OUTPUT 15%	5	0.3	0	2	3.2	0					
50%	2	0	0	1	5.8	0					
85%	1	0	0	0	5.8	0

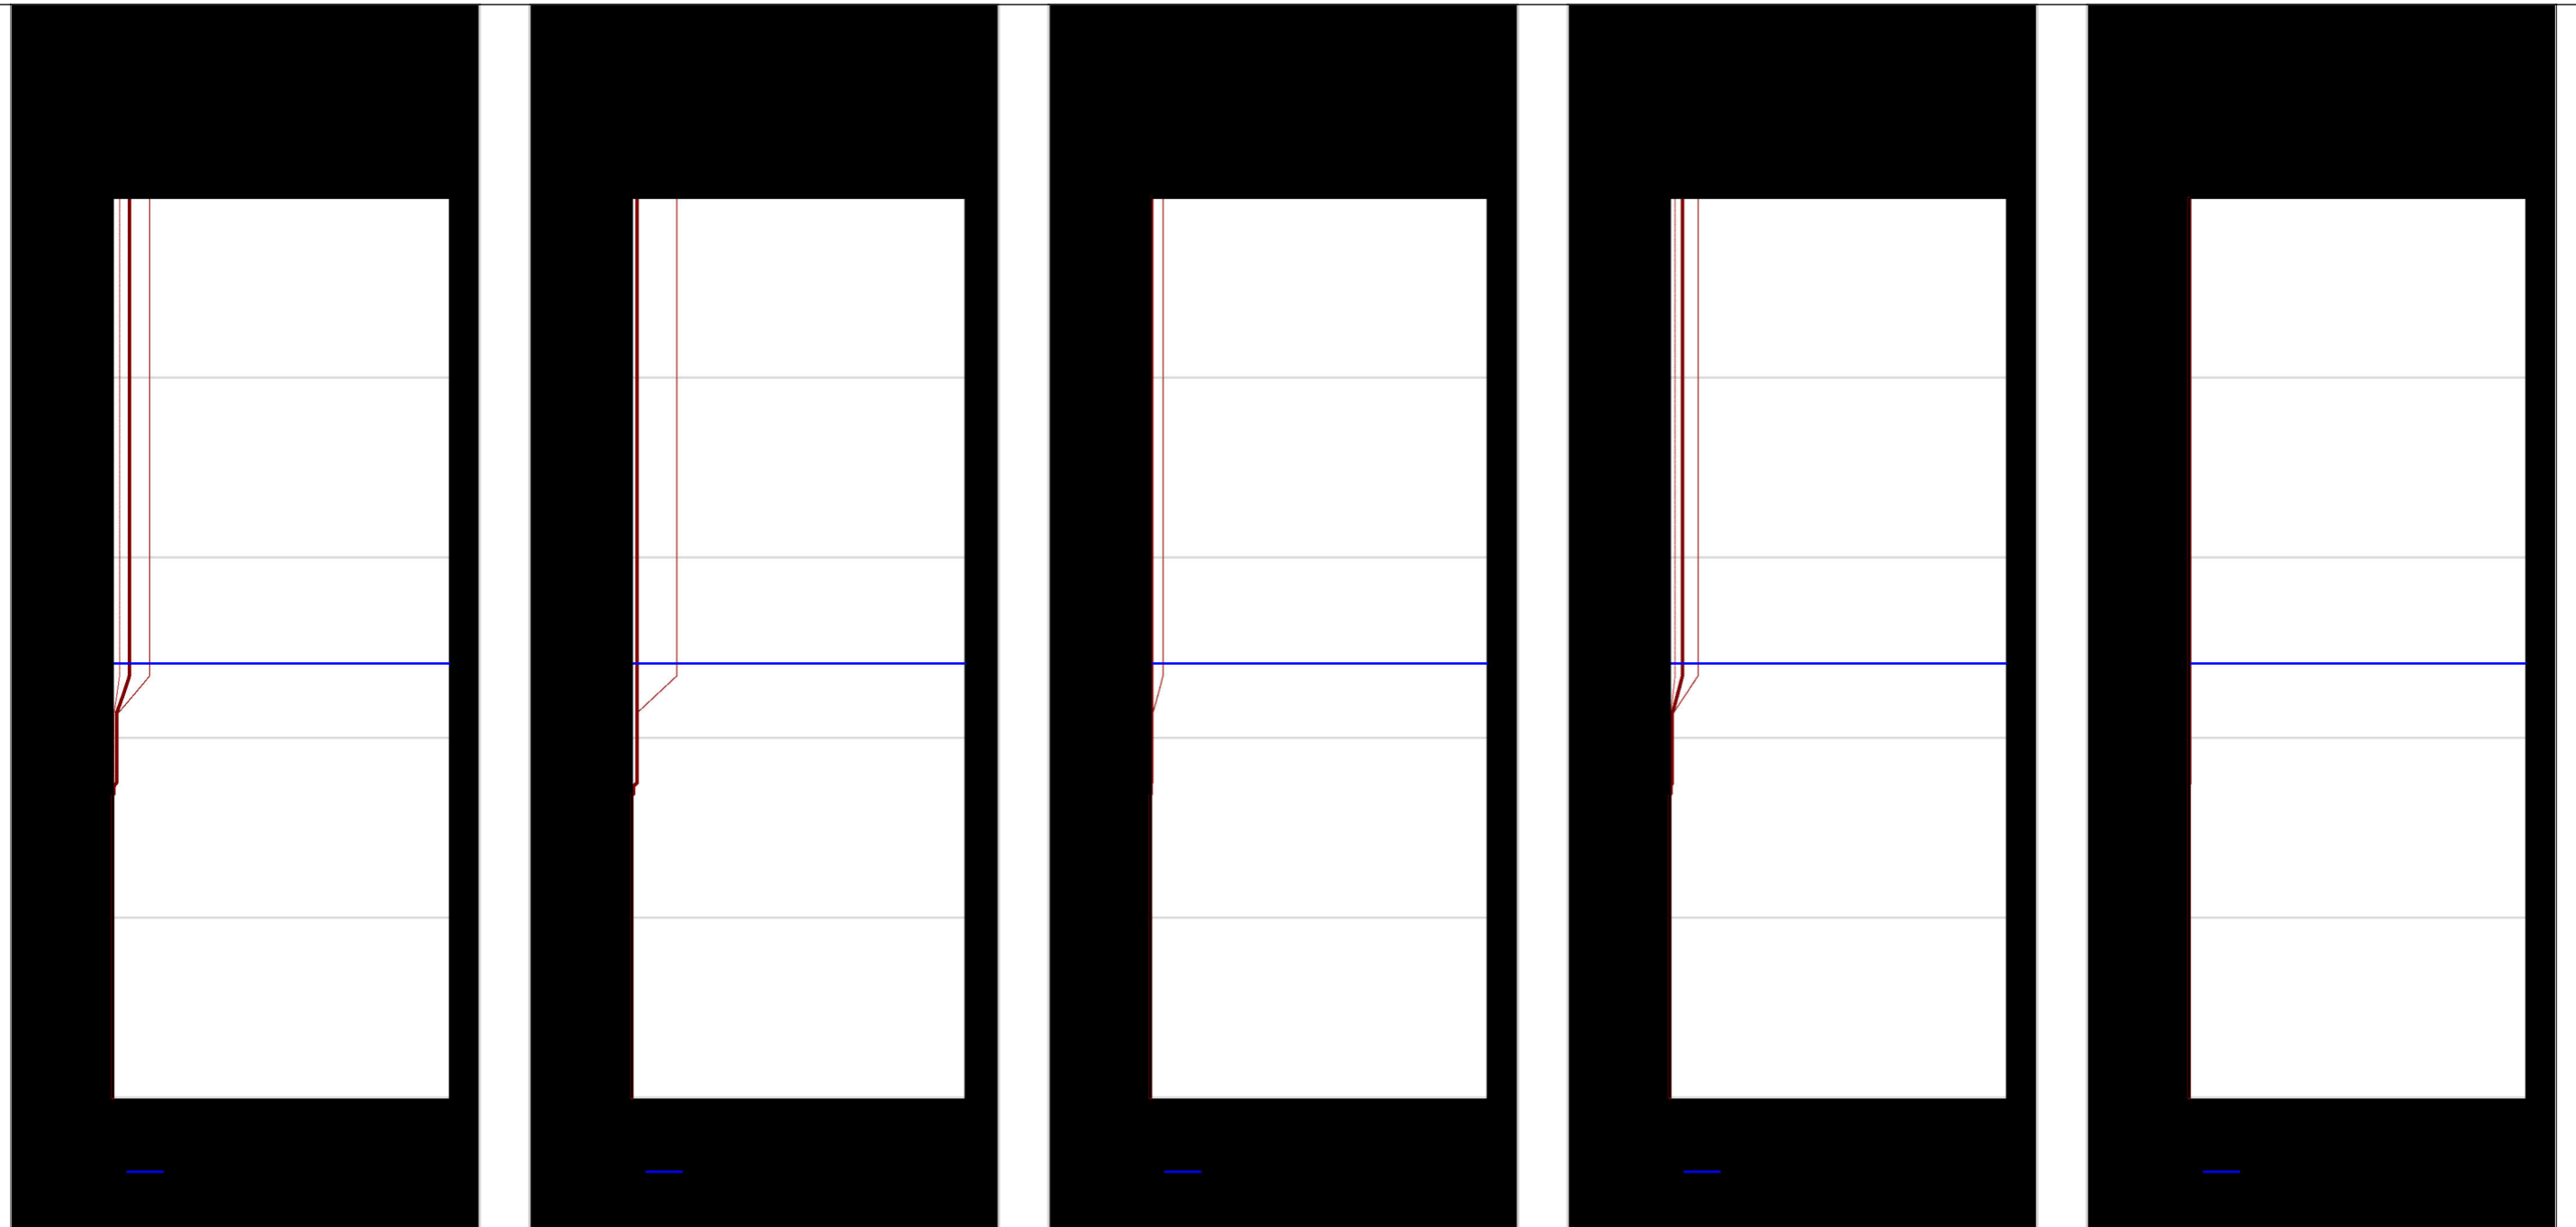
Run Description	TTGD ID	Investigation Date	Pre-drill (m)	Magnitude	PGA (g)	Trigger Method	Settlement Method	$\gamma$ (kN/m <sup>3</sup> )	Surcharge/Cut/Fill	Surcharge (kPa)	Cut/Fill Height (m)
INPUT CPT02	140509	30/07/2019	2	6	0.29	BI-2014	ZRB-2002	18		0

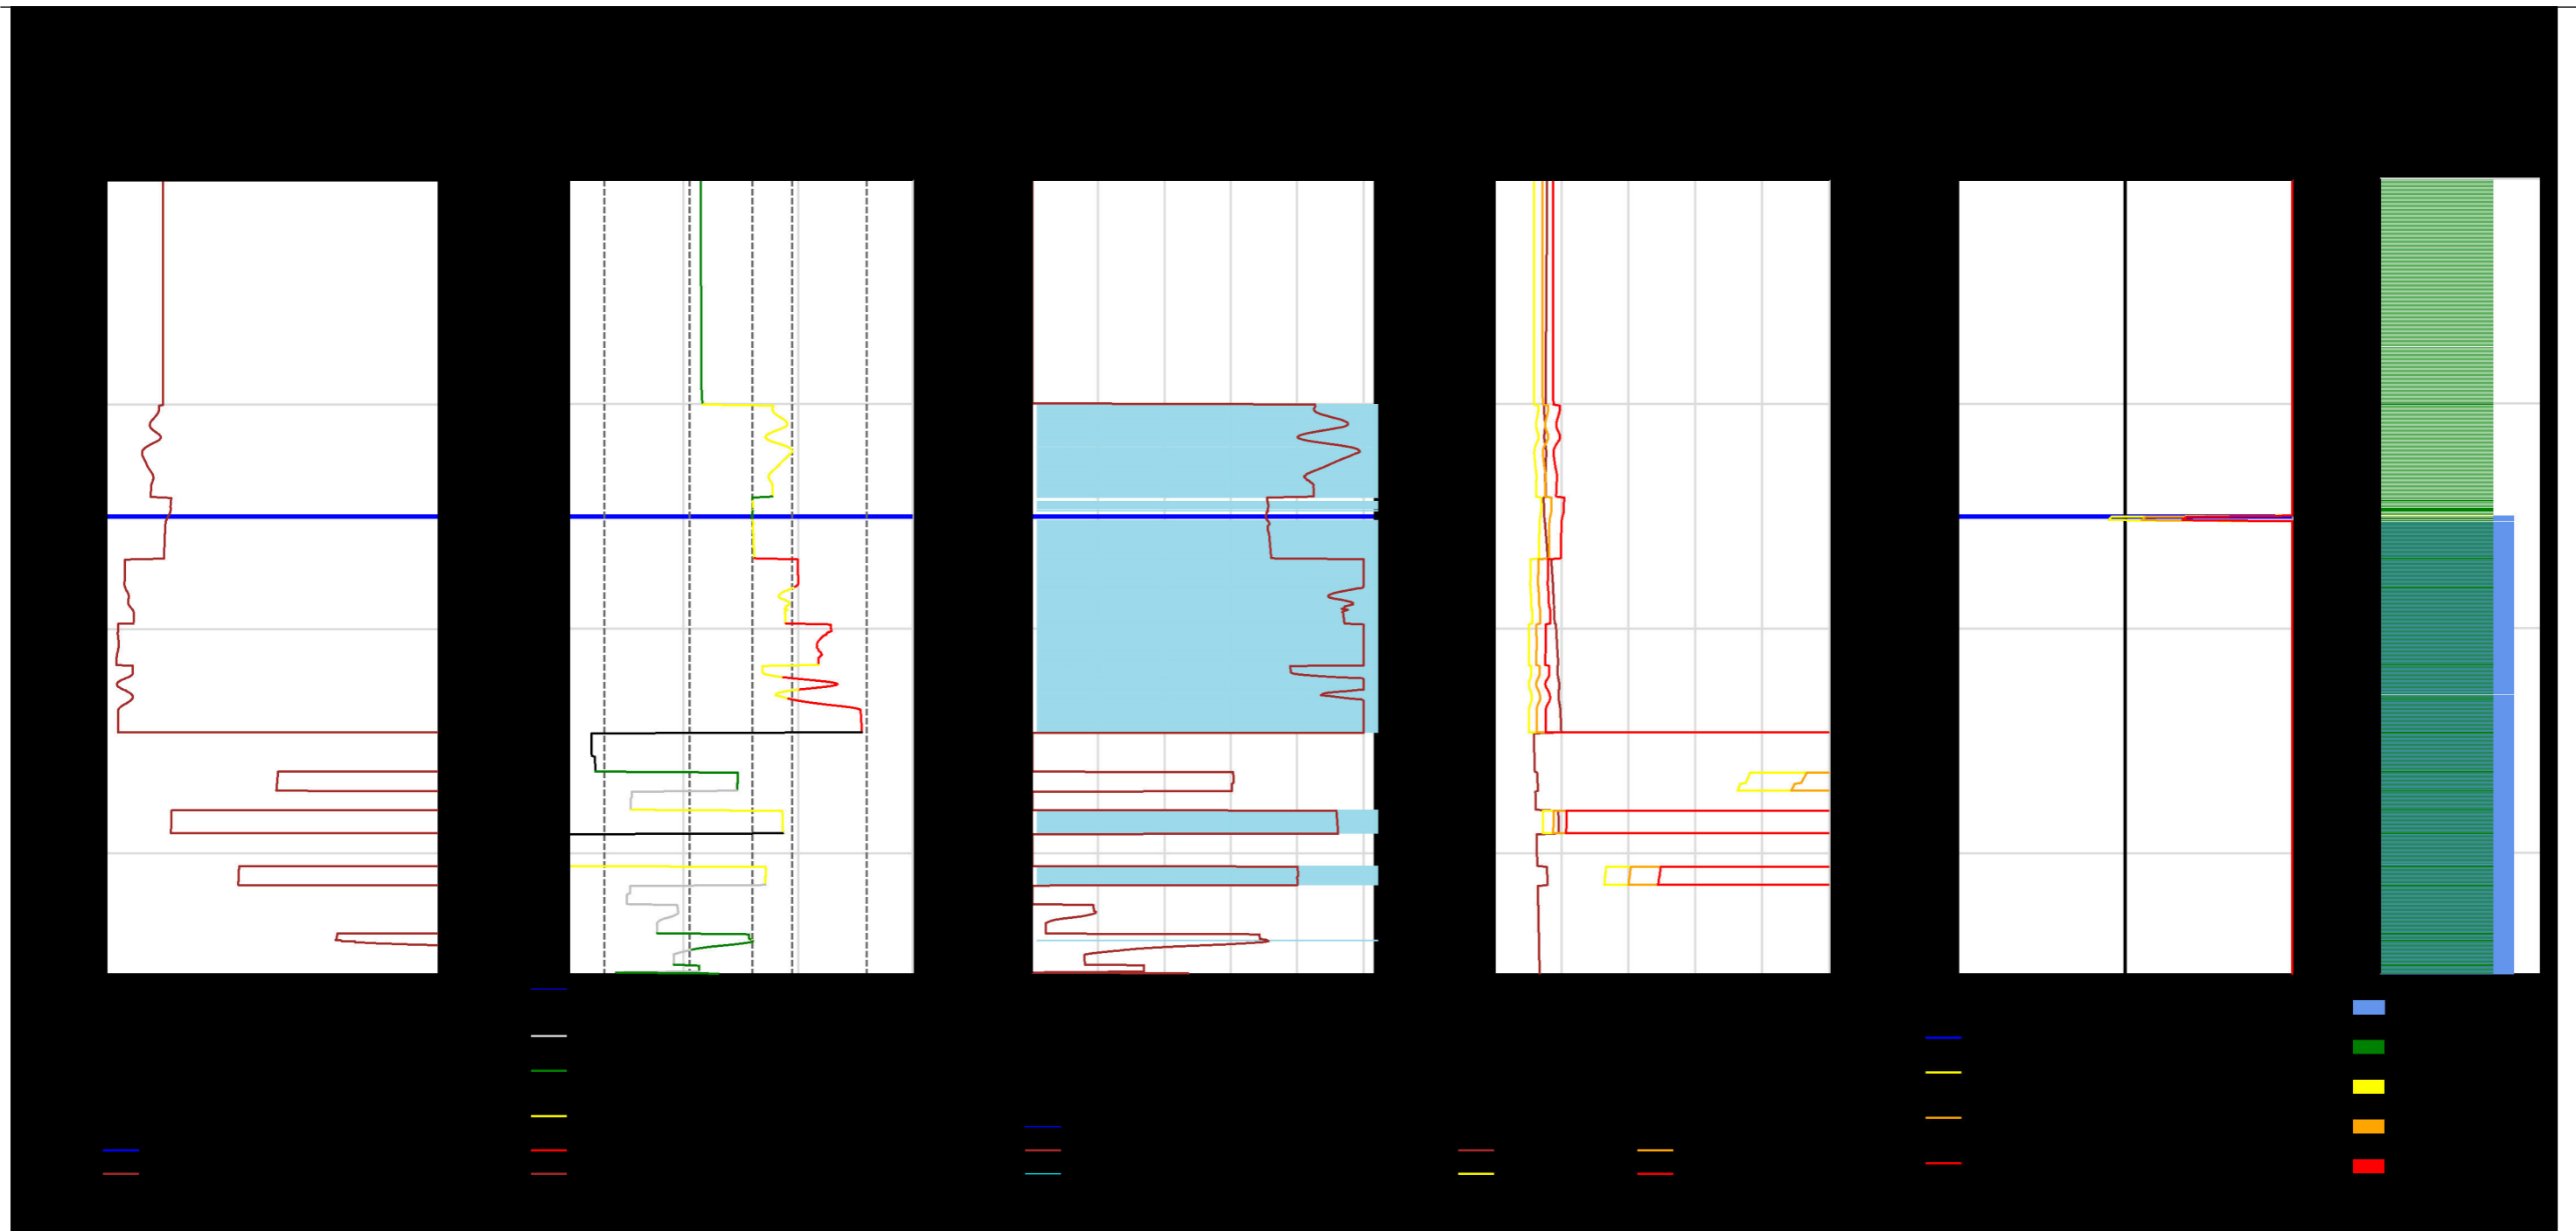
Note: Inverse filtered  $Q_c/F_s$  data (10 cm<sup>2</sup>) used.

Run Description	TTGD ID	Investigation Date	Pre-drill (m)	Magnitude	PGA (g)	Trigger Method	Settlement Method	$\gamma$ (kN/m <sup>3</sup> )	Surcharge/Cut/Fill	Surcharge (kPa)	Cut/Fill Height (m)
INPUT CPT04	140514	1/01/2014	2	6	0.29	BI-2014	ZRB-2002	18		0

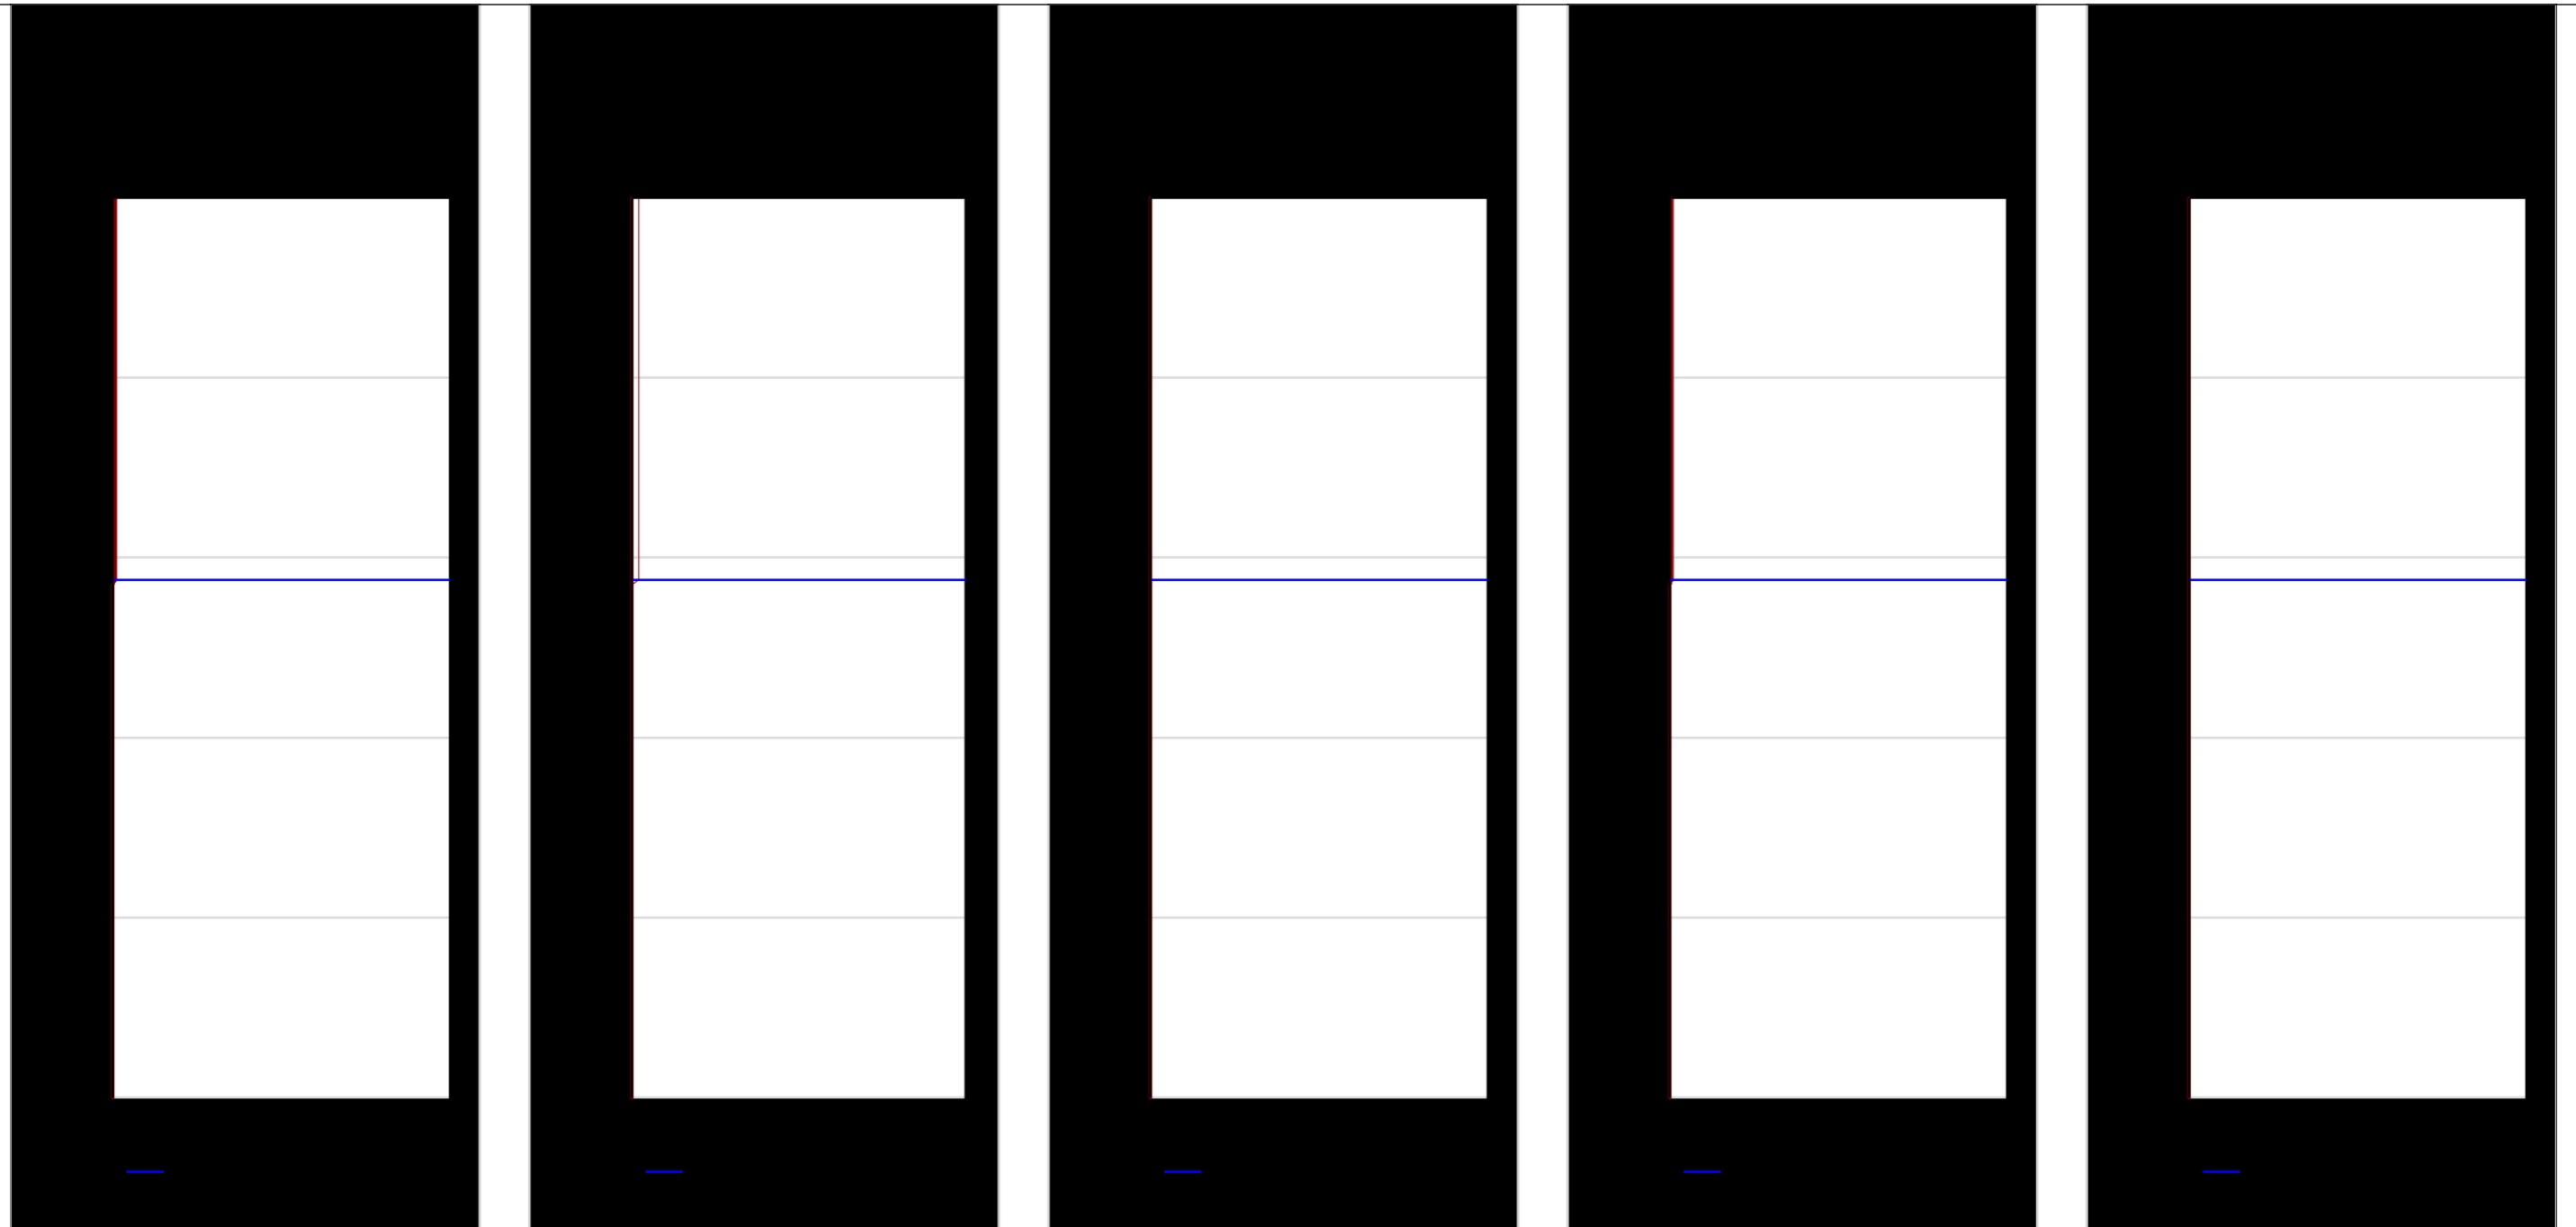
Run Description	TTGD ID	Investigation Date	Pre-drill (m)	Magnitude	PGA (g)	Trigger Method	Settlement Method	$\gamma$ (kN/m <sup>3</sup> )	Surcharge/Cut/Fill	Surcharge (kPa)	Cut/Fill Height (m)
INPUT CPT04	140514	1/01/2014	2	6	0.29	BI-2014	ZRB-2002	18		0
