# RESOURCE CONSENT APPLICATION AND ASSESSMENT OF ENVIRONMENTAL EFFECTS

Brougham Street Commercial  
Development

for K.D. Holdings Limited

Rev 1 - 29/04/2020

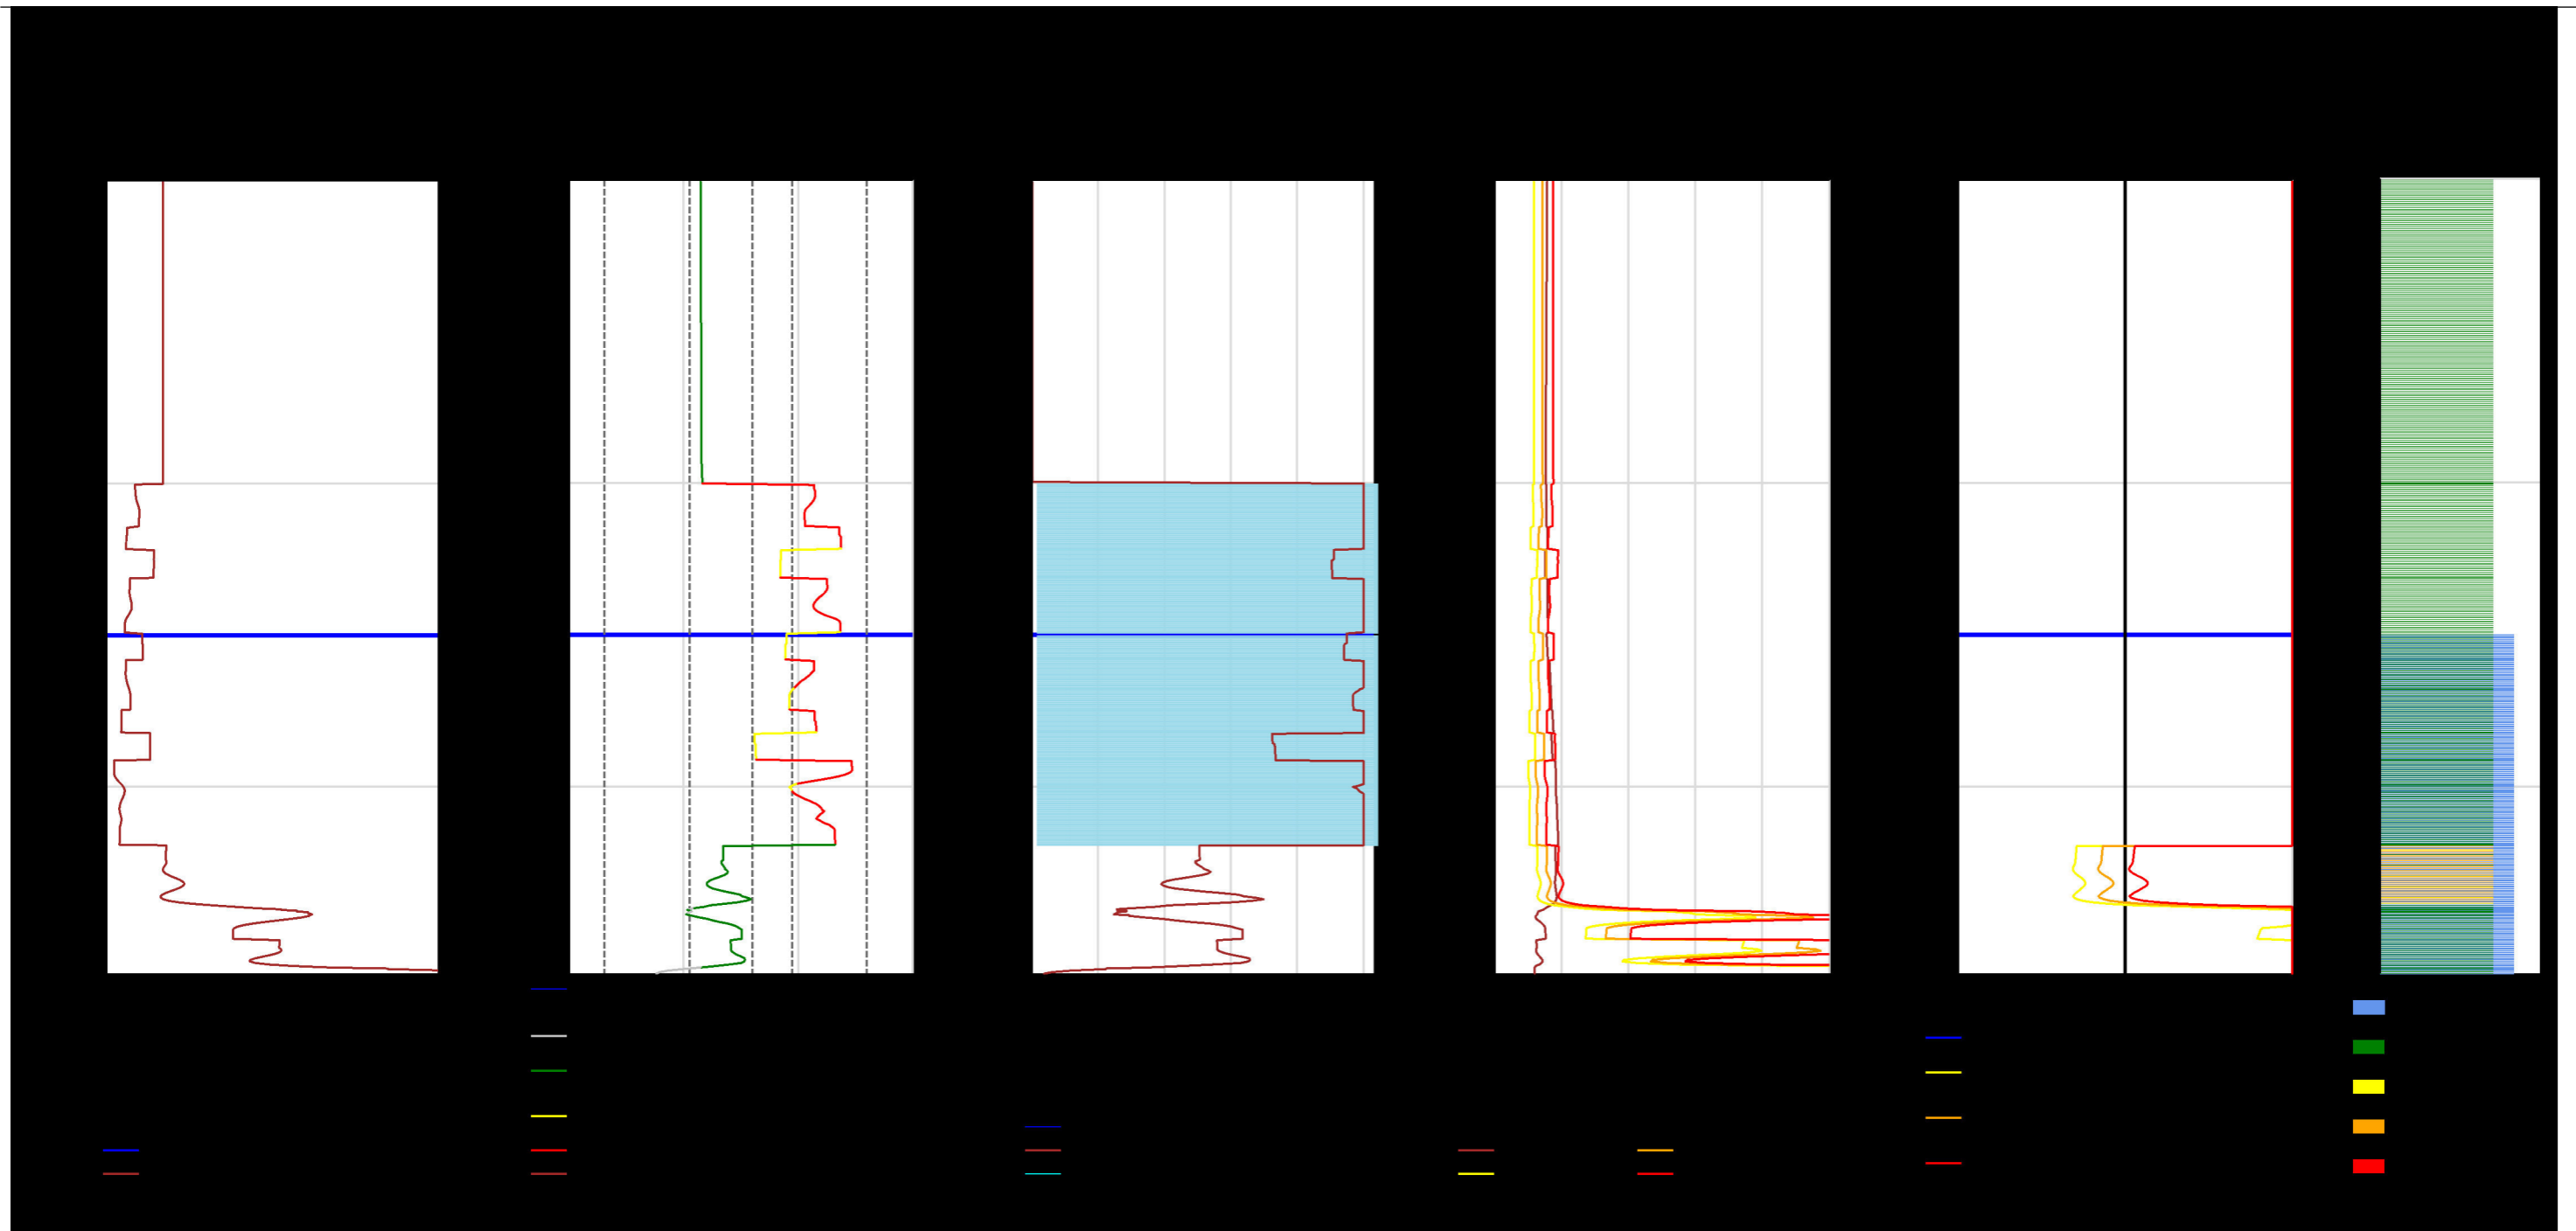
Note: Inverse filtered Qc/Fs data (10 cm<sup>2</sup>) used.

Run Description	TTGD ID	Investigation Date	Pre-drill (m)	Magnitude	PGA (g)	Trigger Method	Settlement Method	$\gamma$ (kN/m <sup>3</sup> )	Surcharge/Cut/Fill	Surcharge (kPa)	Cut/Fill Height (m)
INPUT CPT05	140515	1/01/2014	2	6	0.29	BI-2014	ZRB-2002	18		0	
PL	SV1D (mm)	CTL (m)	LPI	LSN	CT (m)	LPlish					
OUTPUT 15%	10	0.4	1	2	4.5	0					
50%	7	0.4	0	2	4.5	0					
85%	3	0	0	1	5.2	0

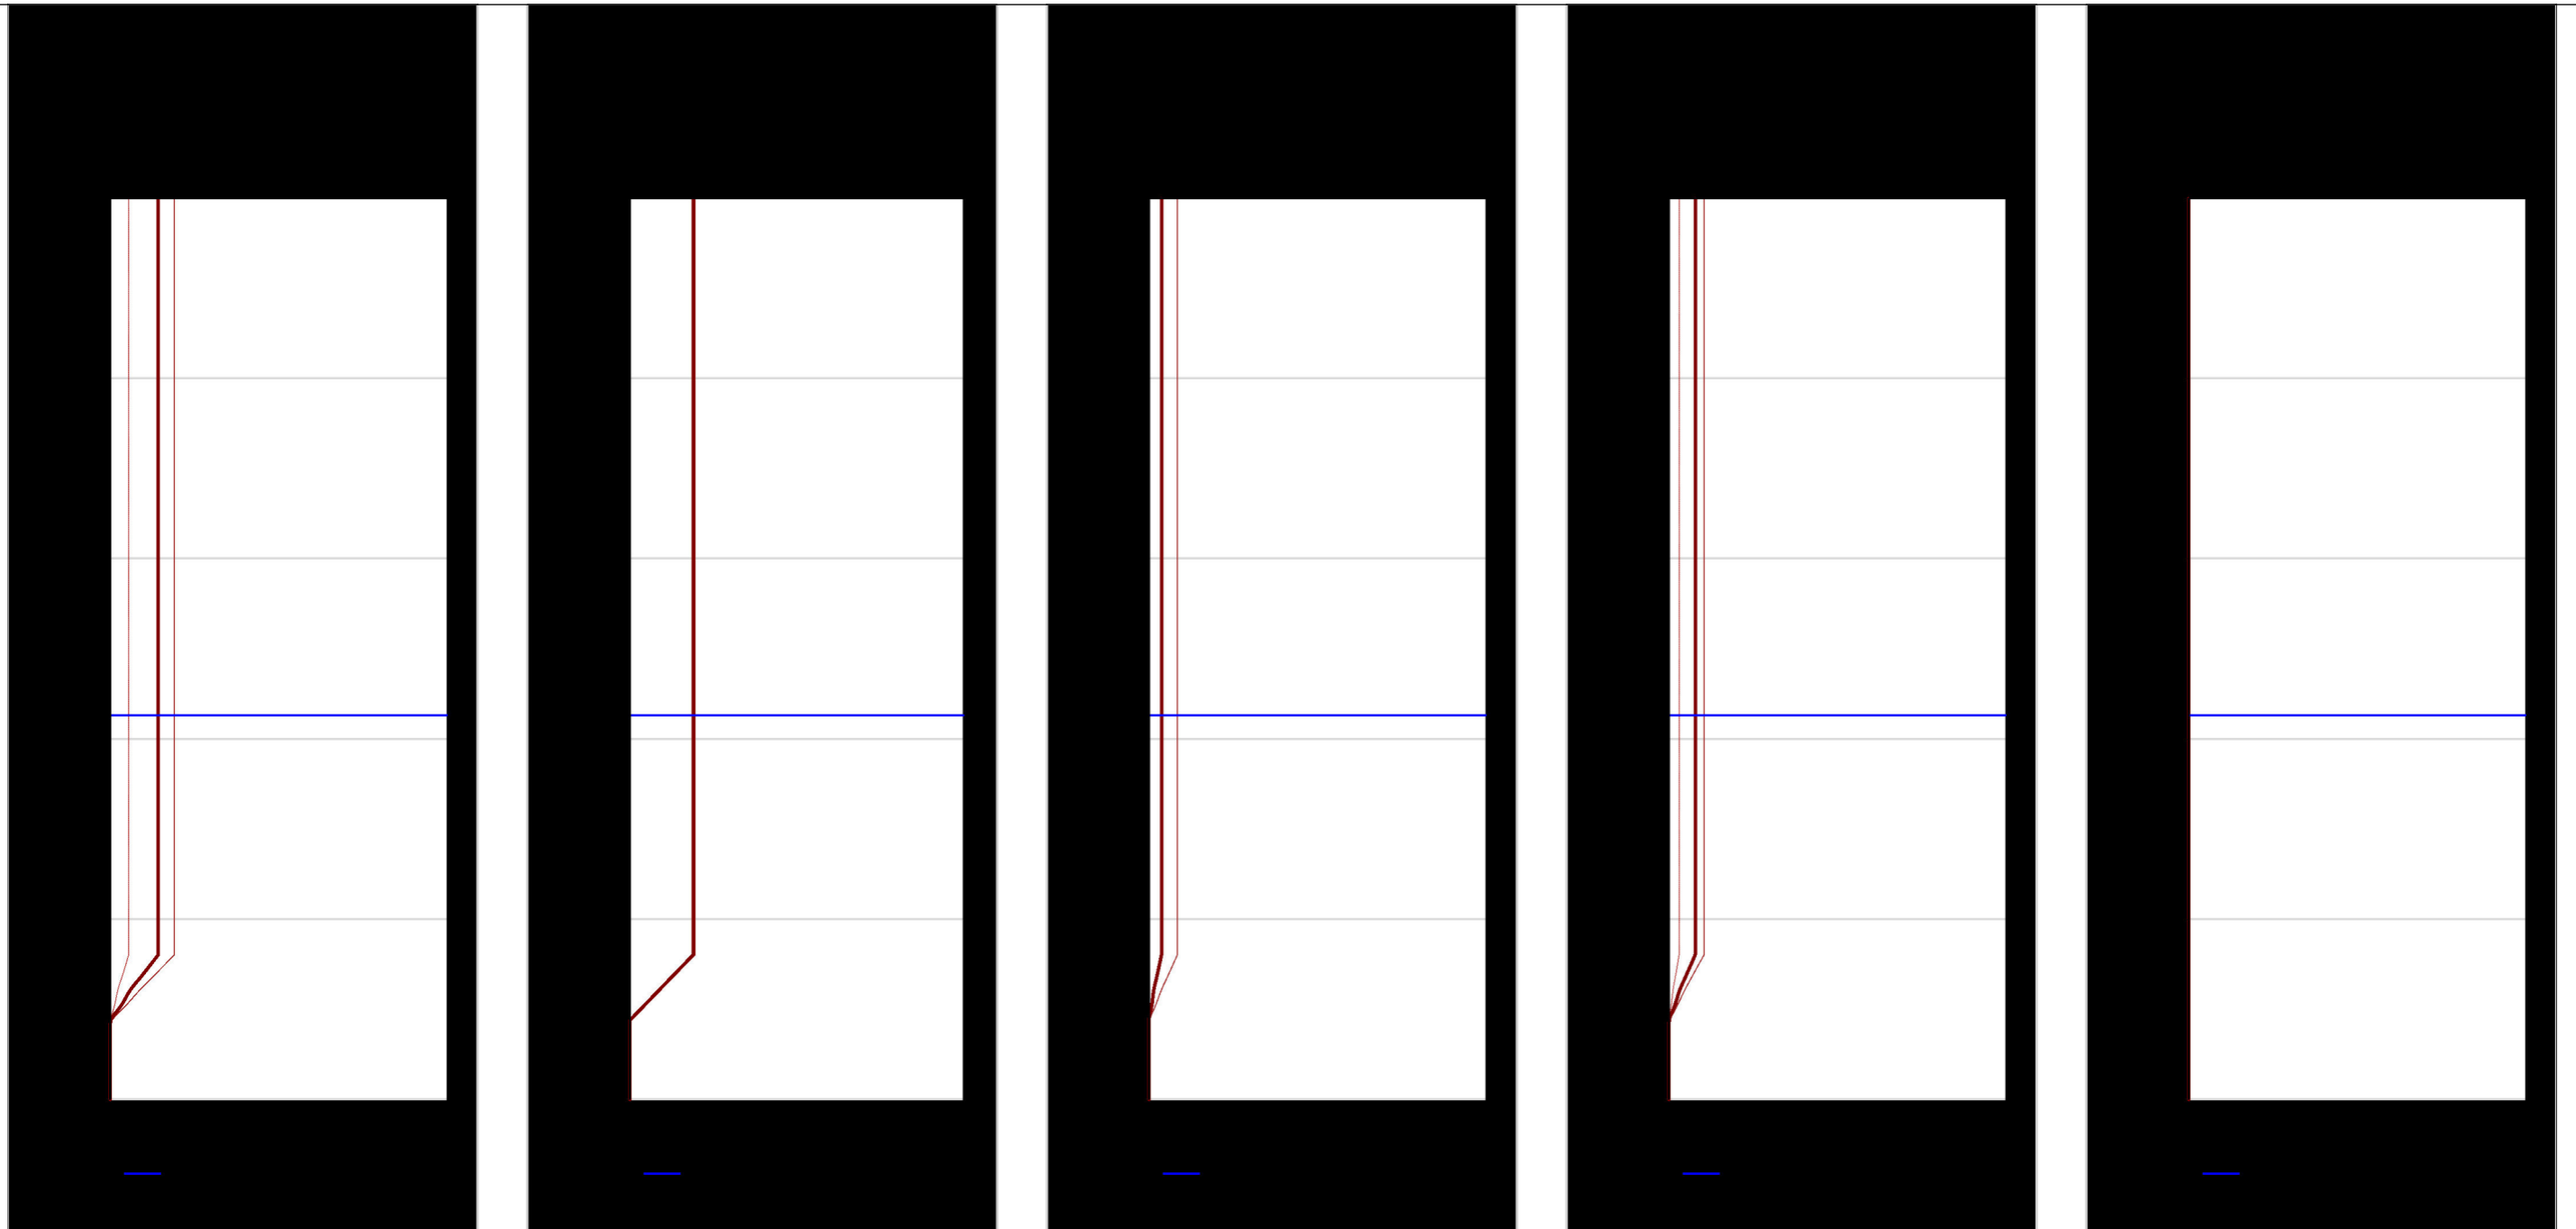
Run Description	TTGD ID	Investigation Date	Pre-drill (m)	Magnitude	PGA (g)	Trigger Method	Settlement Method	$\gamma$ (kN/m <sup>3</sup> )	Surcharge/Cut/Fill	Surcharge (kPa)	Cut/Fill Height (m)
INPUT CPT05	140515	1/01/2014	2	6	0.29	BI-2014	ZRB-2002	18		0

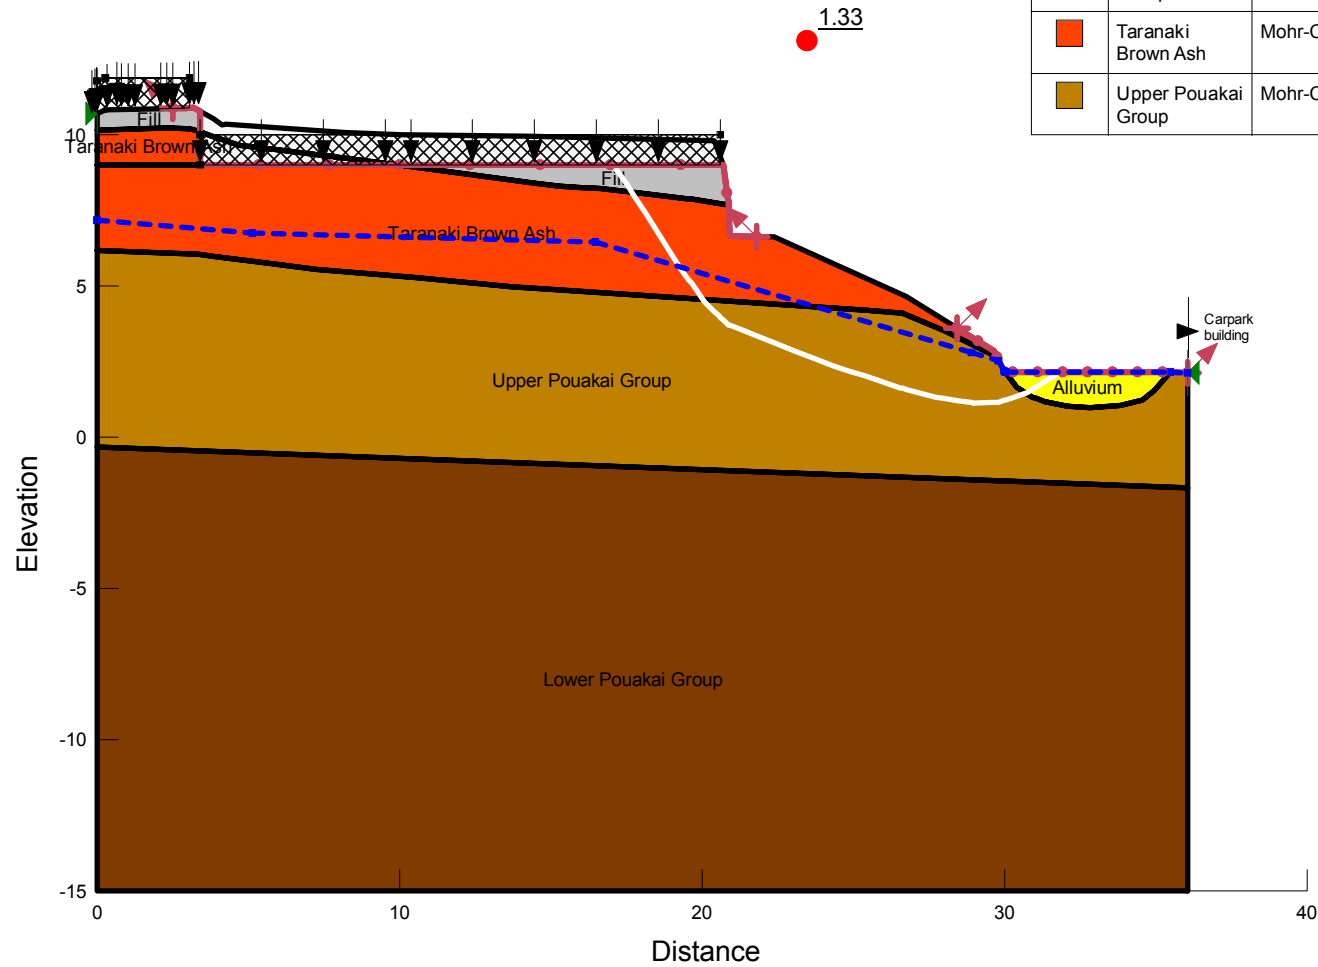
Title: 51 Brougham Slope W\_20191203.gsz

1. Name: 2. Static Normal GW Conditions
2. Method: Morgenstern-Price
3. Direction of movement: Left to Right
4. Slip Surface Option: Entry and Exit
5. PWP Conditions Source: Piezometric Line
6. Optimization: Yes
7. Tension Crack Option: (none)
8. F of S Calculation Option: Constant
9. Horz Seismic Load:

Color	Name	Model	Unit Weight (kN/m <sup>3</sup> )	Cohesion' (kPa)	Phi' (°)	Piezometric Line
Yellow	Alluvium	Mohr-Coulomb	18	2	32	1
Grey	Fill	Mohr-Coulomb	16	2	30	1
Brown	Lower Pouakai Group	Mohr-Coulomb	18	0	40	1
Orange	Taranaki Brown Ash	Mohr-Coulomb	16	5	40	1
Light Brown	Upper Pouakai Group	Mohr-Coulomb	18	2	35	1

Analysis: 2. Static Normal GW Conditions

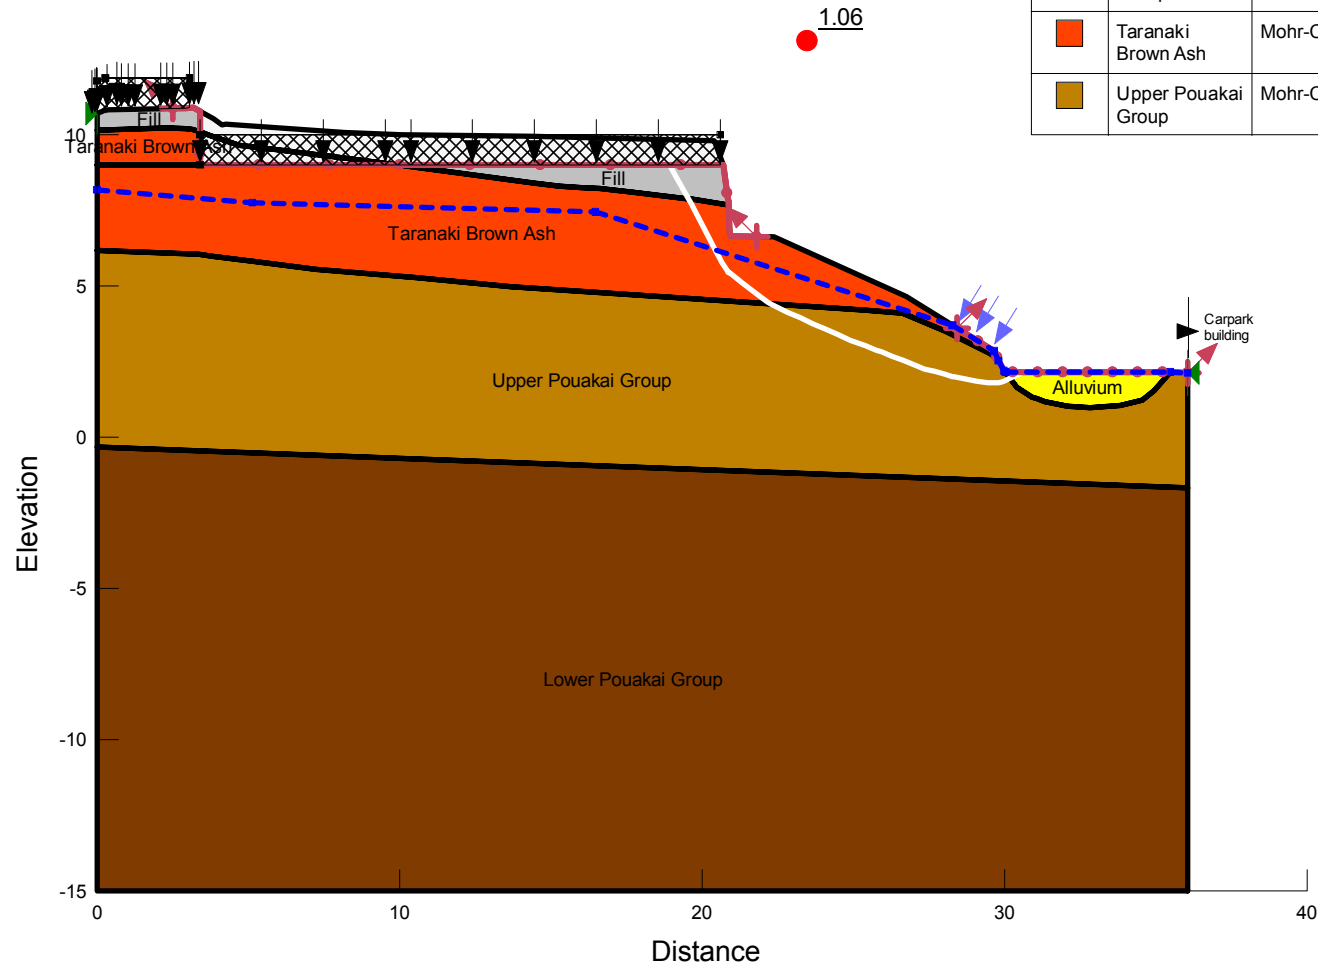
Title: 51 Brougham Slope W\_20191203.gsz

1. Name: 3. Elevated GW Conditions
2. Method: Morgenstern-Price
3. Direction of movement: Left to Right
4. Slip Surface Option: Entry and Exit
5. PWP Conditions Source: Piezometric Line
6. Optimization: Yes
7. Tension Crack Option: (none)
8. F of S Calculation Option: Constant
9. Horz Seismic Load:

Color	Name	Model	Unit Weight (kN/m <sup>3</sup> )	Cohesion' (kPa)	Phi' (°)	Piezometric Line
Yellow	Alluvium	Mohr-Coulomb	18	2	32	1
Grey	Fill	Mohr-Coulomb	16	2	30	1
Brown	Lower Pouakai Group	Mohr-Coulomb	18	0	40	1
Orange	Taranaki Brown Ash	Mohr-Coulomb	16	5	40	1
Gold	Upper Pouakai Group	Mohr-Coulomb	18	2	35	1

Analysis: 3. Elevated GW Conditions

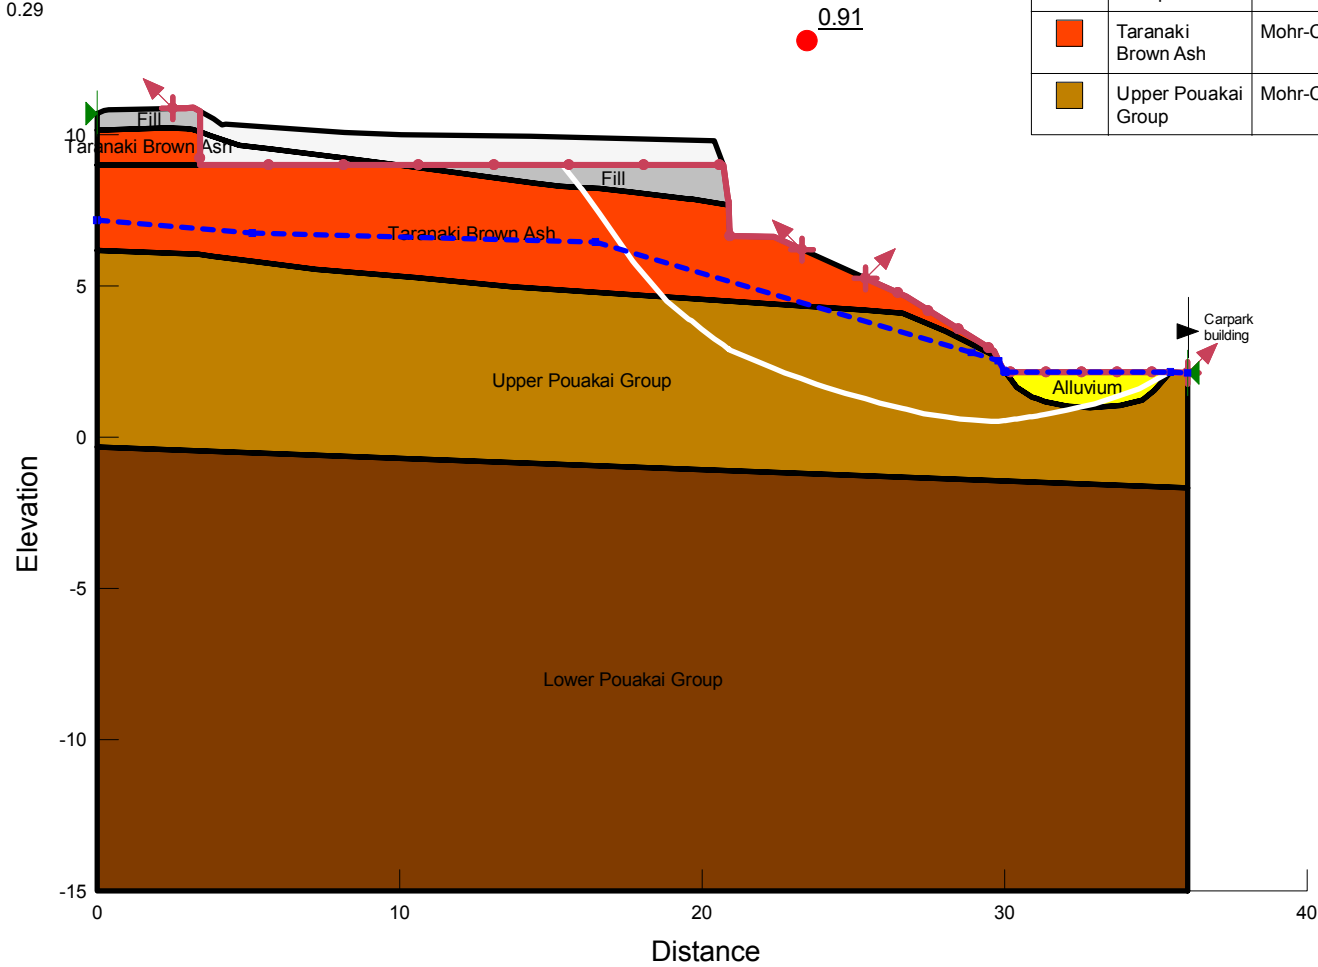
Title: 51 Brougham Slope W\_20191203.gsz

1. Name: 4. Seismic with Static Normal GW Conditions
2. Method: Morgenstern-Price
3. Direction of movement: Left to Right
4. Slip Surface Option: Entry and Exit
5. PWP Conditions Source: Piezometric Line
6. Optimization: Yes
7. Tension Crack Option: (none)
8. F of S Calculation Option: Constant
9. Horz Seismic Load: 0.29

Color	Name	Model	Unit Weight (kN/m <sup>3</sup> )	Cohesion' (kPa)	Phi' (°)	Piezometric Line
Yellow	Alluvium	Mohr-Coulomb	18	2	32	1
Grey	Fill	Mohr-Coulomb	16	2	30	1
Brown	Lower Pouakai Group	Mohr-Coulomb	18	0	40	1
Orange	Taranaki Brown Ash	Mohr-Coulomb	16	5	40	1
Gold	Upper Pouakai Group	Mohr-Coulomb	18	2	35	1

Analysis: 4. Seismic with Static Normal GW Conditions

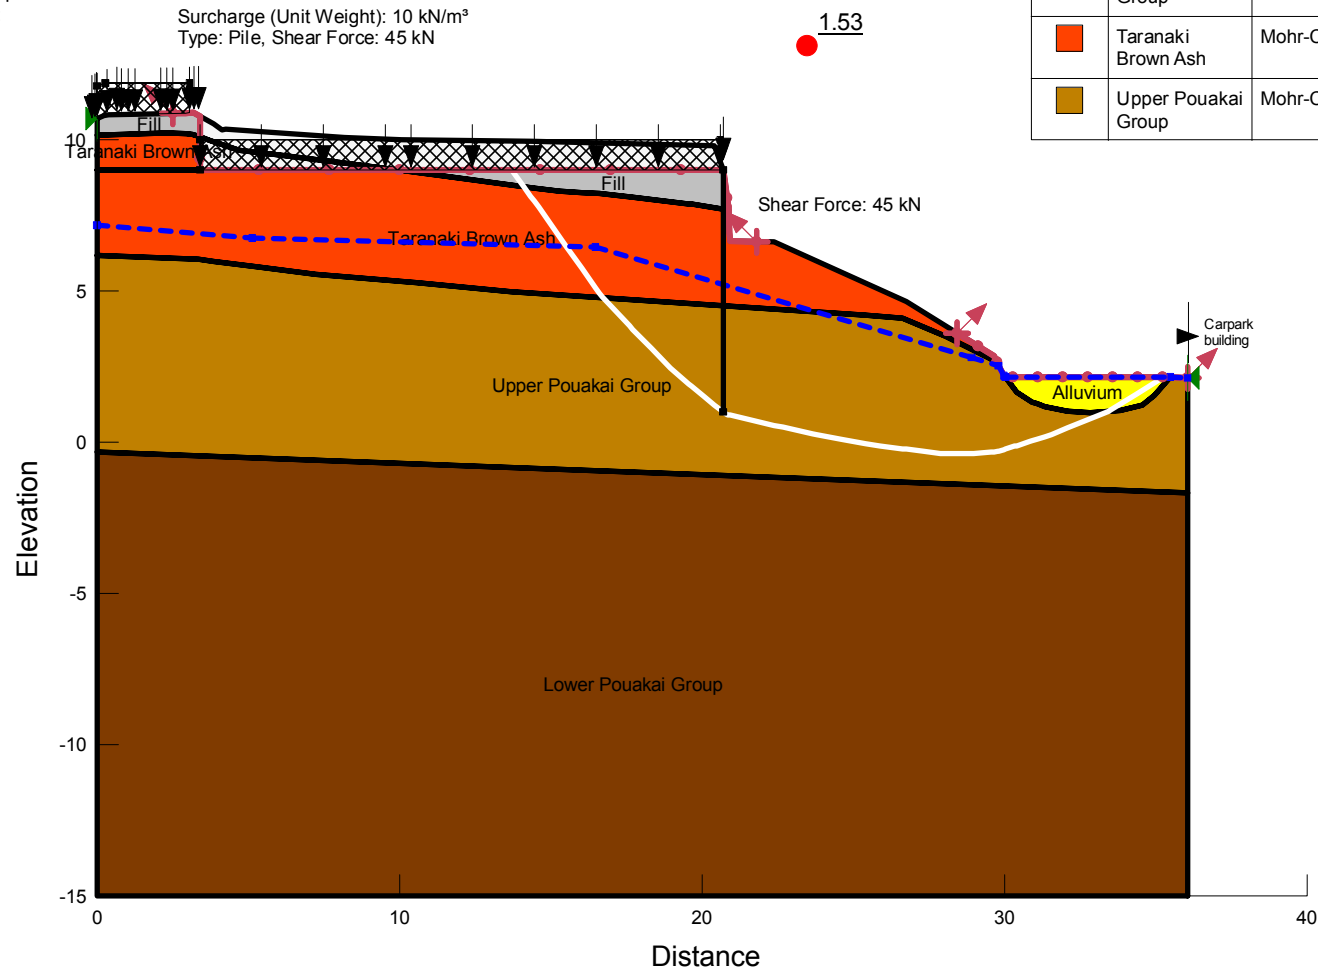
Title: 51 Brougham Slope W\_20191203.gsz

1. Name: 2. Static Normal GW Conditions, pile length optimized
2. Method: Morgenstern-Price
3. Direction of movement: Left to Right
4. Slip Surface Option: Entry and Exit
5. PWP Conditions Source: Piezometric Line
6. Optimization: Yes
7. Tension Crack Option: (none)
8. F of S Calculation Option: Constant
9. Horz Seismic Load:

Color	Name	Model	Unit Weight (kN/m <sup>3</sup> )	Cohesion' (kPa)	Phi' (°)	Piezometric Line
Yellow	Alluvium	Mohr-Coulomb	18	2	32	1
Grey	Fill	Mohr-Coulomb	16	2	30	1
Brown	Lower Pouakai Group	Mohr-Coulomb	18	0	40	1
Orange	Taranaki Brown Ash	Mohr-Coulomb	16	5	40	1
Light Brown	Upper Pouakai Group	Mohr-Coulomb	18	2	35	1

Analysis: 2. Static Normal GW Conditions, pile length optimized

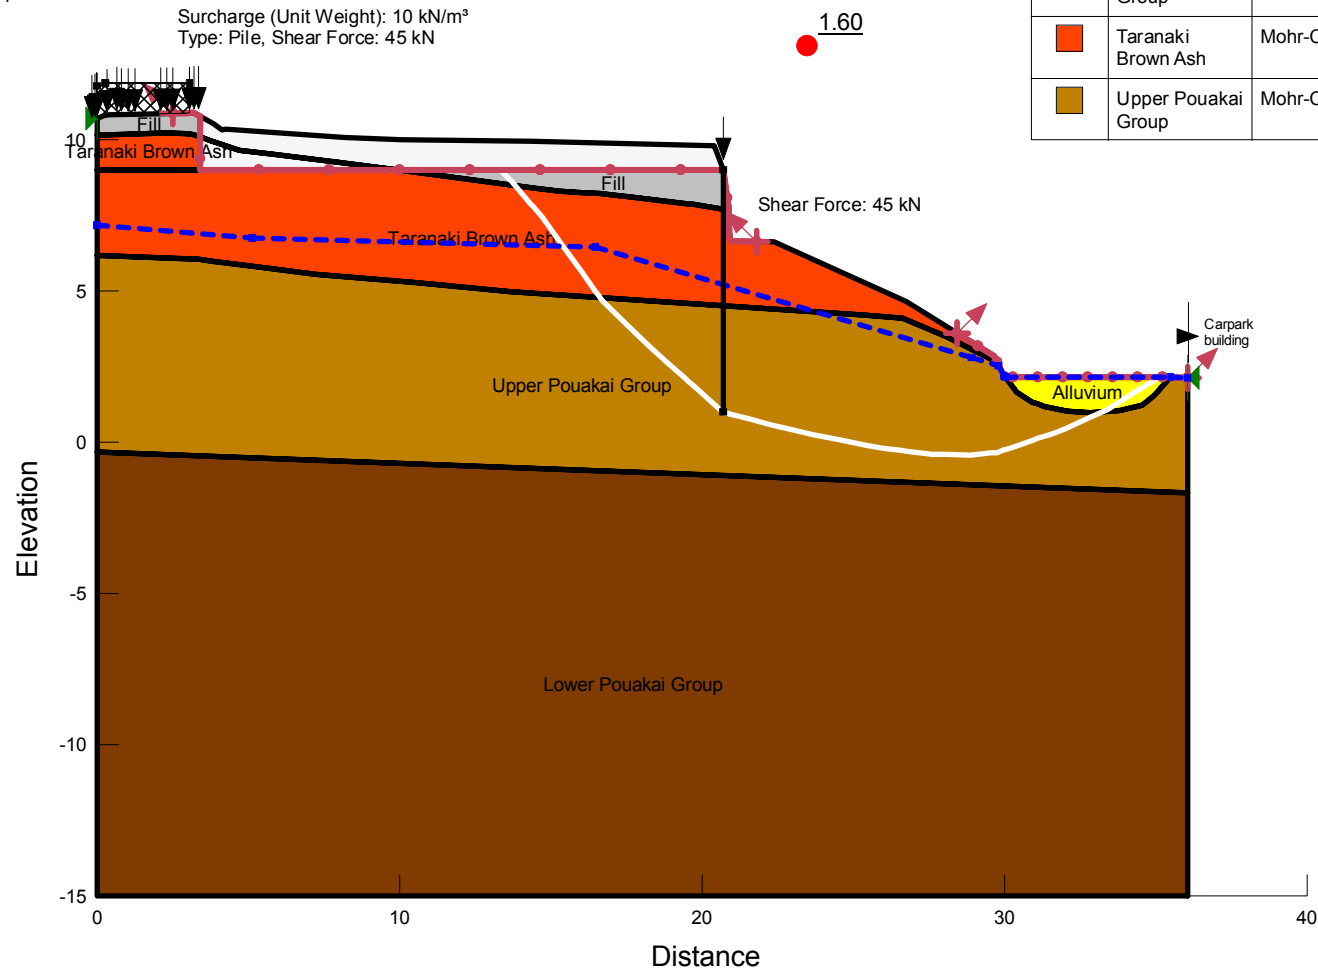
Title: 51 Brougham Slope W\_20191203.gsz

1. Name: 2. Static Normal GW Conditions, pile length optimized, susp floor
2. Method: Morgenstern-Price
3. Direction of movement: Left to Right
4. Slip Surface Option: Entry and Exit
5. PWP Conditions Source: Piezometric Line
6. Optimization: Yes
7. Tension Crack Option: (none)
8. F of S Calculation Option: Constant
9. Horz Seismic Load:

Color	Name	Model	Unit Weight (kN/m <sup>3</sup> )	Cohesion' (kPa)	Phi' (°)	Piezometric Line
Yellow	Alluvium	Mohr-Coulomb	18	2	32	1
Grey	Fill	Mohr-Coulomb	16	2	30	1
Brown	Lower Pouakai Group	Mohr-Coulomb	18	0	40	1
Orange	Taranaki Brown Ash	Mohr-Coulomb	16	5	40	1
Light Brown	Upper Pouakai Group	Mohr-Coulomb	18	2	35	1

Analysis: 2. Static Normal GW Conditions, pile length optimized, susp floor

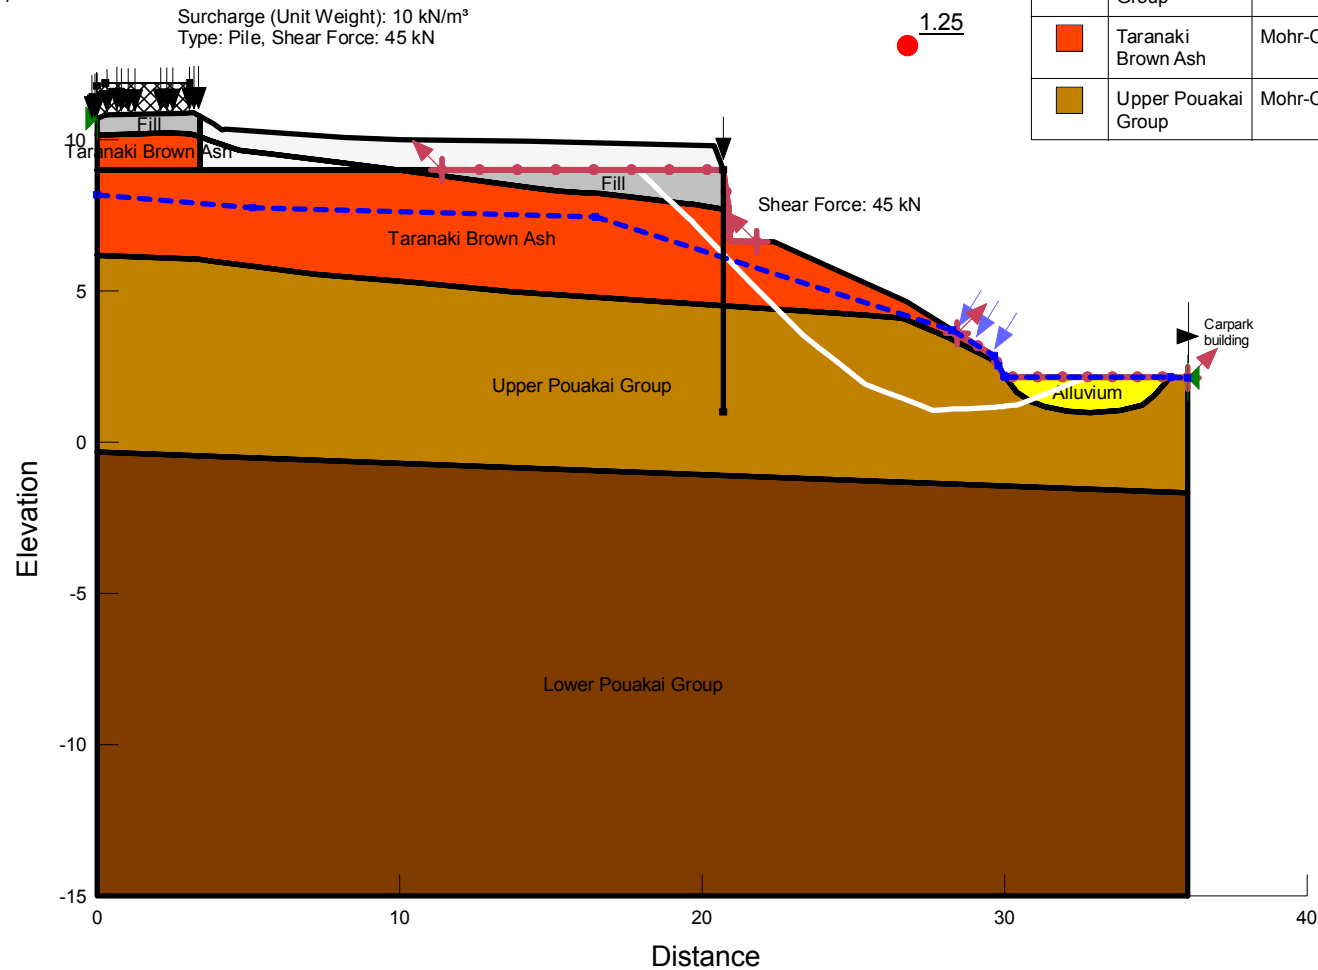
Title: 51 Brougham Slope W\_20191203.gsz

1. Name: 3. Elevated GW Conditions, pile length optimized
2. Method: Morgenstern-Price
3. Direction of movement: Left to Right
4. Slip Surface Option: Entry and Exit
5. PWP Conditions Source: Piezometric Line
6. Optimization: Yes
7. Tension Crack Option: (none)
8. F of S Calculation Option: Constant
9. Horz Seismic Load:

Color	Name	Model	Unit Weight (kN/m <sup>3</sup> )	Cohesion' (kPa)	Phi' (°)	Piezometric Line
Yellow	Alluvium	Mohr-Coulomb	18	2	32	1
Grey	Fill	Mohr-Coulomb	16	2	30	1
Brown	Lower Pouakai Group	Mohr-Coulomb	18	0	40	1
Orange	Taranaki Brown Ash	Mohr-Coulomb	16	5	40	1
Gold	Upper Pouakai Group	Mohr-Coulomb	18	2	35	1

Analysis: 3. Elevated GW Conditions, pile length optimized

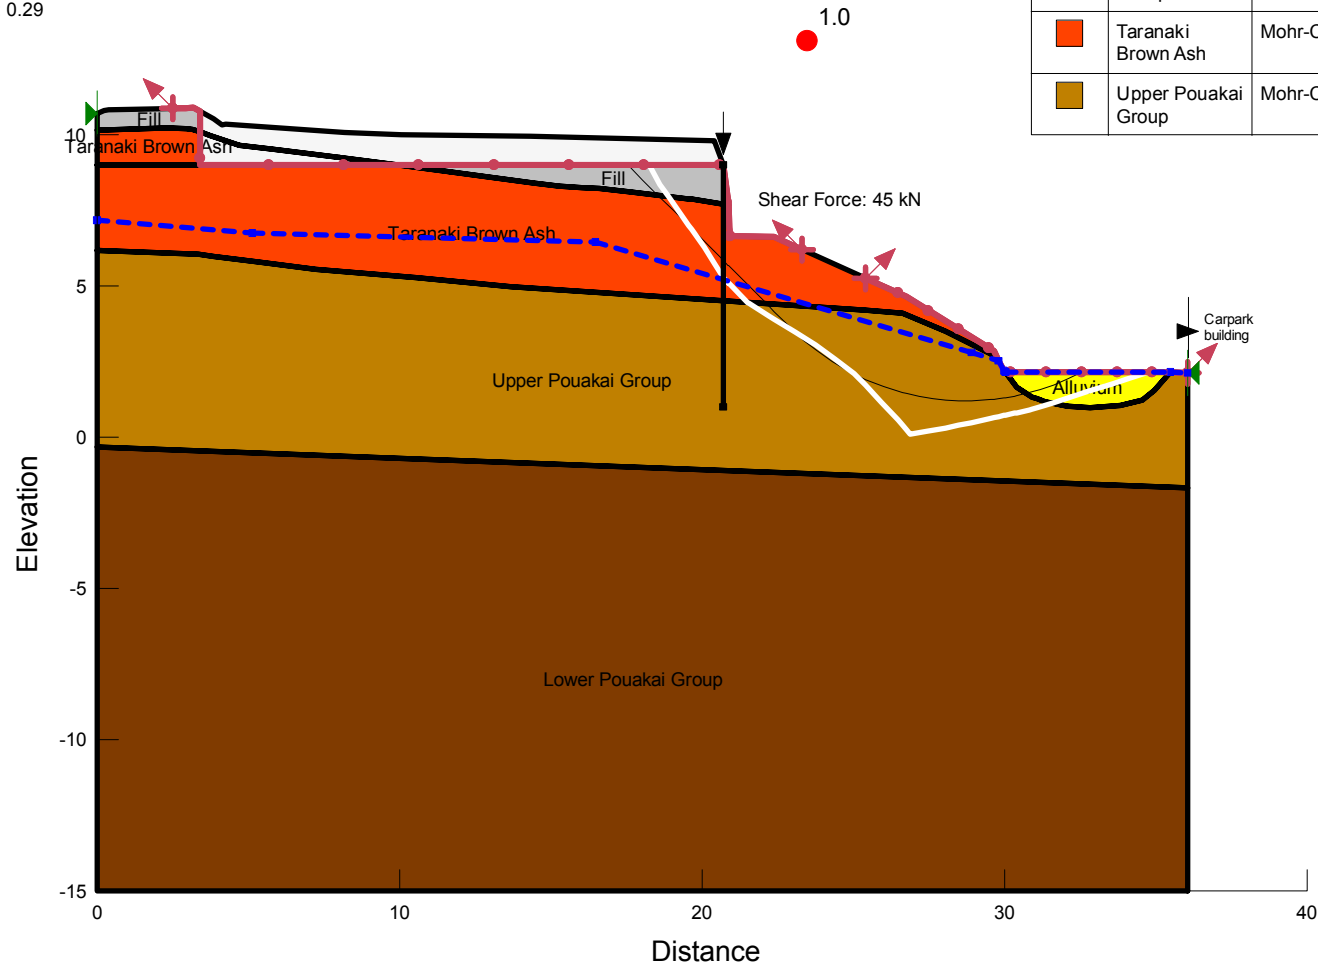
Title: 51 Brougham Slope W\_20191203.gsz

1. Name: 4. Seismic with Static Normal GW Conditions, pile length optimized (45kN)
2. Method: Morgenstern-Price
3. Direction of movement: Left to Right
4. Slip Surface Option: Entry and Exit
5. PWP Conditions Source: Piezometric Line
6. Optimization: Yes
7. Tension Crack Option: (none)
8. F of S Calculation Option: Constant
9. Horz Seismic Load: 0.29

Color	Name	Model	Unit Weight (kN/m <sup>3</sup> )	Cohesion' (kPa)	Phi' (°)	Piezometric Line
Yellow	Alluvium	Mohr-Coulomb	18	2	32	1
Grey	Fill	Mohr-Coulomb	16	2	30	1
Brown	Lower Pouakai Group	Mohr-Coulomb	18	0	40	1
Orange	Taranaki Brown Ash	Mohr-Coulomb	16	5	40	1
Gold	Upper Pouakai Group	Mohr-Coulomb	18	2	35	1

Analysis: 4. Seismic with Static Normal GW Conditions, pile length optimized (45kN)

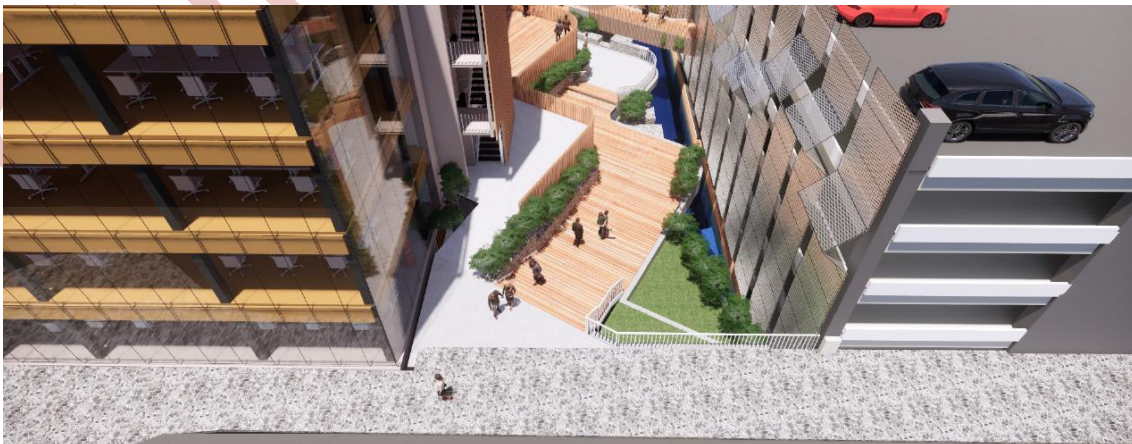
Figure L 9: Draft redesign of Huatoki Stream area with connection to 45-51 Brougham Street (Source: BOON Limited)

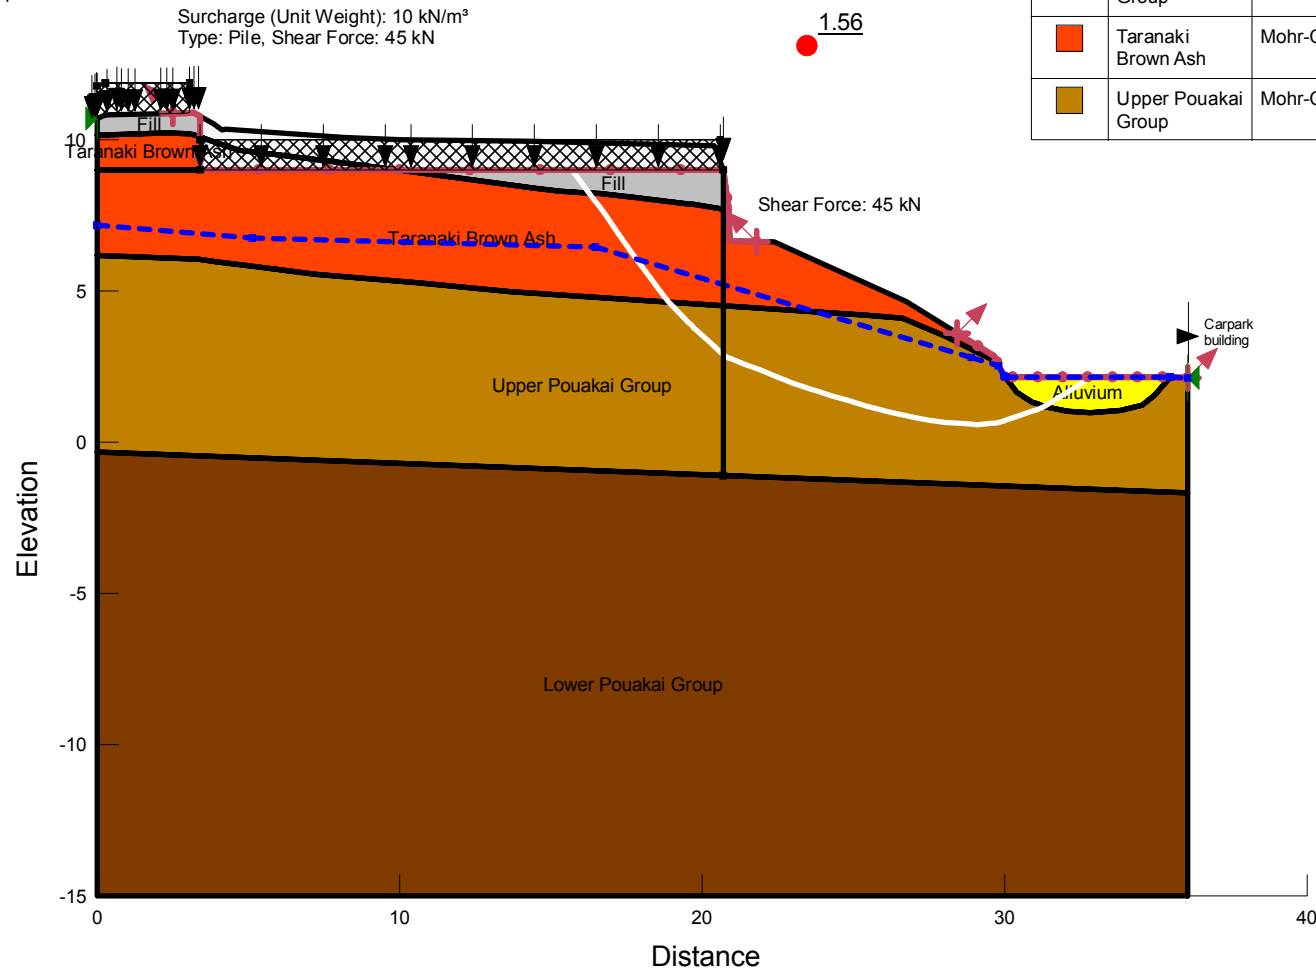
Title: 51 Brougham Slope W\_20190915.gsz

1. Name: 2. Static Normal GW Conditions, pile
2. Method: Morgenstern-Price
3. Direction of movement: Left to Right
4. Slip Surface Option: Entry and Exit
5. PWP Conditions Source: Piezometric Line
6. Optimization: Yes
7. Tension Crack Option: (none)
8. F of S Calculation Option: Constant
9. Horz Seismic Load:

Color	Name	Model	Unit Weight (kN/m <sup>3</sup> )	Cohesion' (kPa)	Phi' (°)	Piezometric Line
Yellow	Alluvium	Mohr-Coulomb	18	2	32	1
Grey	Fill	Mohr-Coulomb	16	2	30	1
Brown	Lower Pouakai Group	Mohr-Coulomb	18	0	40	1
Orange	Taranaki Brown Ash	Mohr-Coulomb	16	5	40	1
Gold	Upper Pouakai Group	Mohr-Coulomb	18	2	35	1

Analysis: 2. Static Normal GW Conditions, pile

- a) They recommend pile foundations for the proposed building,
- b) They have assessed three different slope stability cases and in all three cases a slip plane forms within 51 Brougham Street as described on the attached cross sections where the slip plane is indicated by the white line, and
- c) They recommend a suspended concrete basement slab to span over the potential slip area.

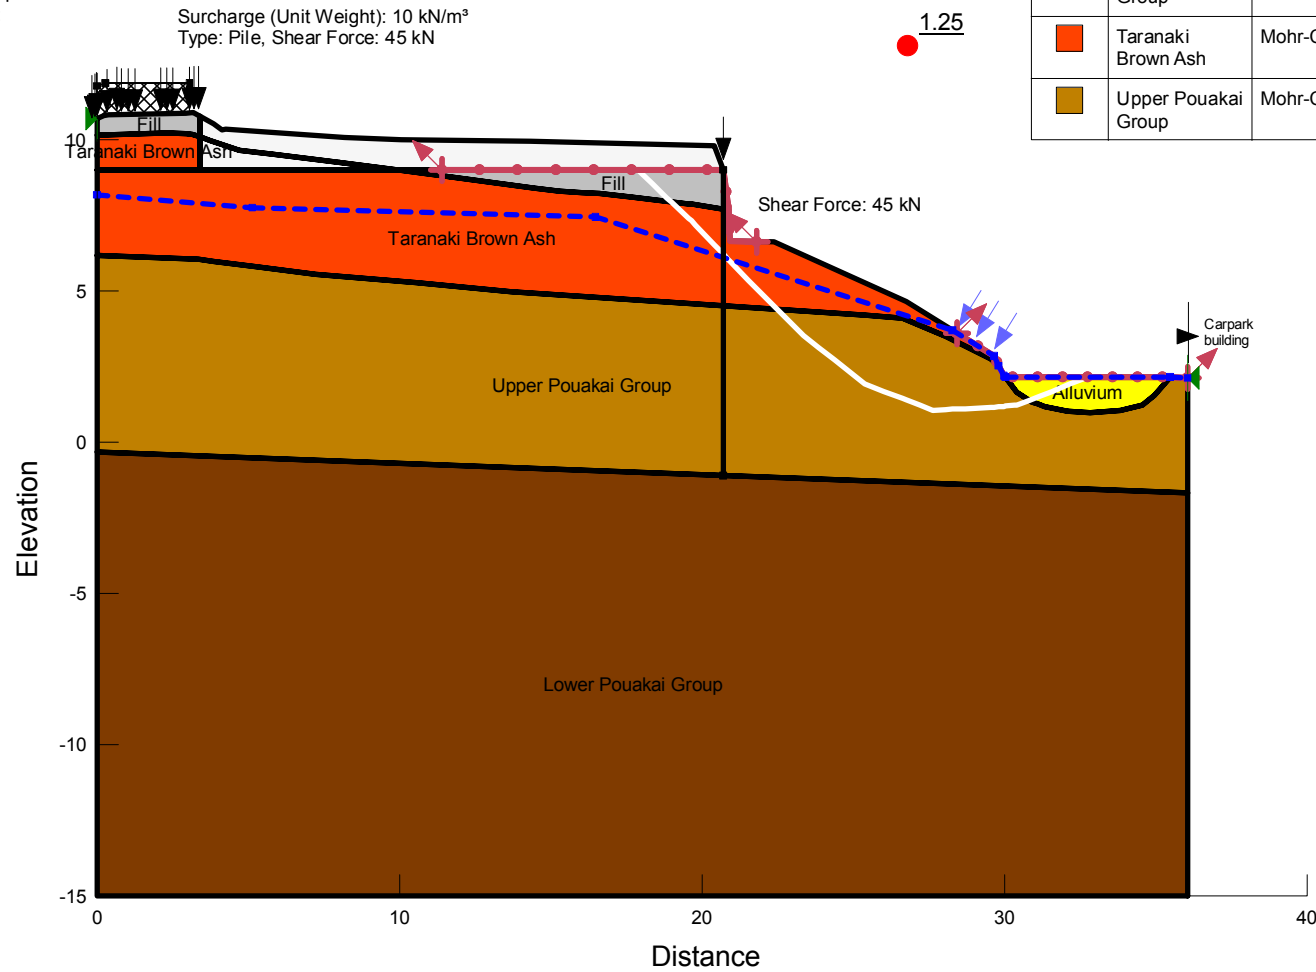
Title: 51 Brougham Slope W\_20190915.gsz

1. Name: 3. Elevated GW Conditions, pile
2. Method: Morgenstern-Price
3. Direction of movement: Left to Right
4. Slip Surface Option: Entry and Exit
5. PWP Conditions Source: Piezometric Line
6. Optimization: Yes
7. Tension Crack Option: (none)
8. F of S Calculation Option: Constant
9. Horz Seismic Load:

Color	Name	Model	Unit Weight (kN/m <sup>3</sup> )	Cohesion' (kPa)	Phi' (°)	Piezometric Line
Yellow	Alluvium	Mohr-Coulomb	18	2	32	1
Grey	Fill	Mohr-Coulomb	16	2	30	1
Brown	Lower Pouakai Group	Mohr-Coulomb	18	0	40	1
Orange	Taranaki Brown Ash	Mohr-Coulomb	16	5	40	1
Gold	Upper Pouakai Group	Mohr-Coulomb </td <td>18</td> <td>2</td> <td>35</td> <td>1</td>	18	2	35	1

Analysis: 3. Elevated GW Conditions, pile

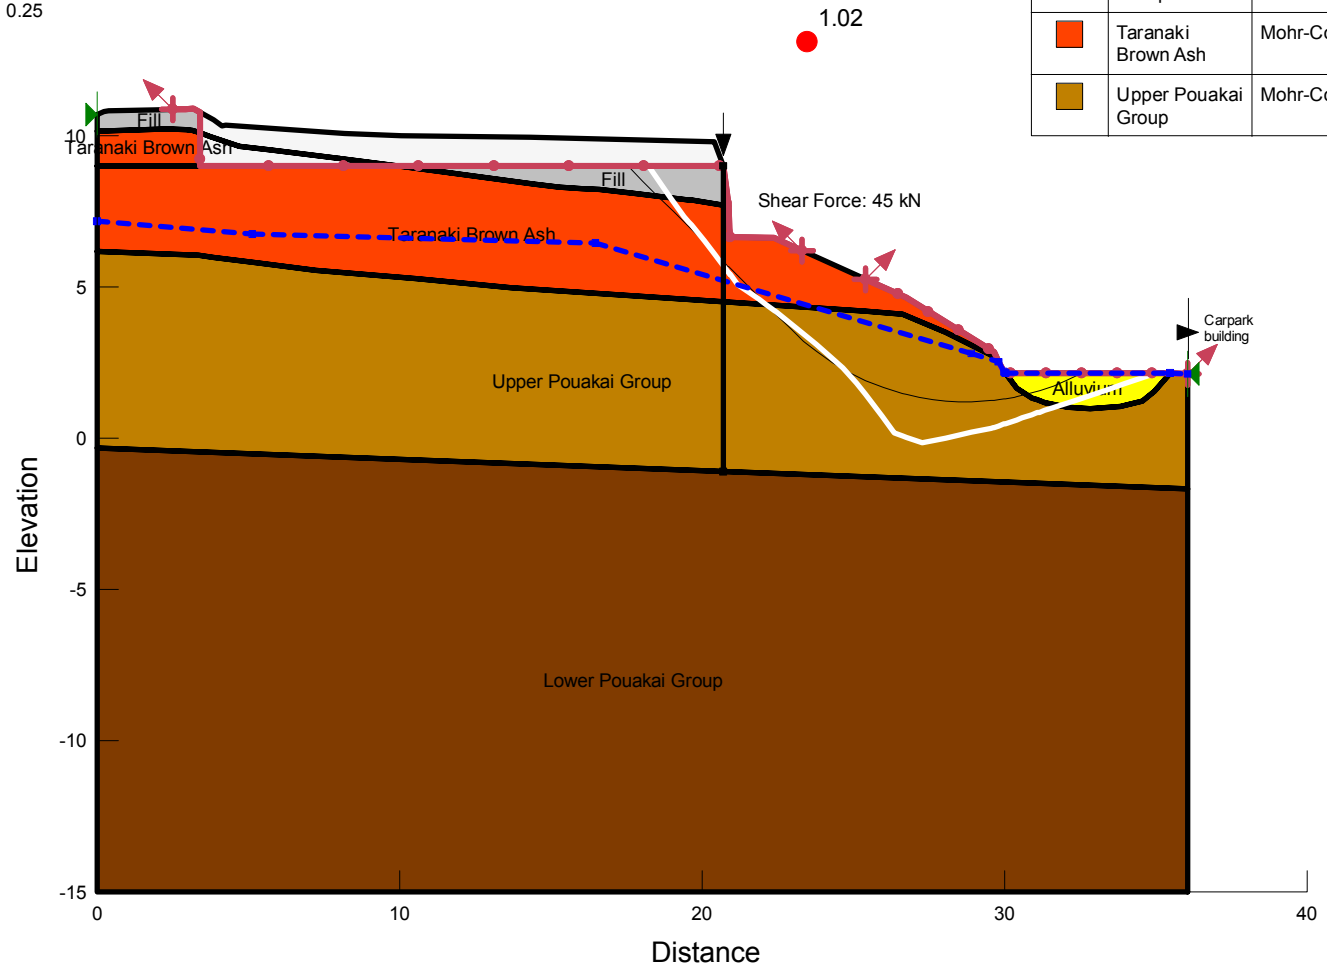
Title: 51 Brougham Slope W\_20190915.gsz

1. Name: 4. Seismic with Static Normal GW Conditions, pile
2. Method: Morgenstern-Price
3. Direction of movement: Left to Right
4. Slip Surface Option: Entry and Exit
5. PWP Conditions Source: Piezometric Line
6. Optimization: Yes
7. Tension Crack Option: (none)
8. F of S Calculation Option: Constant
9. Horz Seismic Load: 0.25

Color	Name	Model	Unit Weight (kN/m <sup>3</sup> )	Cohesion' (kPa)	Phi' (°)	Piezometric Line
Yellow	Alluvium	Mohr-Coulomb	18	2	32	1
Grey	Fill	Mohr-Coulomb	16	2	30	1
Brown	Lower Pouakai Group	Mohr-Coulomb	18	0	40	1
Orange	Taranaki Brown Ash	Mohr-Coulomb	16	5	40	1
Gold	Upper Pouakai Group	Mohr-Coulomb	18	2	35	1

Analysis: 4. Seismic with Static Normal GW Conditions, pile
