Ecology supplementary report – Freshwater Ecology

February 2018

River Lake Ltd

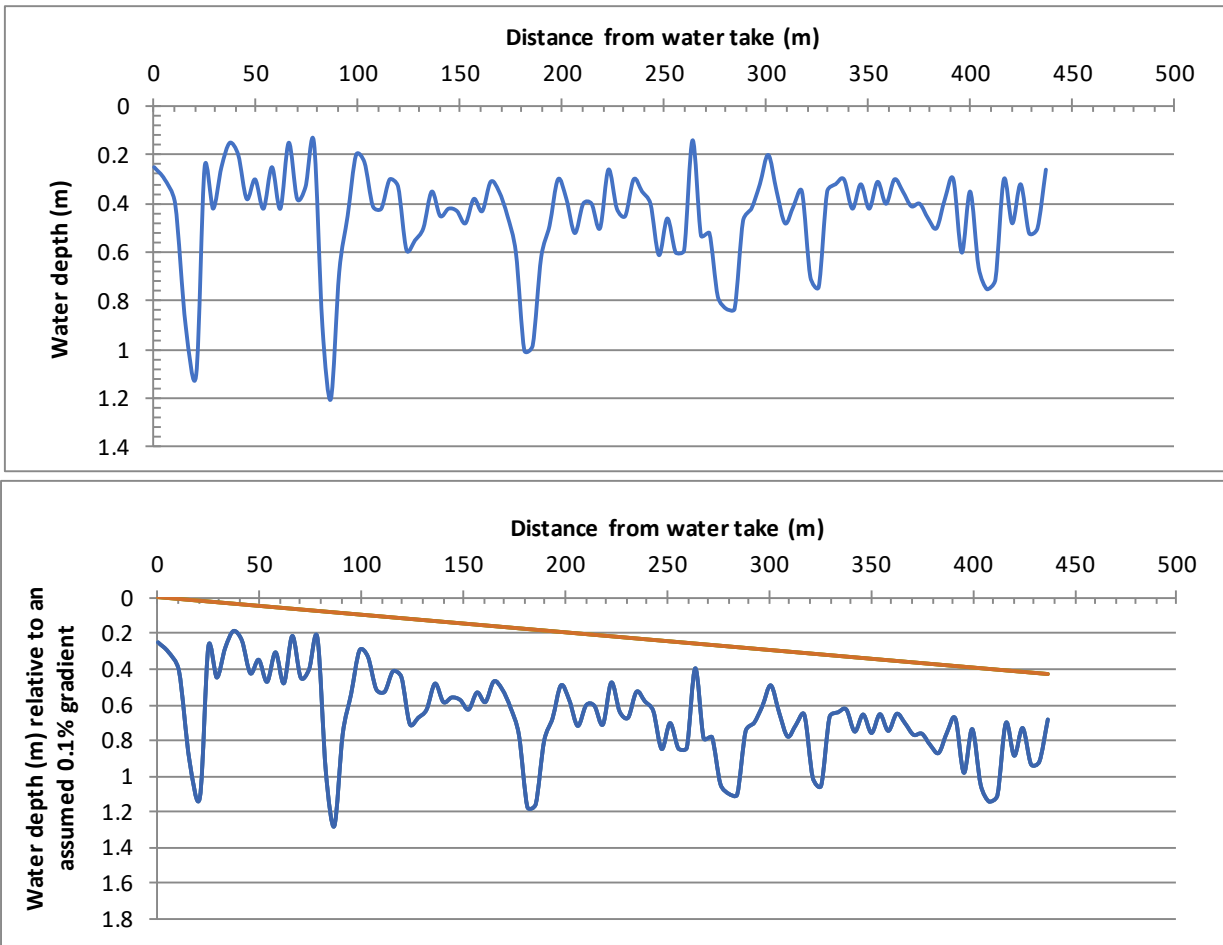
Figure 2.2 – Water depth longitudinally down the Mangapepeke Stream, downstream of the proposed water take (1 November 2017). The top graph is relative to water level, the bottom graph has an assumed gradient of 0.1%.

The western branch of the Mangapepeke Stream enters about 20 metres downstream of the current SH3 culvert (start of survey) and is associated with the first meander and deep hole. A constructed boulder weir about 76m downstream appears to have raised the stream bed, and the stream is generally deeper downstream of this structure (Figure 2.2).

The stream water depth in the Mangapepeke Stream could well be about 0.1 m lower during summer low flow compared to that during the November survey. Even under these lower flow conditions, most of the river habitat would be deeper than 0.25m deep (i.e. suited to inanga) and there would be little change in the depth of the deep pools that provide refuge for large eels during the day.

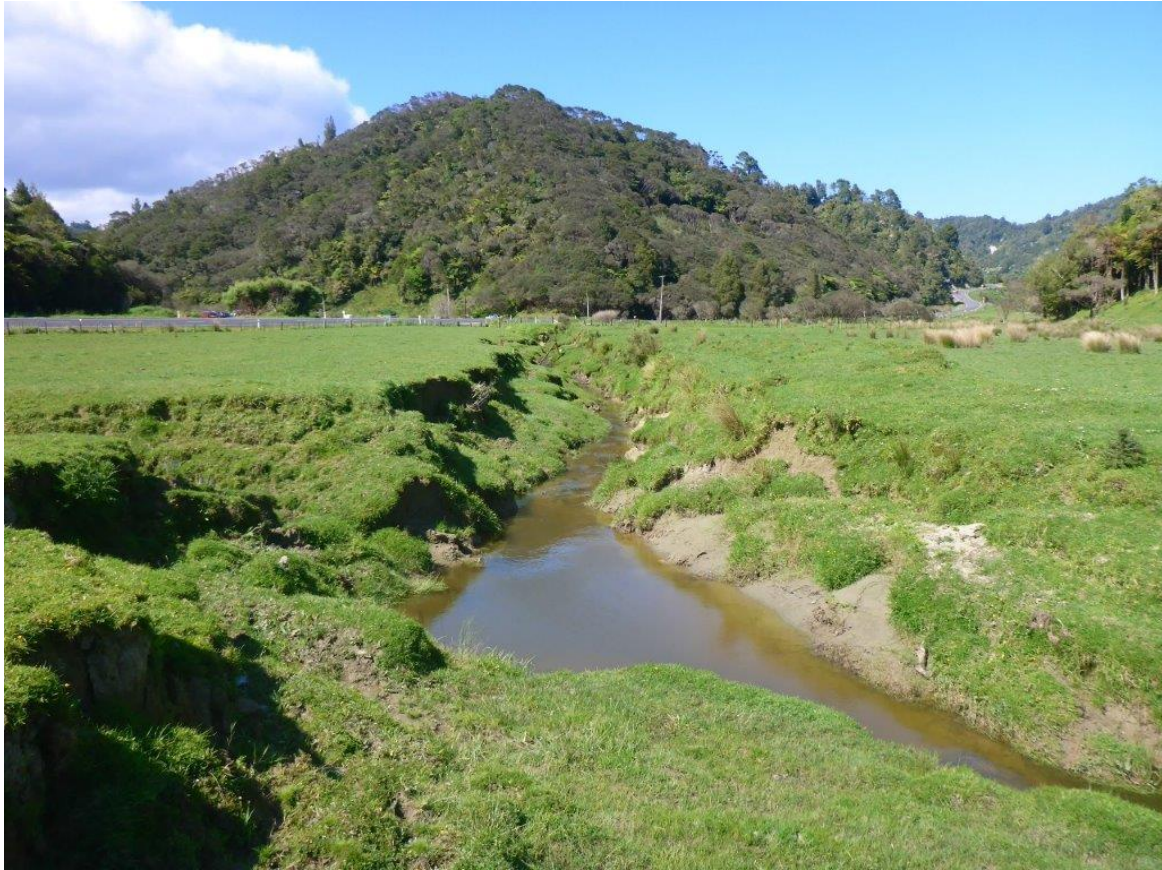
Figure 2.3 – Mangapepeke Stream facing upstream towards SH3. Photo taken from about 95m downstream of SH3 culvert.

The riparian vegetation is predominantly grassed pasture and there is very little shading or over-hanging vegetative cover. Occasionally wood in the stream provides cover. There was little macrophyte cover (*Glyceria fluitans* and *Chara* sp.) at the time of the survey.

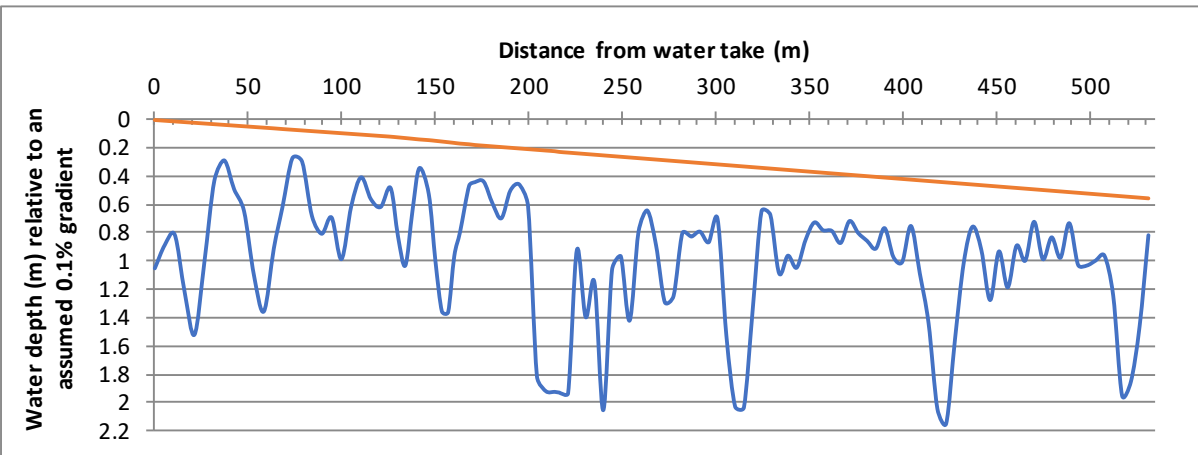
Figure 2.4 – Water depth longitudinally down the Mimi River, downstream of the proposed water take (1 November 2017). The top graph is relative to water level, the bottom graph has an assumed gradient of 0.1%.

The Mimi River downstream of the confluence of the proposed water take is about 2.1 m wide and about 0.3 to 0.6 m deep in runs. The stream typically has a U-shaped cross-sectional profile, is incised and has frequent slumping of the stream banks. The river is highly sinuous with wide, deep scour pools (about 1 m to 1.8 m deep) particularly apparent on meander bends. Small side drains enter the river at about 150 m (from true left (TL)), 300 m (from TR), and 400 m (from TL) (Figure 2.4 and Figure 2.5).

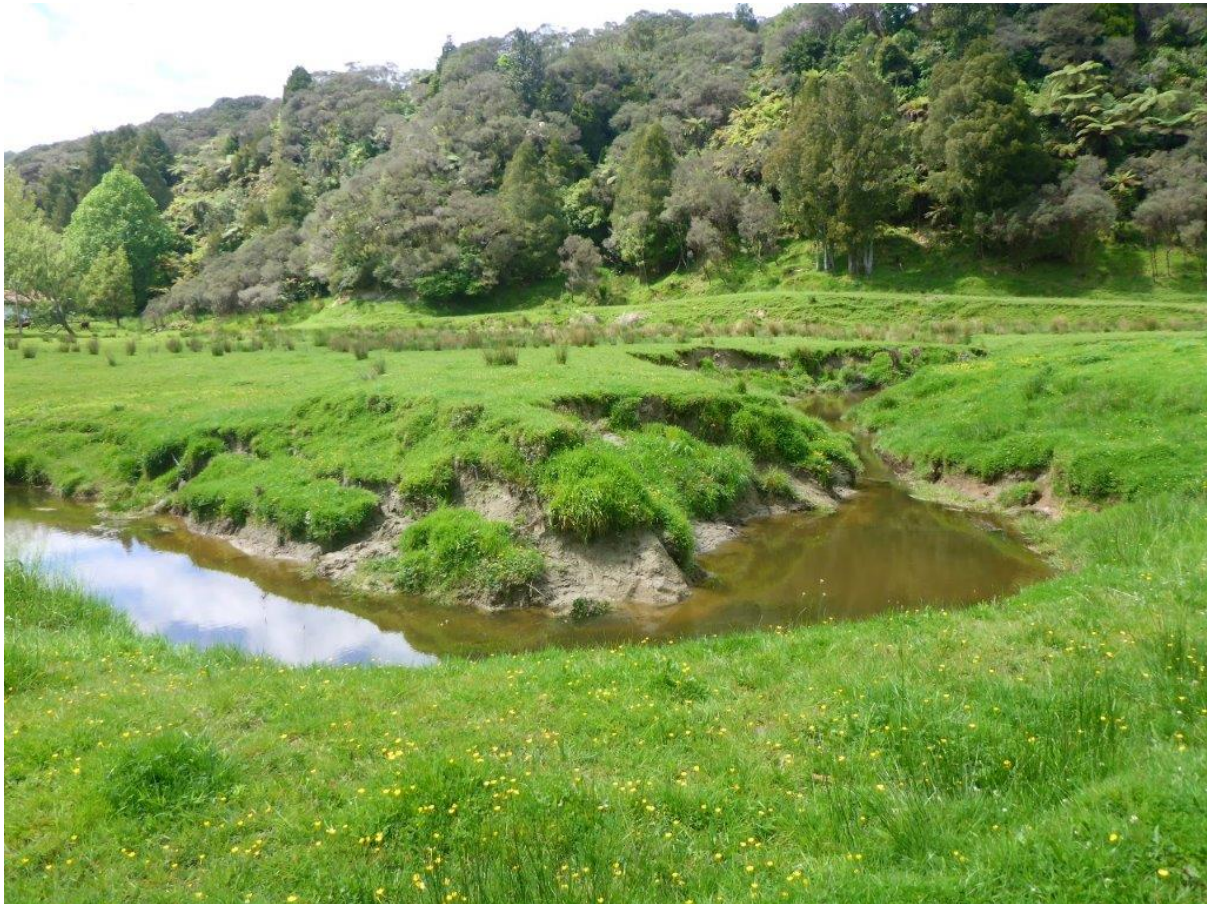
Figure 2.5 – Mimi River near site Ea24.

The riparian vegetation is predominantly grassed pasture and there is very little shading or over-hanging vegetative cover. There was little macrophyte cover at the time of the survey.

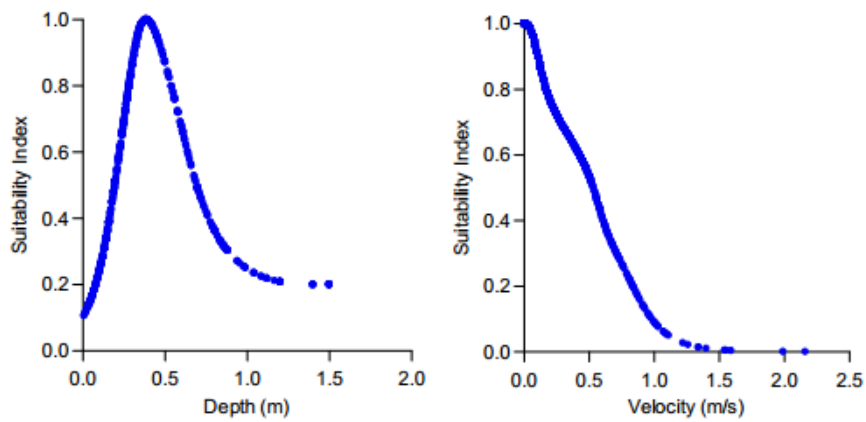
Figure A1 – Habitat preference curves for large longfin eel during the day (top graphs) and at night (bottom graphs) (Garnoth and Brooker 2009).

Large longfin eels preferred deep (0.4m), slow-flowing water. In larger rivers they move from deep water during the day into shallower water at night (Garnoth and Brooker 2009, Appendix A). Small longfin eel prefer slow flowing water near cover on the river margins and are more commonly found in shallow areas (<0.21 m) compared to large eels. However,

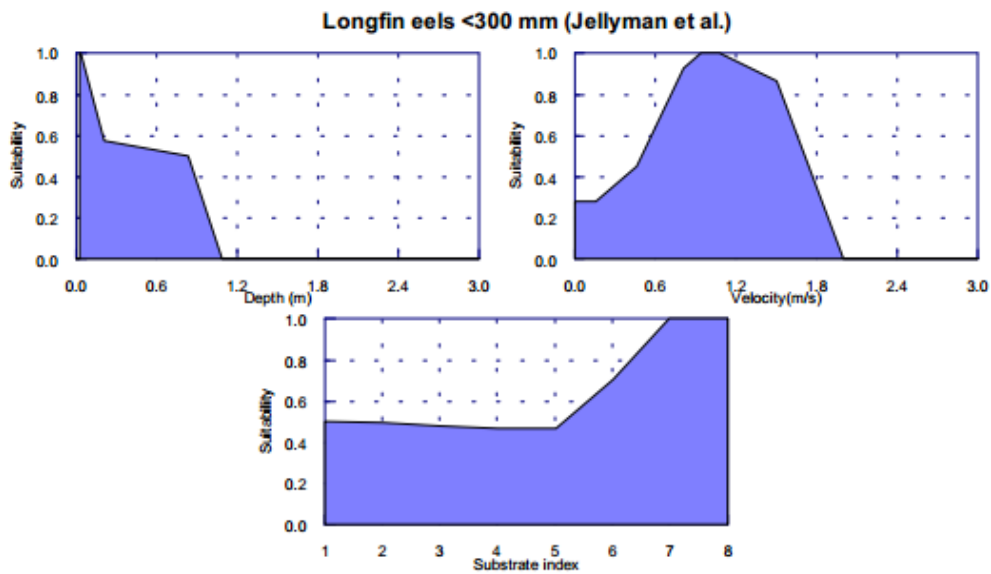
Figure A2 – Habitat preference curves for small to medium longfin eel (Jowett and Richardson 2008)

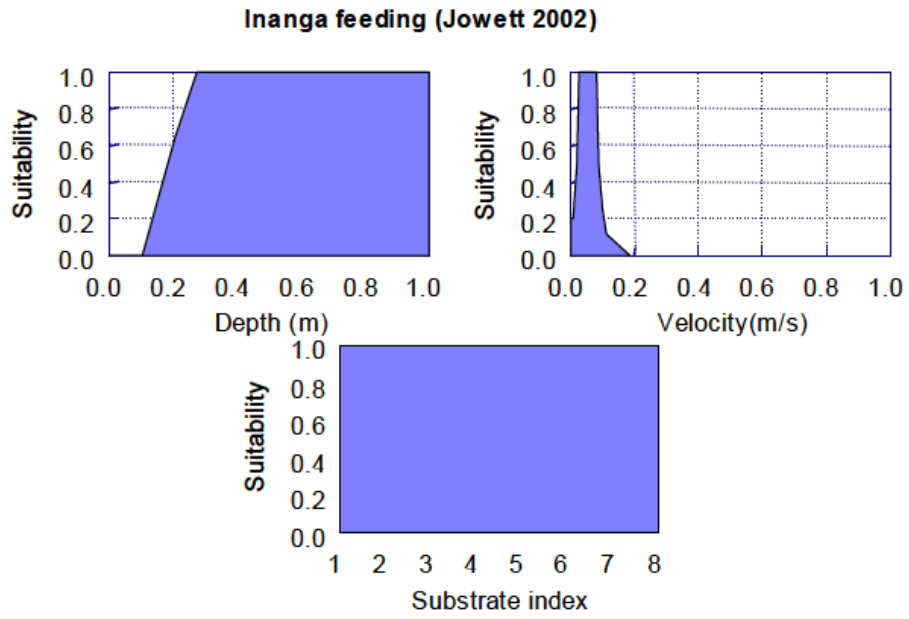
Figure A3 – Habitat preference curves for inanga (derived from Jowett 2002, in Jowett and Richardson 2008).

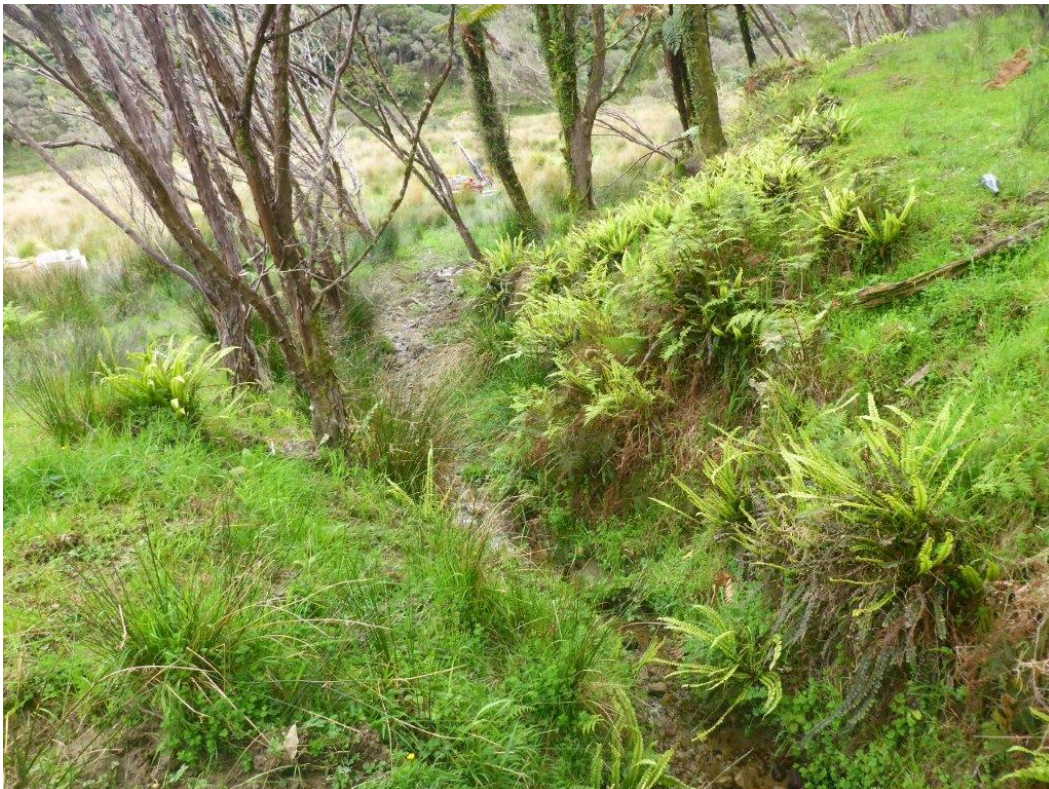
Figure C 4: Site Ea5, Mangapepeke Stream catchment. Dissipates into wet pasture with no formed channel.

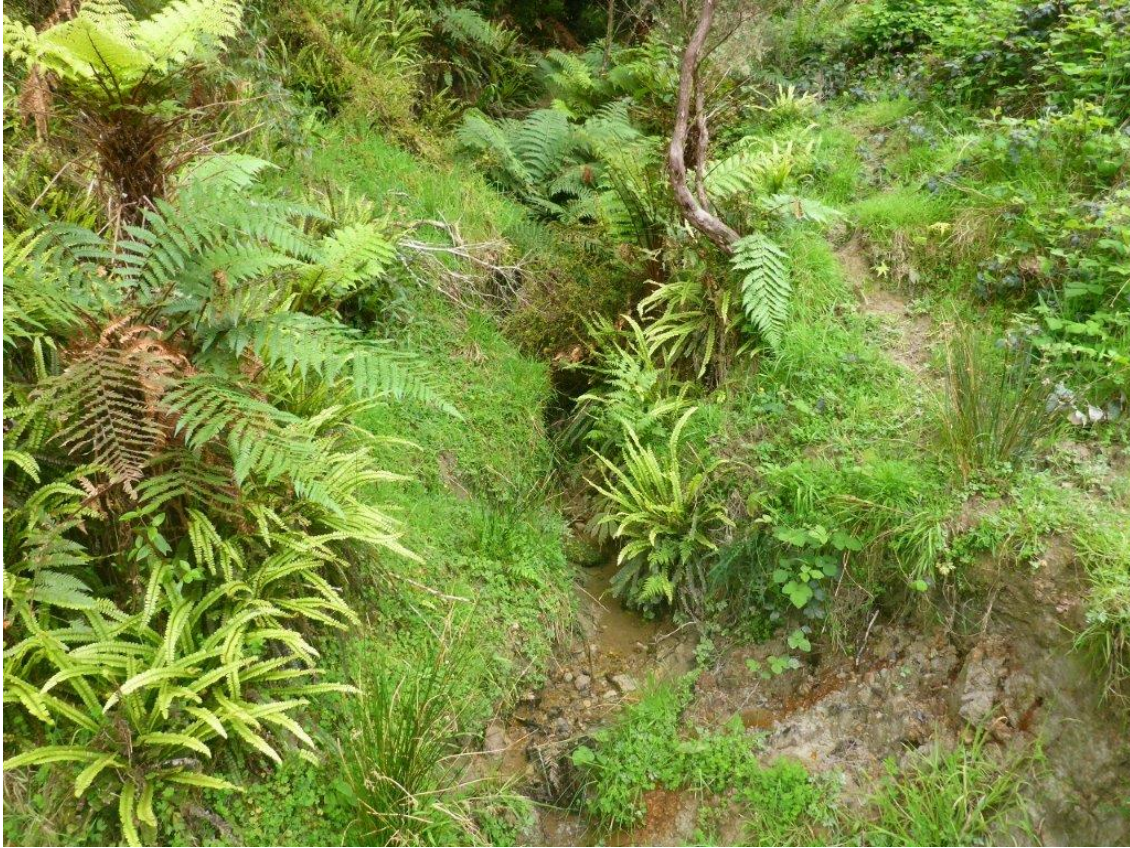
Figure C 5: Site Ea6, Mangapepeke Stream catchment. Dry sections in places.

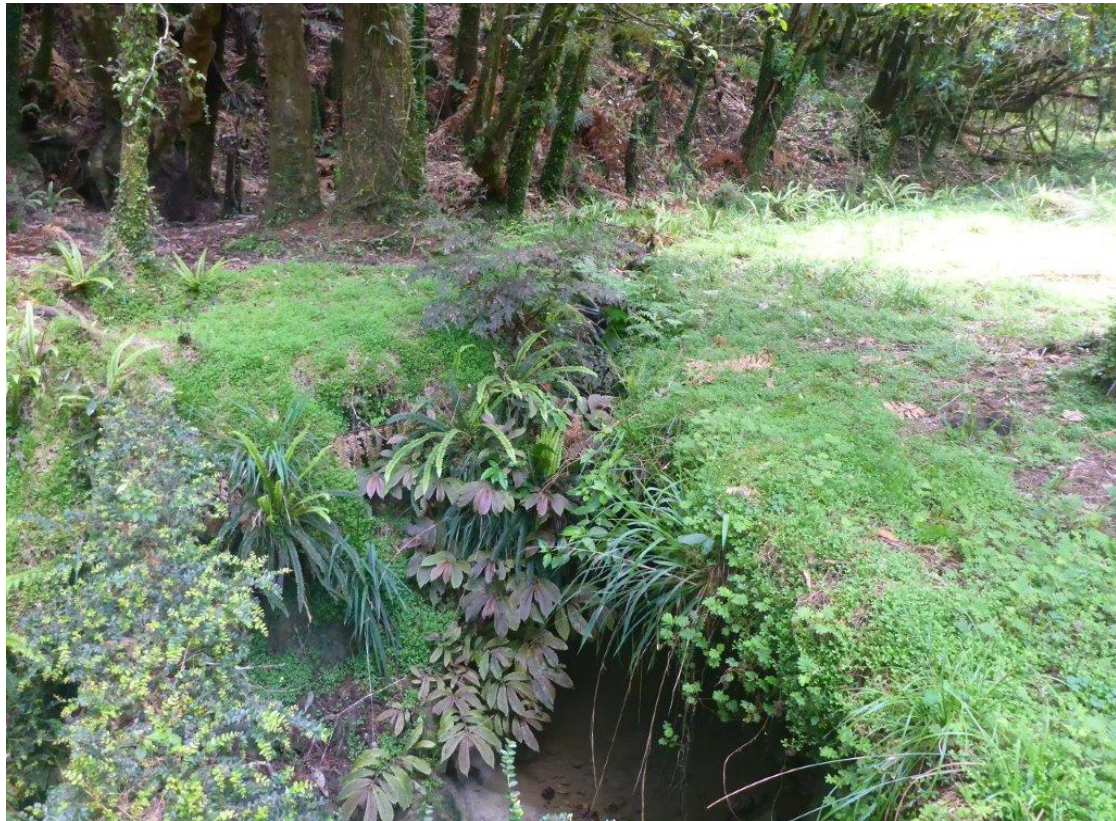
Figure C 6: Site Ea7, Mangapepeke Stream catchment. Deeply incised.

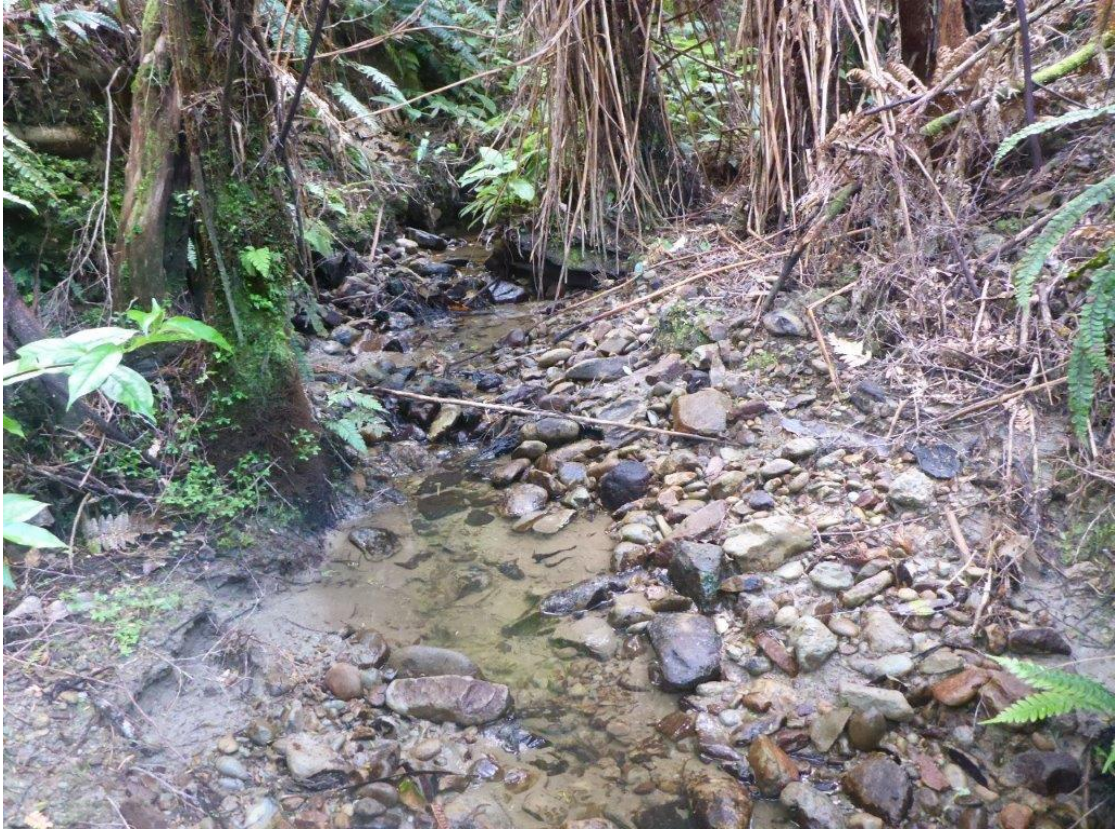
Figure C 6a: Site Ea7, Mangapepeke Stream catchment, shaded section.

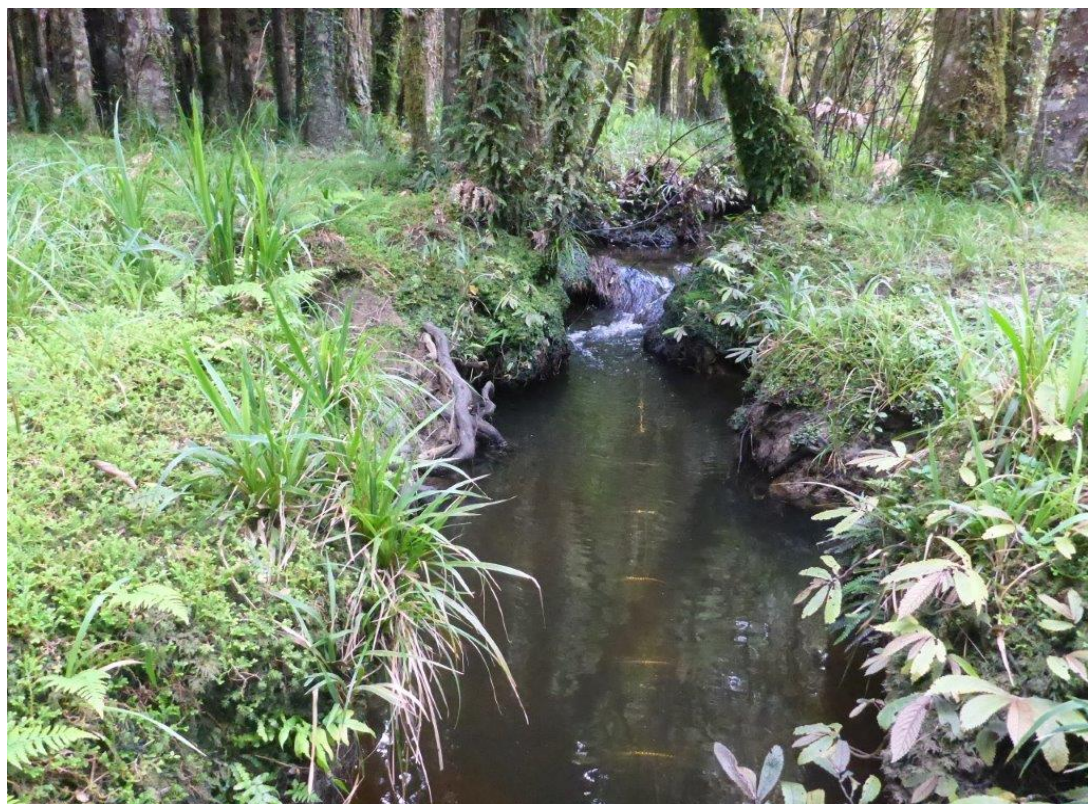
Figure C 9: Site Ea10, Mangapepeke Stream. Fyke net in water.

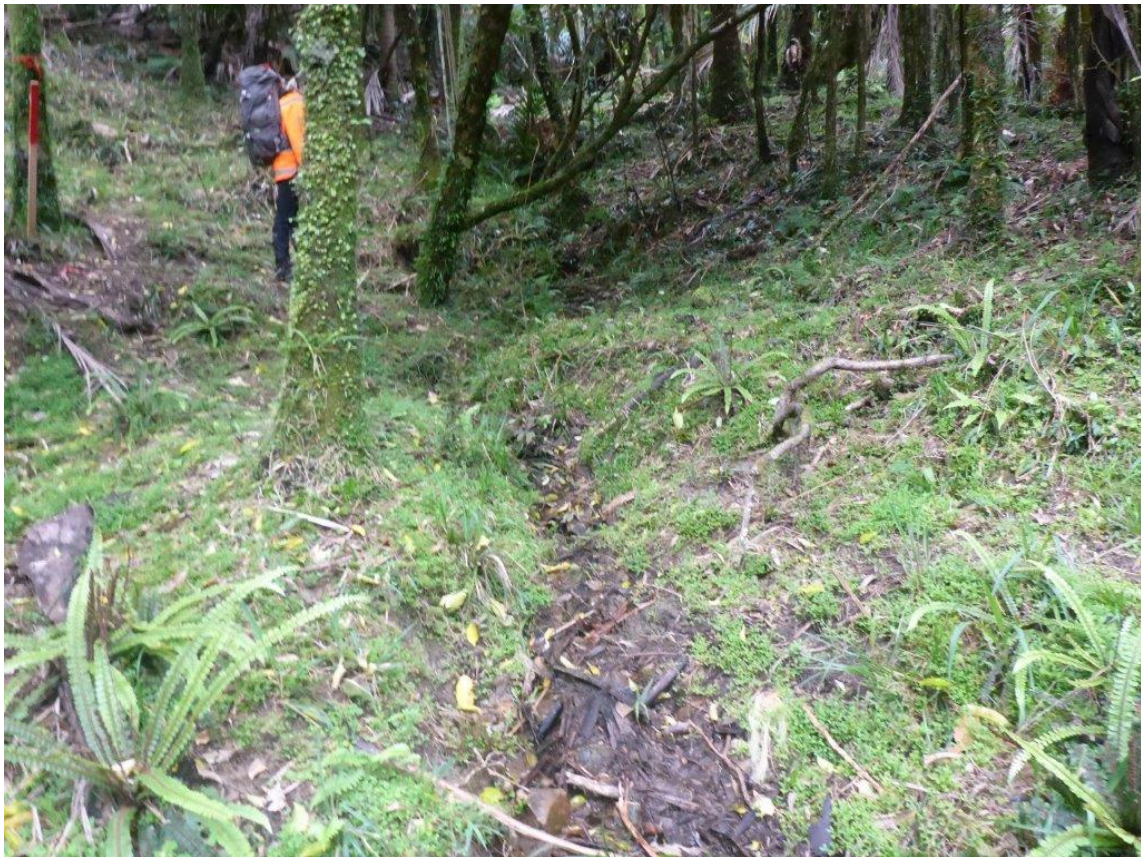
Figure C 11: Site Ea12, Mangapepeke Stream catchment.

- Site Ea12: The stream was ephemeral (i.e. no water present at time of October survey) at the alignment centre. Where there was water downstream of the alignment, only kōura were found.

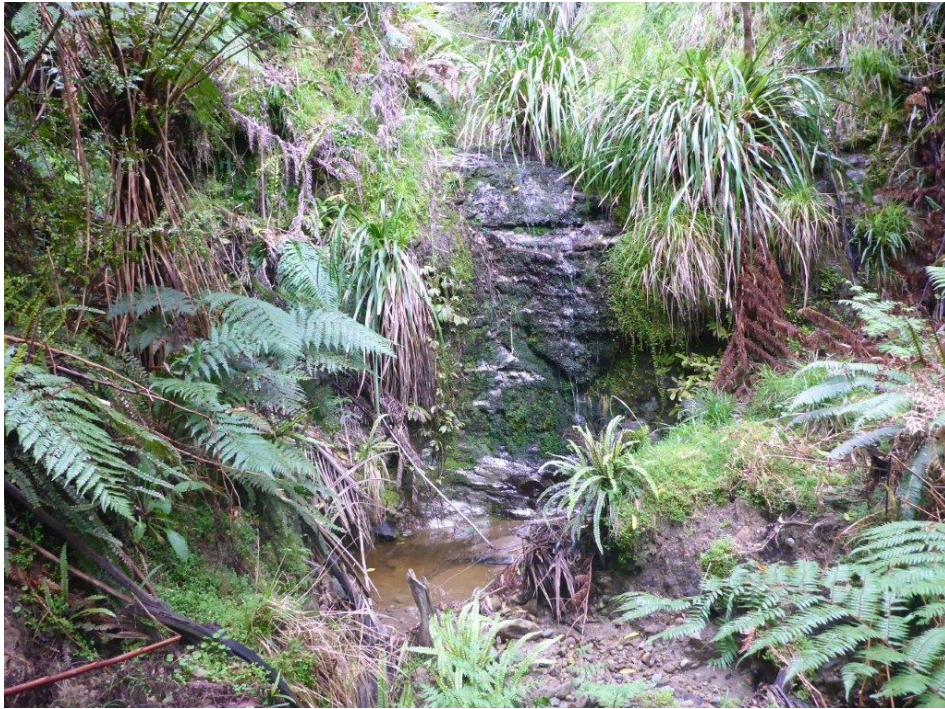
Figure C 12: Site Ea13, Mangapepeke Stream catchment. Small waterfall near upstream extent of fill on Ea13 (Culvert 12).

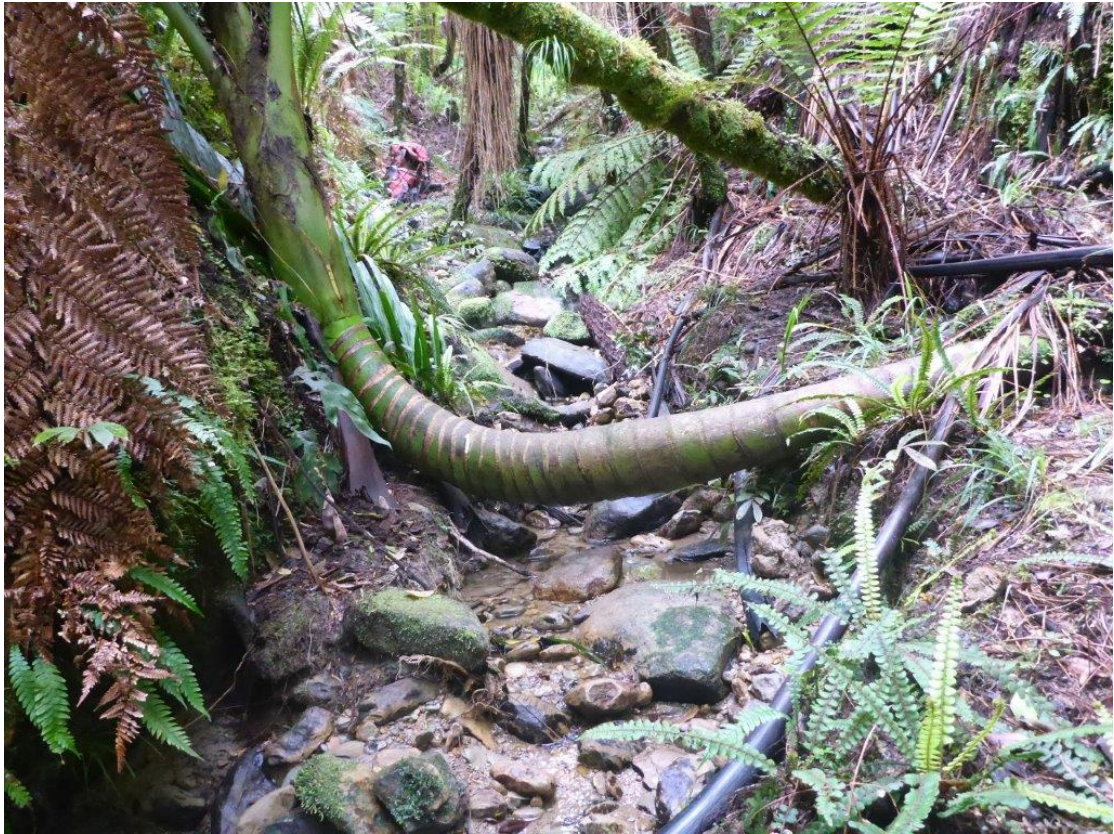
- Site Ea15: The stream was ephemeral about 20m upstream of the Project footprint and the last pool of greater than 5cm deep was within the section being culverted. There was a large waterfall downstream of the alignment but kōura and banded kōkopu were found in pools (about 0.2m deep) just upstream of this waterfall.

Figure C 14: Site Ea15, Mangapepeke Stream catchment upstream of waterfall.

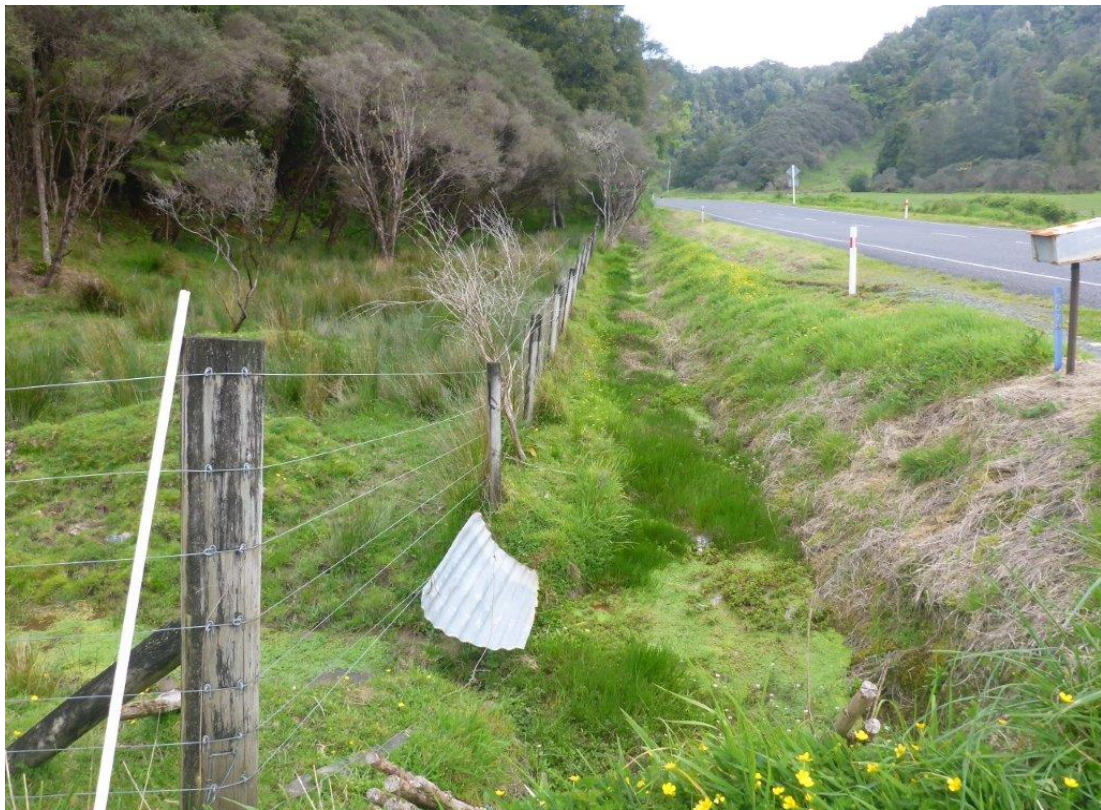
Figure C 15: Site E TL1, Mangapepeke Stream catchment, facing upstream. Adjacent to SH3.

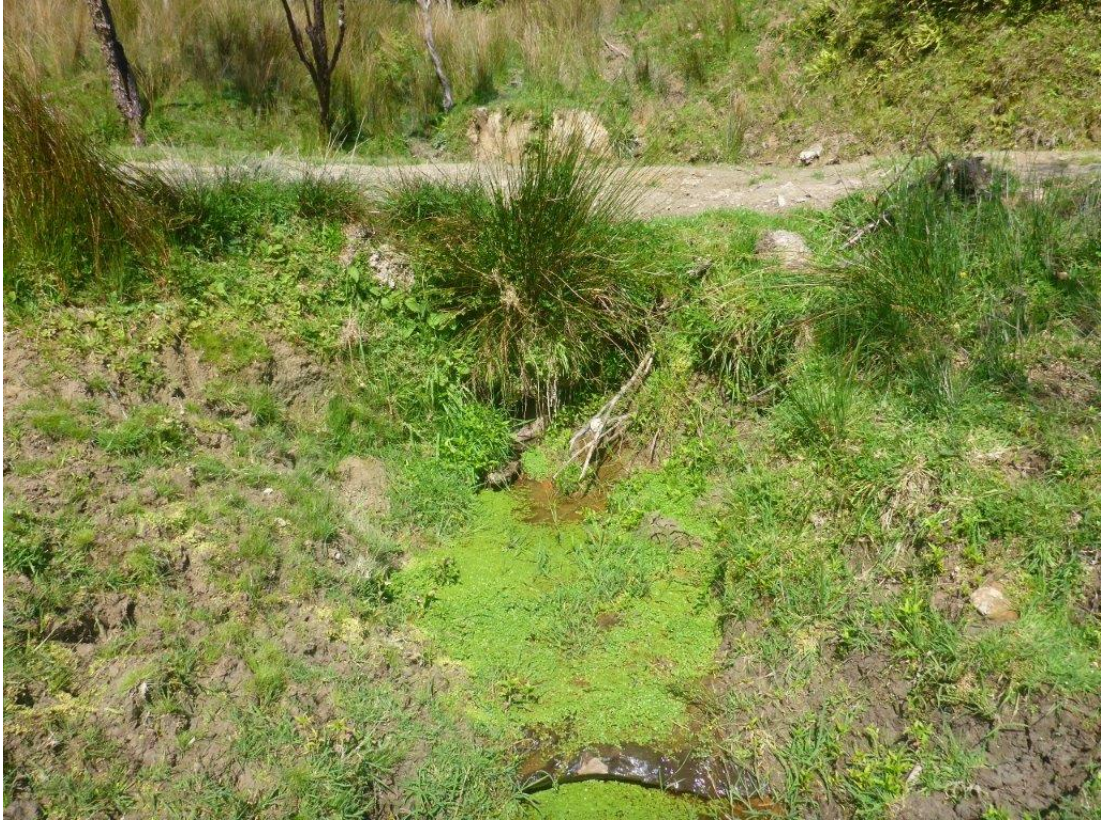
| Site | Catchment | catchment area (ha) | Riparian cover | Morphology | width (m) | depth run | depth pool (m) | Stream description |
|---|---|---|---|---|---|---|---|--|
| E TL2 | Mangapepeke trib | 1.9 | pasture, scrub | Intermittent drain | 0.2 | 0.02 | | Very shallow and degraded |

Figure C 16: Site E TL2, Mangapepeke Stream catchment, facing upstream. Cut off drain upstream draining through a 350mm culvert.

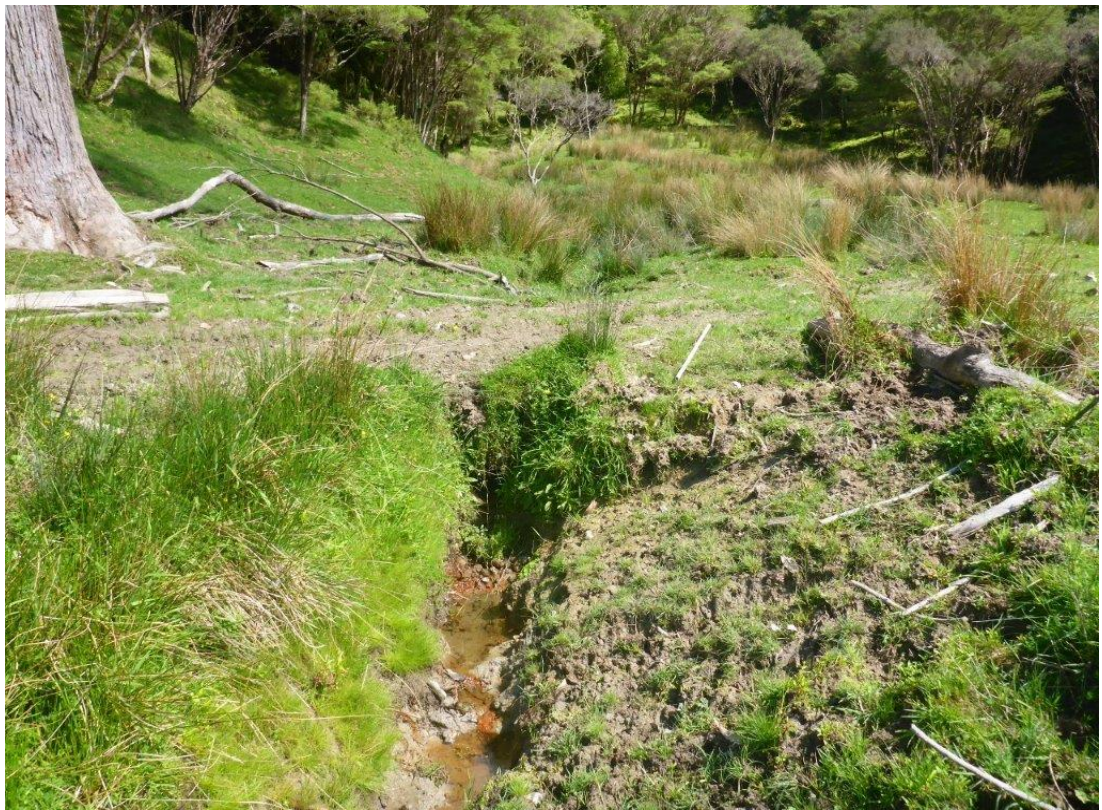
| Site | Catchment | catchment area (ha) | Riparian cover | Morphology | width (m) | depth run | depth pool (m) | Stream description |
|---|---|---|---|---|---|---|---|--|
| E TL3 | Mangapepeke trib | 2.1 | pasture, grazed wetland | Ephemeral drain | 0.2 | 0.02 | | Heavy pugging, degraded stream, tiny flow. |

Figure C 17: Site E TL3, Mangapepeke Stream catchment. Ephemeral in upper valley.

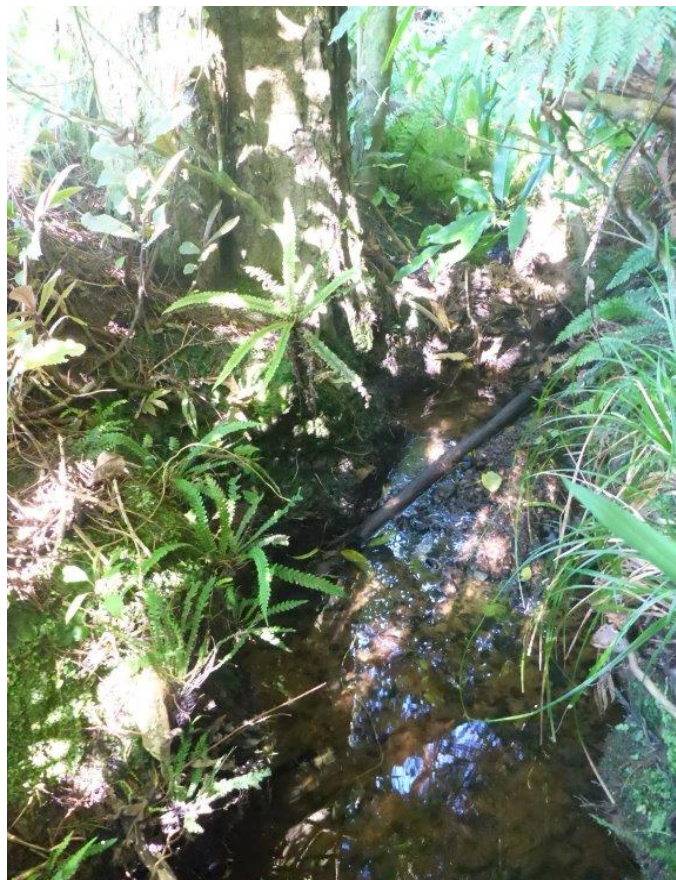
Figure C 21: Site Ea23, Mimi River catchment. Downstream of SH3.

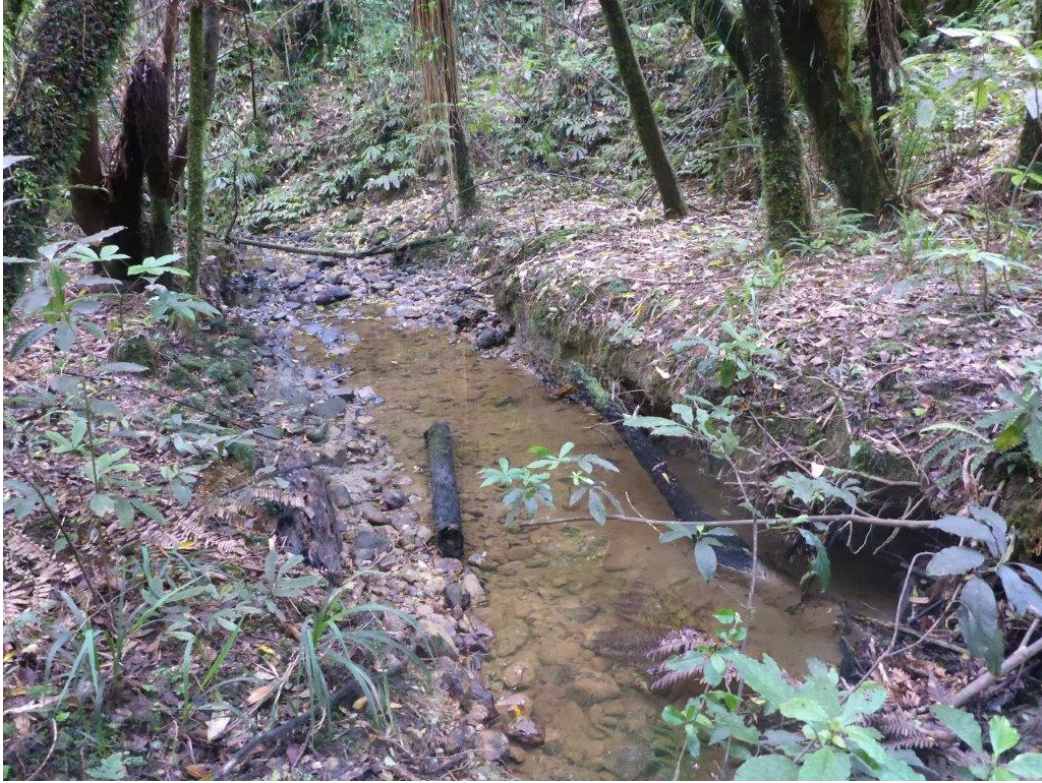
Figure C 22: Site Ea23a, Mimi River catchment. Upstream of SH3.

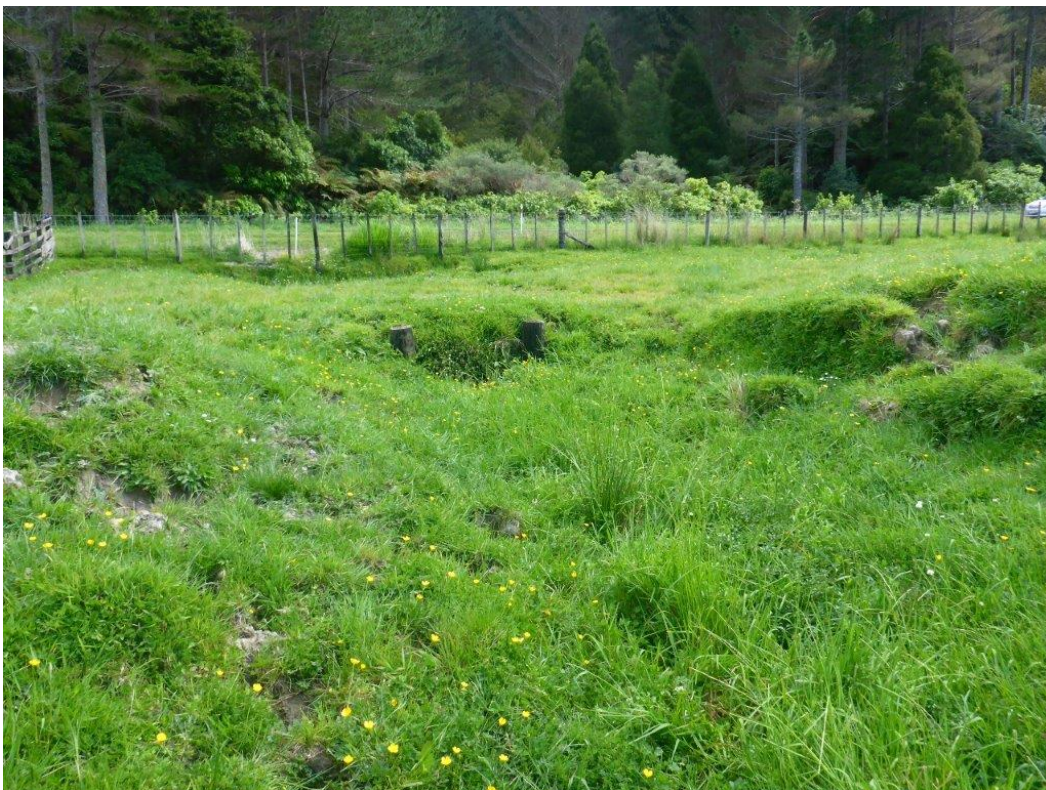
Figure C 23: Site Ea24, Mimi River catchment, facing upstream towards SH3.

| Site | width (m) | Project impact | Effect type | SEVi-C | SEVi-P | SEVi-I | SEVm-P - SEVm-C | ECR | Length of impact (m) | Area of impact (m ²) | Area to restore (m ²) |
|---|---|--|---|---|---|---|---|---|---|---|---|
| Ea24 | 0.6 | Extend/replace existing culvert. Exit to farm drain. | P | 0.35 | 0.77 | 0.23 | 0.24 | 3.4 | 10 | 6 | 20 |

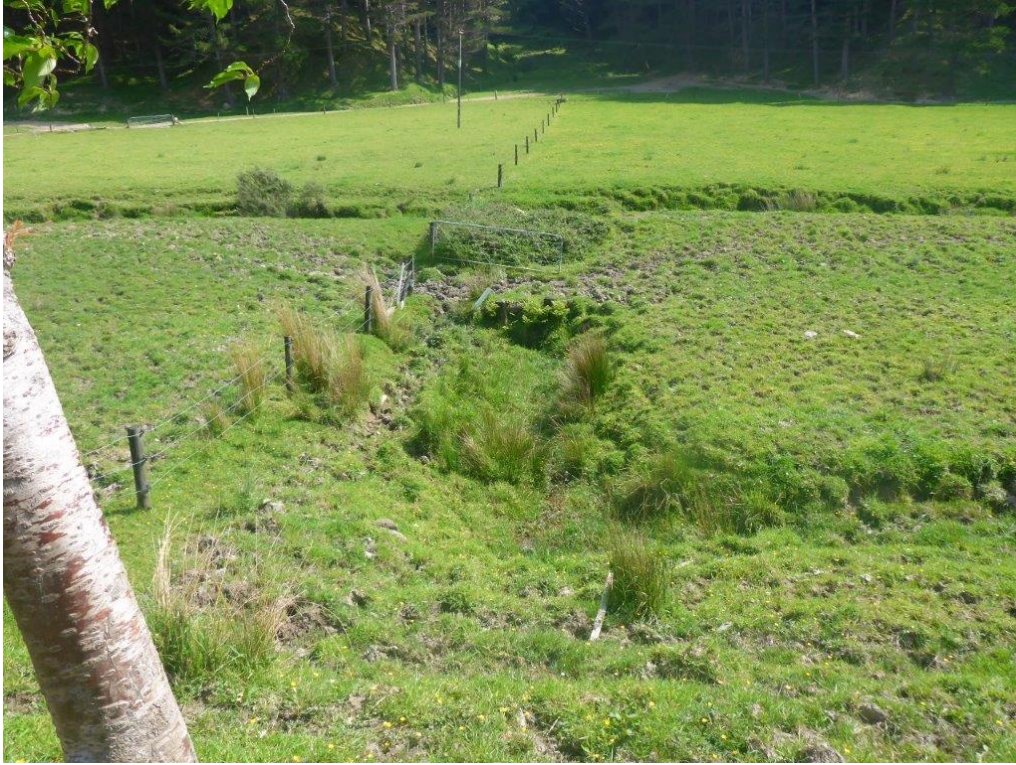
Figure C 24: Site Ea29, Mimi River catchment facing downstream towards Mimi River. No flow on 1 November 2017.

| Site | width (m) | Project impact | Effect type | SEVi-C | SEVi-P | SEVi-I | SEVm-P - SEVm-C | ECR | Length of impact (m) | Area of impact (m ²) | Area to restore (m ²) |
|---|---|--|---|---|---|---|---|---|---|---|---|
| Ea29 | 0.5 | Replace existing culvert with Culvert 21 | P | 0.35 | 0.77 | 0.23 | 0.24 | 3.4 | 10 | 5 | 17 |

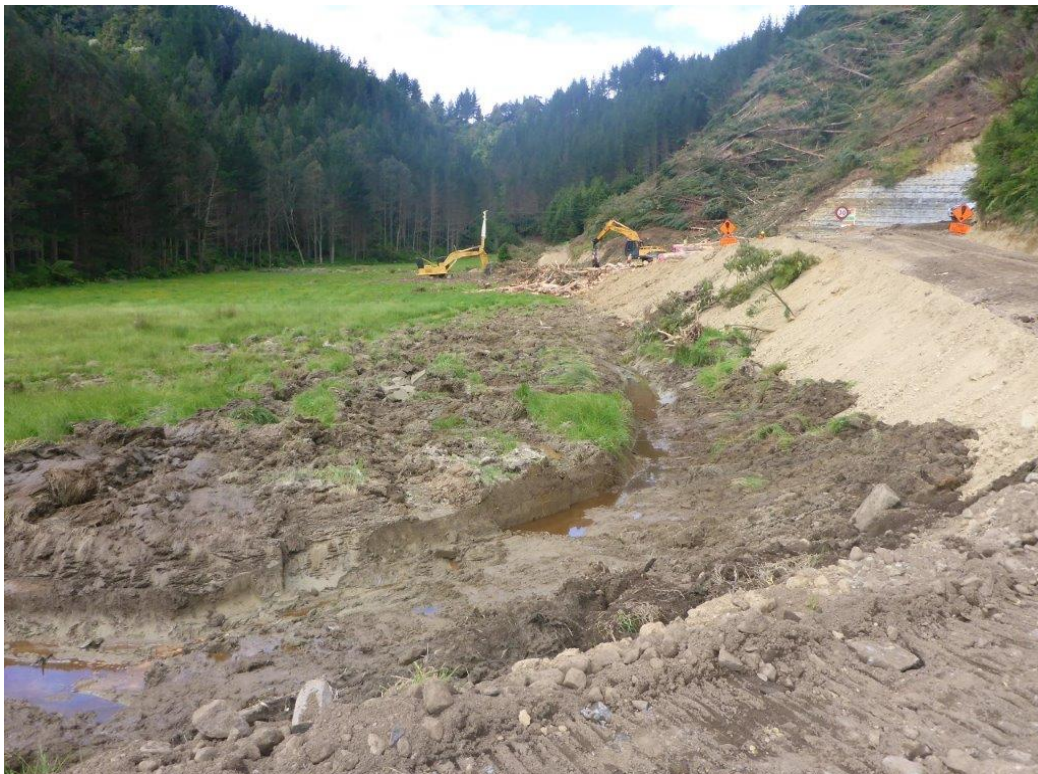
Figure C 25: Site Ea30, Mimi River catchment. Fill is proposed in this valley. The cut-off drain on true right of the valley has been by recent logging. The main stream is on true right of the valley is not affected by the Project.

| Site | width (m) | Project impact | Effect type | SEVi-C | SEVi-P | SEVi-I | SEVm-P - SEVm-C | ECR | Length of impact (m) | Area of impact (m ²) | Area to restore (m ²) |
|---|---|--|---|---|---|---|---|---|---|---|---|
| Ea30 | 0.3 | Main stream avoided. Cut-off drain replaced. | D a | 0.35 | | 0.4 | | 0.5 | 150 | 45 | 23 |
