Subject: Urenui stormwater investigation (2019 – 2022)

Author: T McElroy, Manager – Science & Technology

Document: 3256830

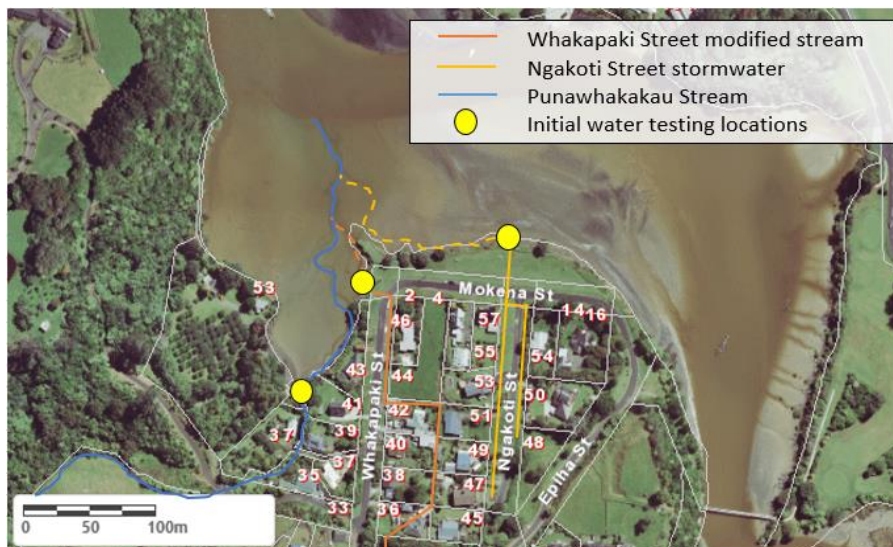
Figure 1 The Lower Urenui Township, with the Punawhakakau Stream (blue), Whakapaki Street modified stream (orange) and Ngakoti Street stormwater network (yellow). Sample locations shown as yellow dots.
