Subject: Wetland Delineation Results and Assessment Against National
Environmental Standards – Freshwater 2020

This technical report has been prepared on behalf of Robe and Roche Investments Limited with regards to the a proposed subdivision of Lot 2 DP 521660 (56 Pohutukawa Place, Bell Block, New Plymouth). Significant ecological features are present along the western and eastern boundary of the northern extent of the project area in the form of the Waipu Lagoons. These water bodies are well studied, with an existing esplanade reserve including a riparian buffer that fringes the project area.

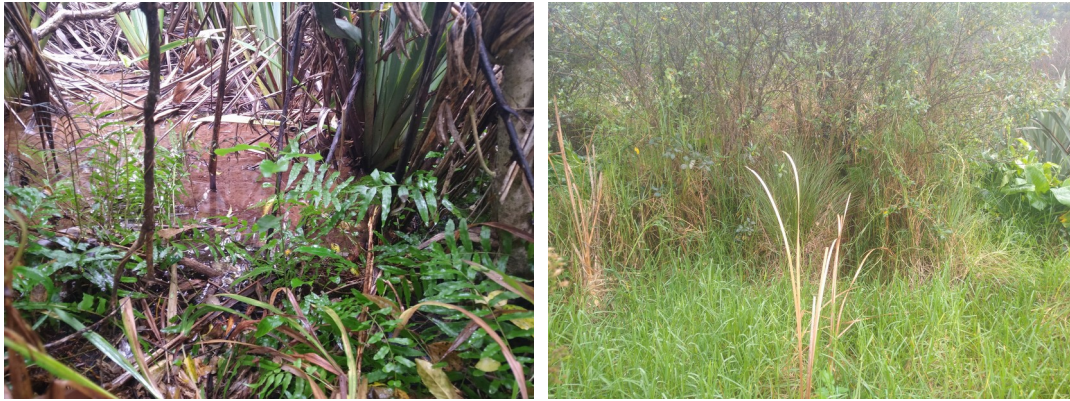
Figure 1a, left, Rapid visual assessment of wetland boundary within reserve; vegetation type changes from flax/harekeke (*Phormium tenax*) a Facultative Wetland Species to kiokio (*Blechnum novae-zelandiae*) a Facultative species and mamaku (*Cyathea medullaris*) a Facultative Upland species. **Figure 1b**, right, Rapid visual assessment of wetland boundary within reserve; vegetation type changes from raupō (*Typha orientalis*) an Obligate species to kikuyu (*Cenchrus clandestinus*) a Facultative Upland species.

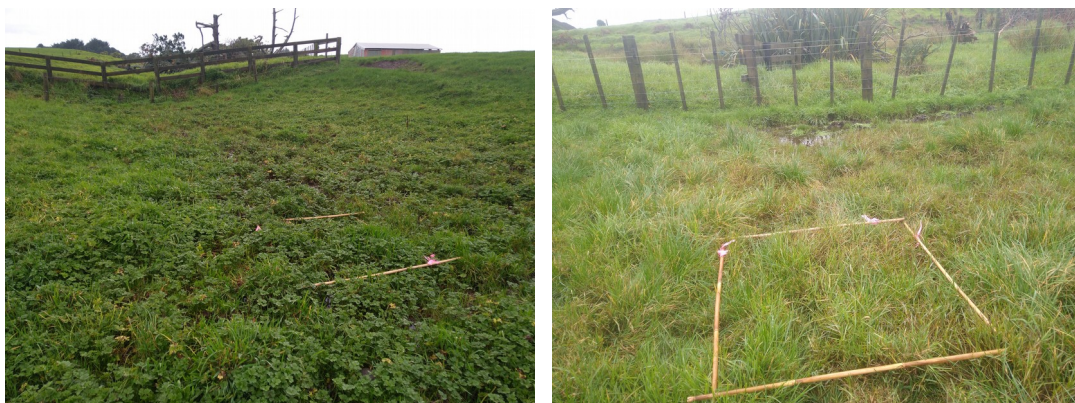
Figure 2a, left, South-western most vegetation plot for Dominance Test and Prevalence Index test calculations; dominated by buttercup (*Ranunculus repens*) a facultative species. This plot passed the Dominance Test and failed the Prevalence Index but shows clear wetland hydrology with likely hydric soils. **Figure 2b**, Eastern most of the western vegetation plots for Dominance Test and Prevalence Index test calculations; dominated by mercer grass (*Paspalum distichum*) a facultative wetland species. This plot passed both the Dominance Test and Prevalence Index tests.

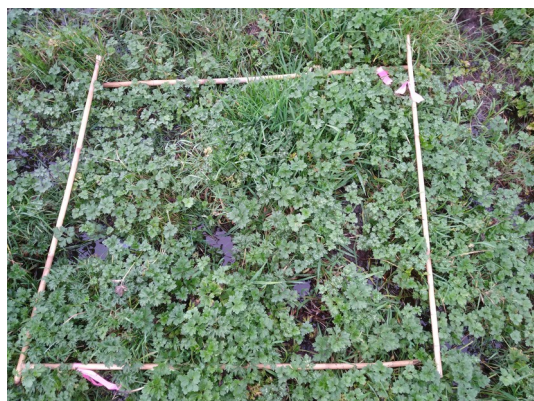
Plot 1 19384475.12 , -4726557.56

Dominance test: Pass

Prevalence test: Fail (3.14)

Hydrology test: Pass

Pasture species: 15%

Notes: pugging from recent (many days) grazing

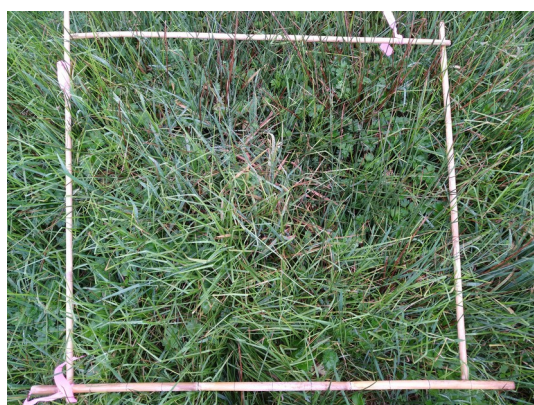
Plot 2 19384466.95, -4726527.20

Of the other five plots, four (Plots #1, 3, 4 and 7) meet the criteria of 'natural wetland'. Plot #2 passed the DT and hydrology test with vegetation dominated by kikuyu, which is considered an invasive weed; this is likely the reason the hydrophytic vegetation present within Plot #2 fails to meet the criteria of a 'natural wetland'. This has been considered in the decision to include this area as a wetland.

Dominance test: Pass

Prevalence test: Fail (3.09)

Hydrology test: Pass

Pasture species: 65%

Notes: Invasive weed (kikuyu) considered pasture species and FACU spp; it is dominating plot and will likely throw off calculations; this area appears to be a wetland

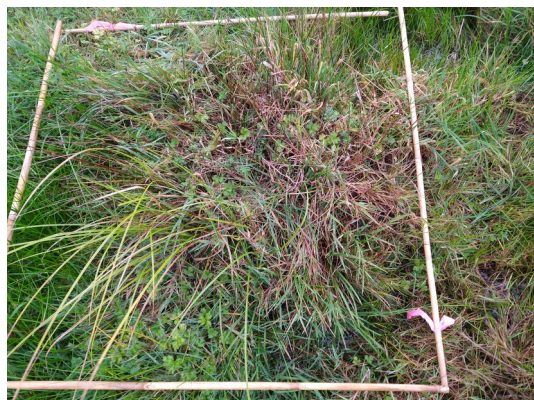
Plot 3 19384453.5, -4726456.0

Dominance test: Pass

Prevalence test: Pass (2.17)

Hydrology test: Pass

Pasture species: 30%

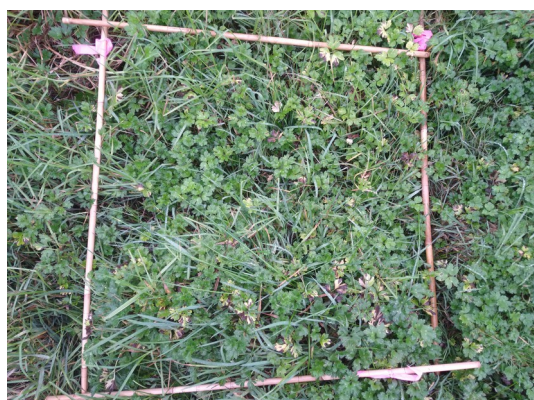
Plot 4 19384471.0, -4726422.6

Dominance test: Pass

Prevalence test: Pass (2.85)

Hydrology test: Pass

Pasture species: 65%

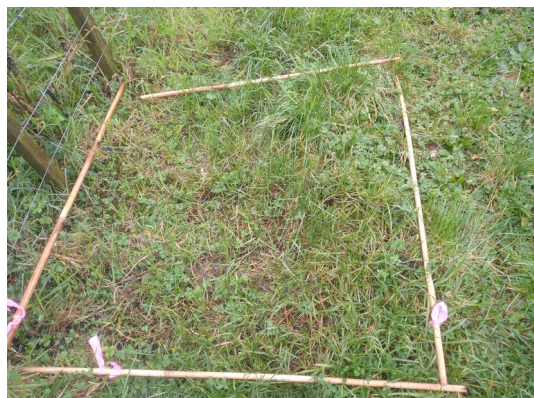
Plot 5 19384731.32, -4726233.86

Dominance test: Fail

Prevalence test: Fail (3.65)

Hydrology test: Pass

Pasture species: 76%

Notes: Recent grazing

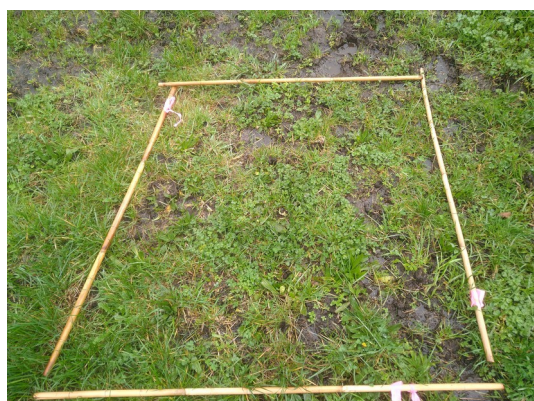
Plot 6 19384744.83, -4726231.83

Dominance test: Fail

Prevalence test: Fail (3.48)

Hydrology test: Fail

Pasture species: 50%

Notes: Recent grazing

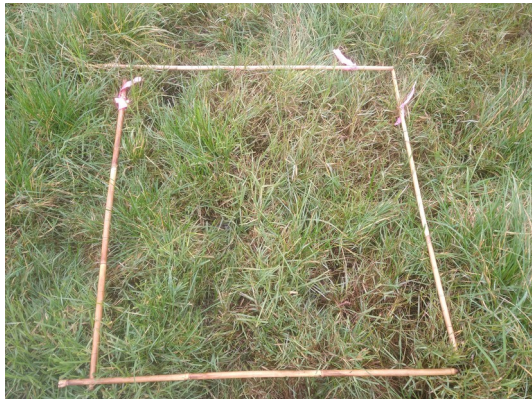
Plot 7 19384480.7, -4726424.7

Dominance test: Pass

Prevalence test: Pass (2.29)

Hydrology test: Pass

Pasture species: 15%

Notes: Recent grazing
