# ENGINEERING REPORT

Project:  
**Proposed Subdivision**  
373 Maude Road, Korito, Kaimiro, Taranaki

Client:  
Rachel Broadmore

JOB NUMBER: 24005  
Rev B  
31 January 2024

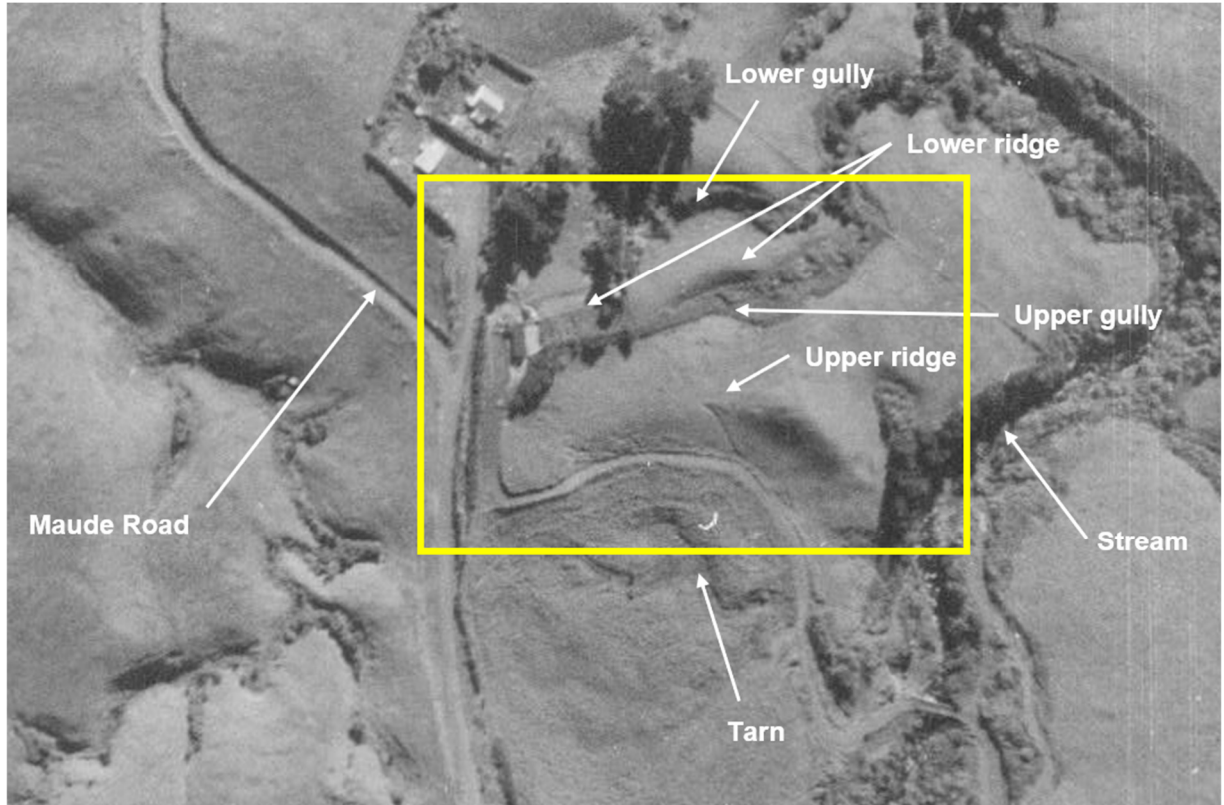
Figure 5: The 1950 aerial photo of the site (Source: Retrolens)

From the above photographs review, we have observed that geotechnical alterations such as site cutting, excavation, backfilling and recontouring occurred in the past. Please refer to Figure 7 and Figure 8 for the location and approximate extent of the observed geotechnical alterations.

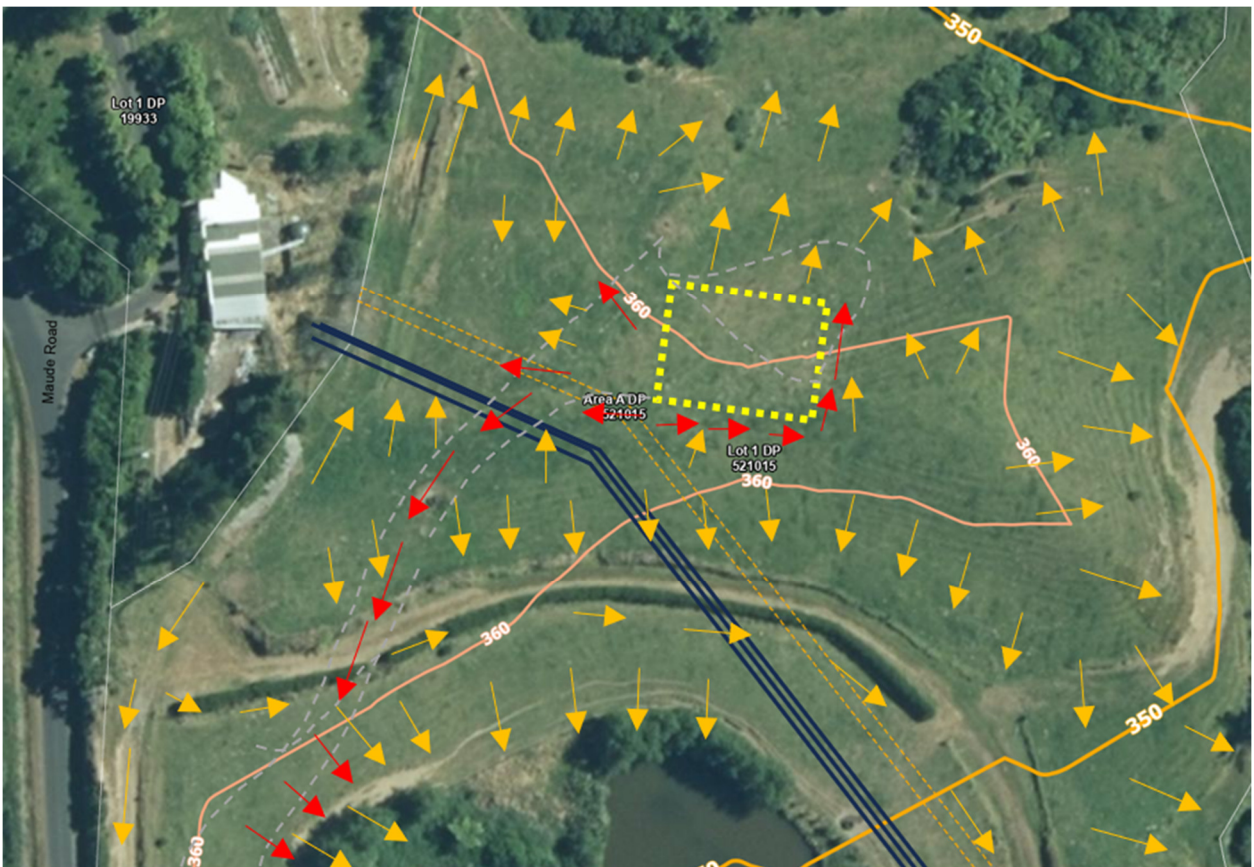
Figure 16: Proposed overland flow paths

The overland flow on the proposed development will be as per existing apart from the overland flows on the proposed building platform and vehicle access. Therefore, the natural drainage pattern on the proposed lot 1 will not be significantly impacted. The overland flow paths for the proposed development are shown on *Figure 16*.

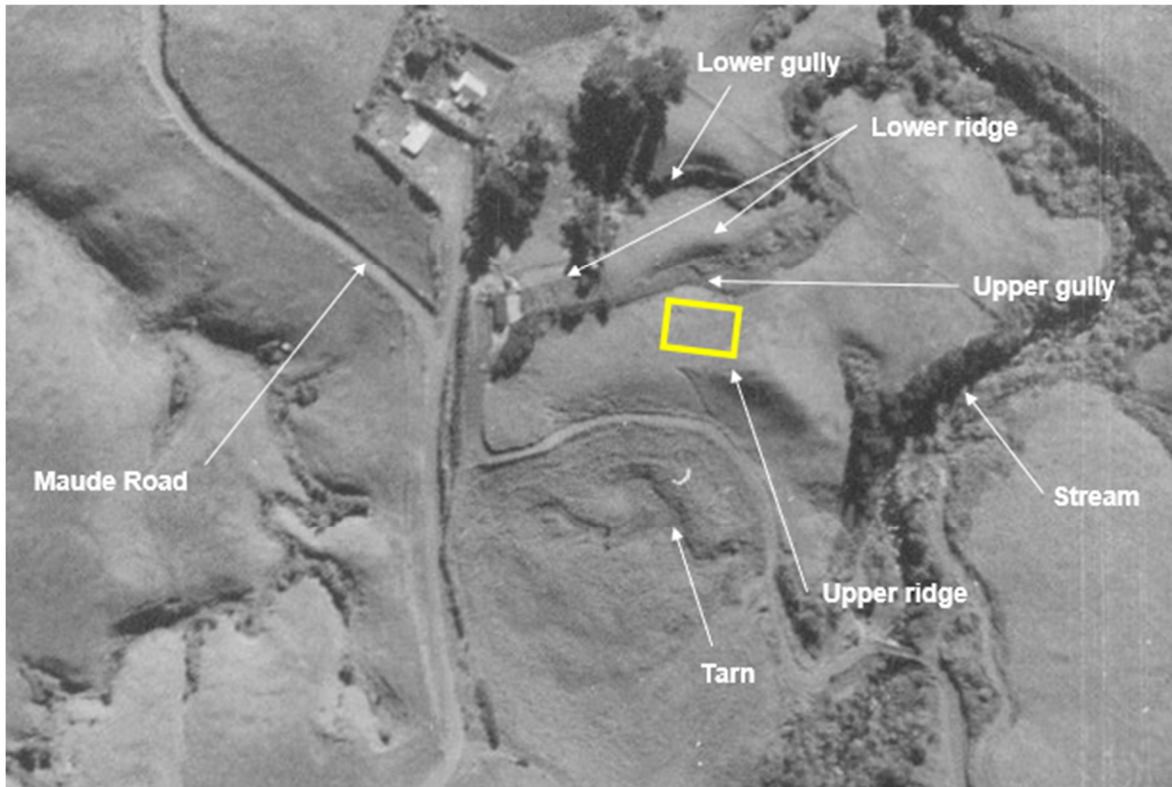
1950 Aerial photo (Source: Retrolense) – upper gully is visible
