Urenui and Onaero Wastewater Treatment Plant - Assessment of Alternative Sites

Prepared for New Plymouth District Council
Prepared by Beca Limited

19 January 2024

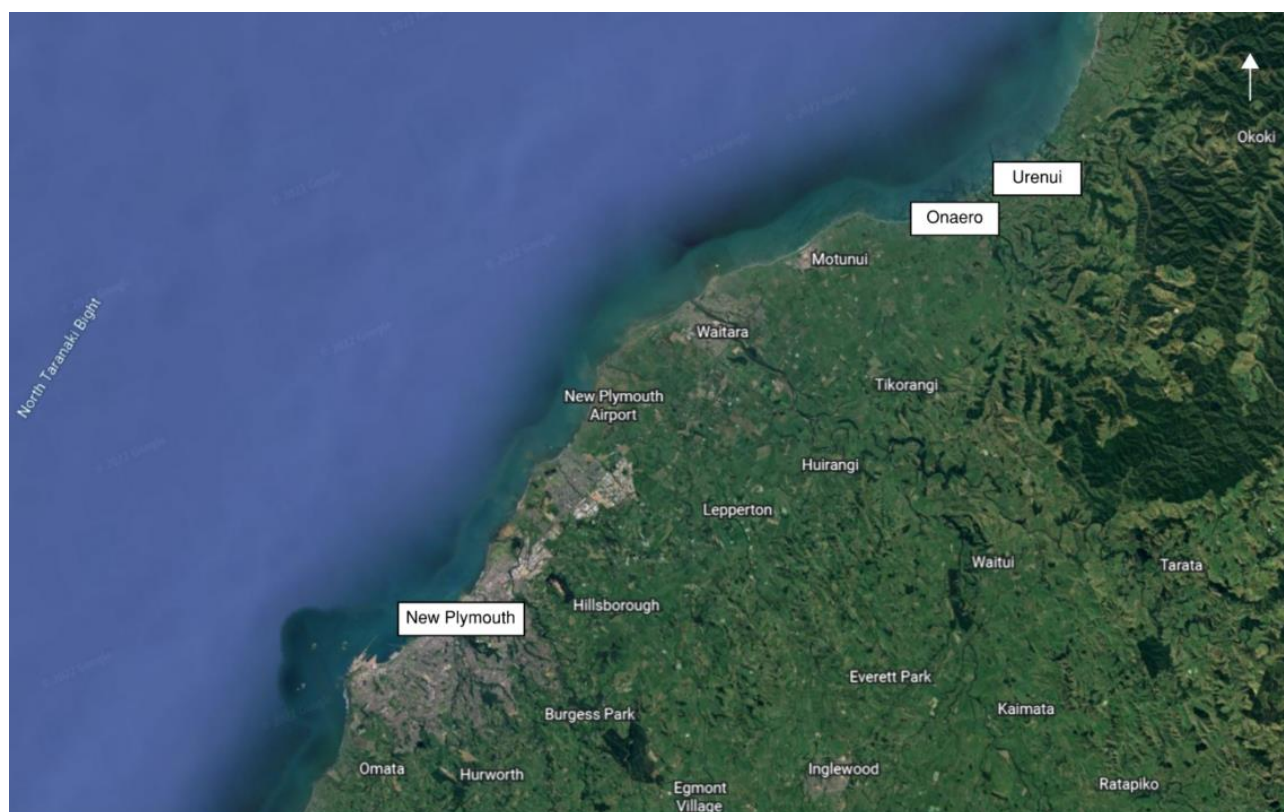
Figure 1. Location of Onaero and Urenui in relation to New Plymouth.

The settlements of Urenui and Onaero are located on the coast approximately 25 km north-east of New Plymouth, New Zealand (Figure 1). These settlements currently do not have a centralised wastewater system and dwellings rely on on-site septic tank systems. New Plymouth District Council (NPDC) are planning on constructing a new Wastewater Treatment Plant (WWTP) to provide a centralised wastewater collection and discharge to land system for these settlements. It is proposed that the discharge to land occur on the WWTP site. Beca Limited (Beca) have been commissioned to undertake an option assessment process to guide site selection for the new WWTP.

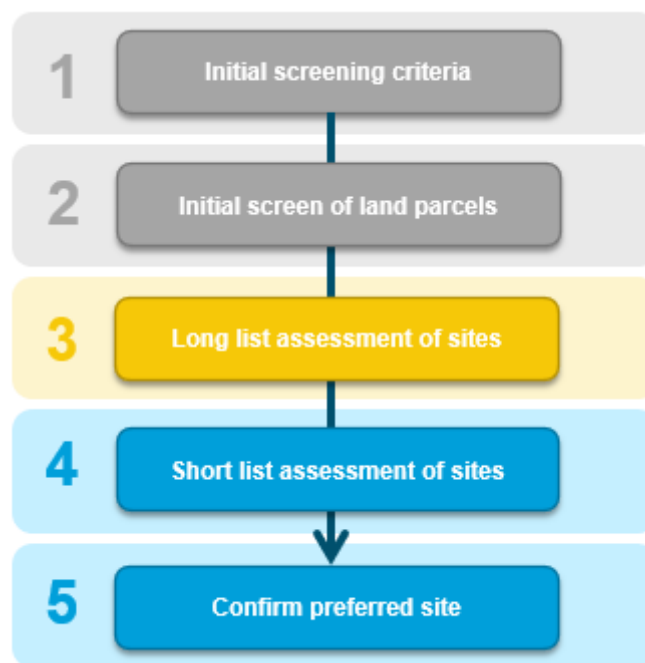
Figure 3: Methodology

This section provides an overview of the assessment of alternatives methodology developed to assess alternative WWTP locations and ultimately determine a preferred site. The key steps are outlined in Figure 3 and described below. Each step is explained in detail in the sections that follow.

The process for the assessment of alternatives was as follows:

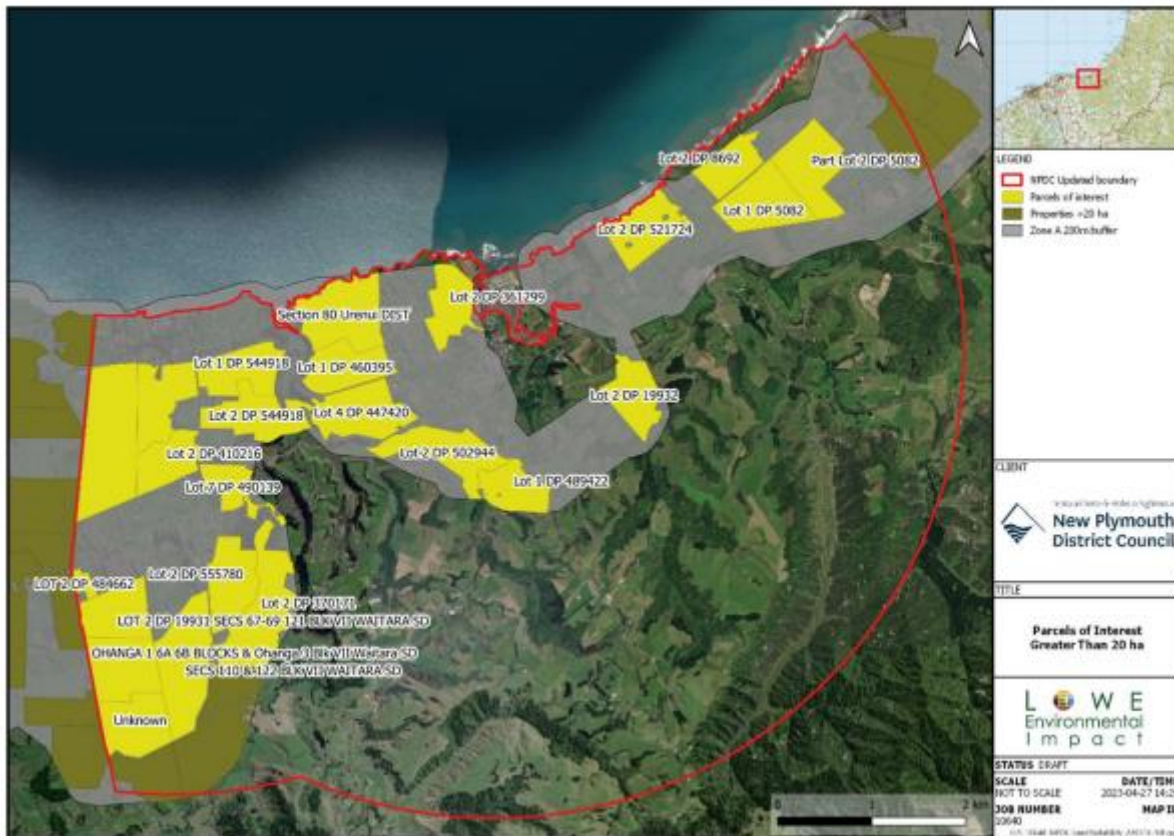
Figure 4. Properties considered for the project (Zone Aa land – identified in Appendix B)²

The following section outlines the long list sites considered for this project. As described in Section 4.2, an initial long list of 23 possible sites was developed at a property level as shown in Figure 4.

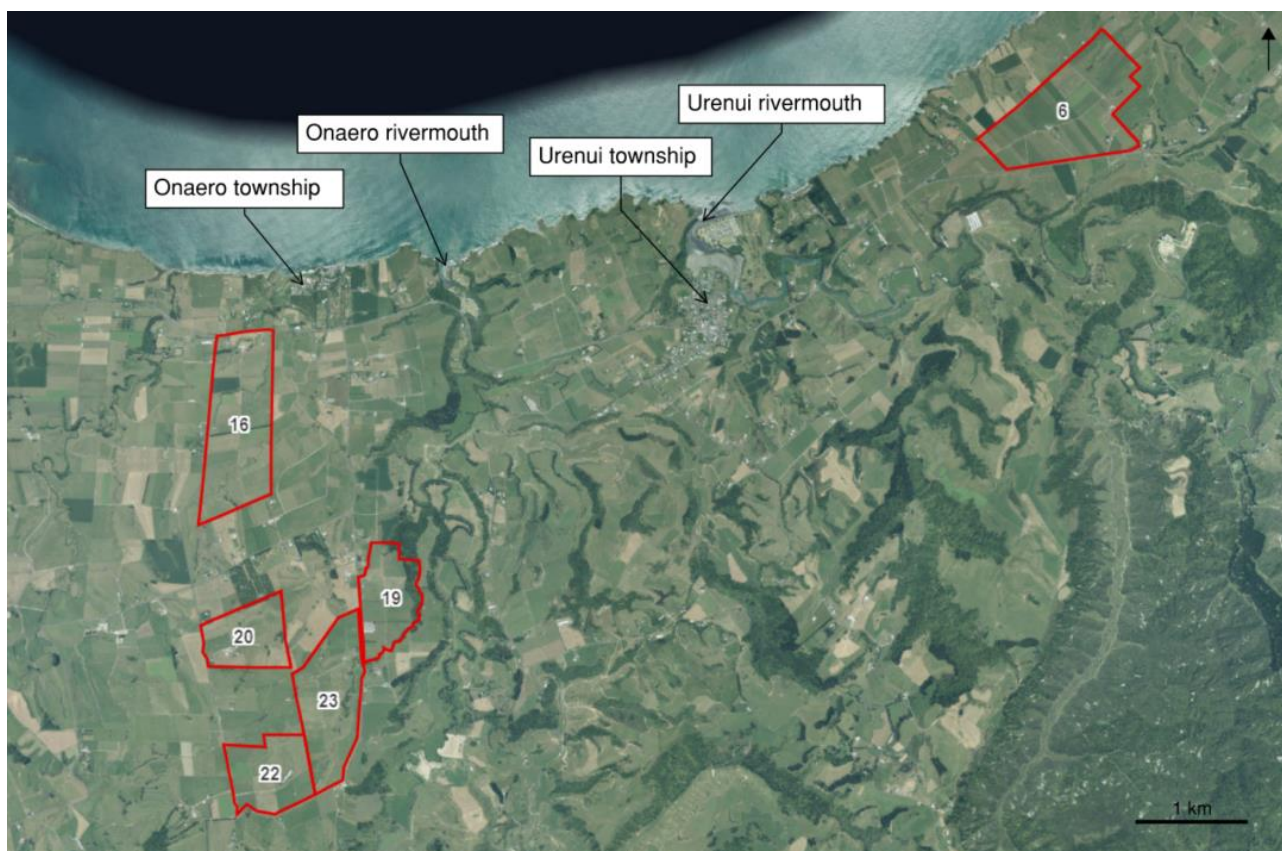
Figure 5. Map showing the location of short list sites.

Options 6, 16, 19, 20, 22, and 23 proceeded to the short list stage and these sites are shown in Figure 5 below.

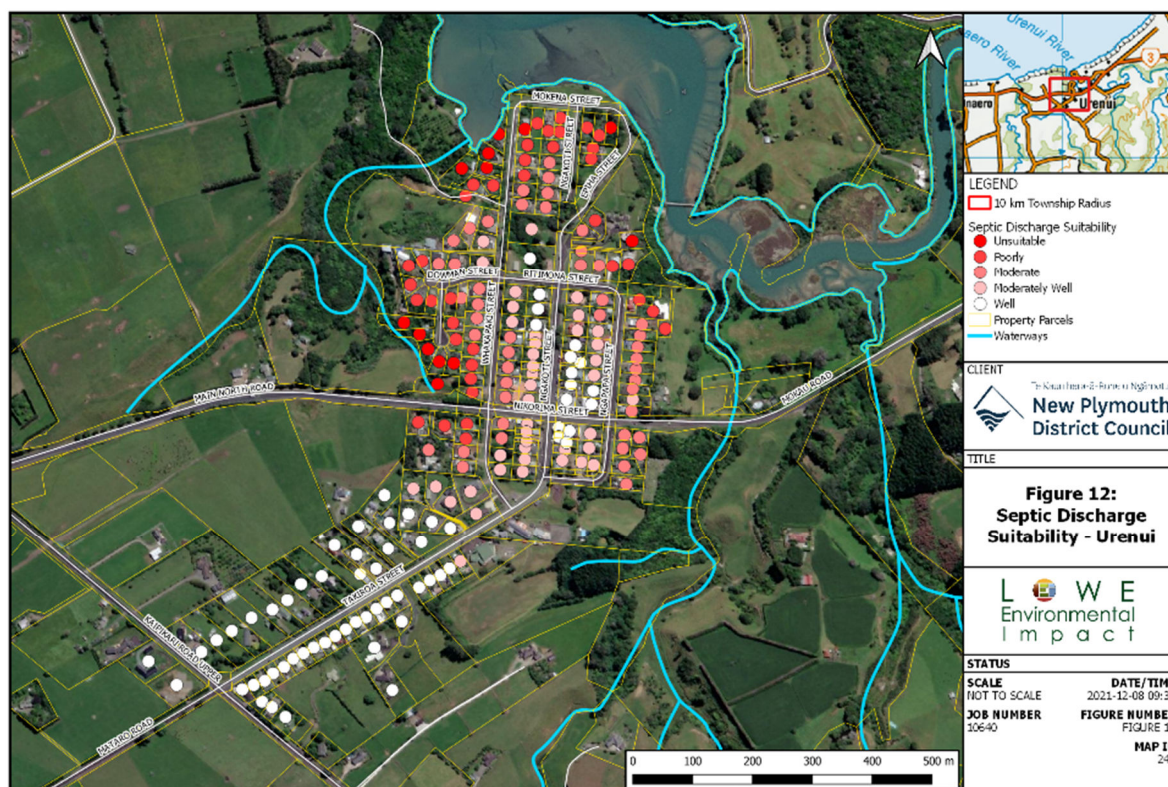
Figure 3.1: Septic Tanks Suitability for Urenui

The values given in Table 3.1 have been used to create a risk based on proximity to receptor (typically surface water paths). Figures 3.1 and 3.2 (and Figures 12 and 13, Appendix A) show the suitability for a new septic tank discharge for sites within Urenui and Onaero. No information on the location, design, and construction of existing septic tanks and discharge fields was able to be reviewed for this investigation. There is potential that a large proportion of systems in operation in the two towns do not meet current design standards. This assessment does not apply to systems which do not meet current standards. Replacement of aged systems may be considered.

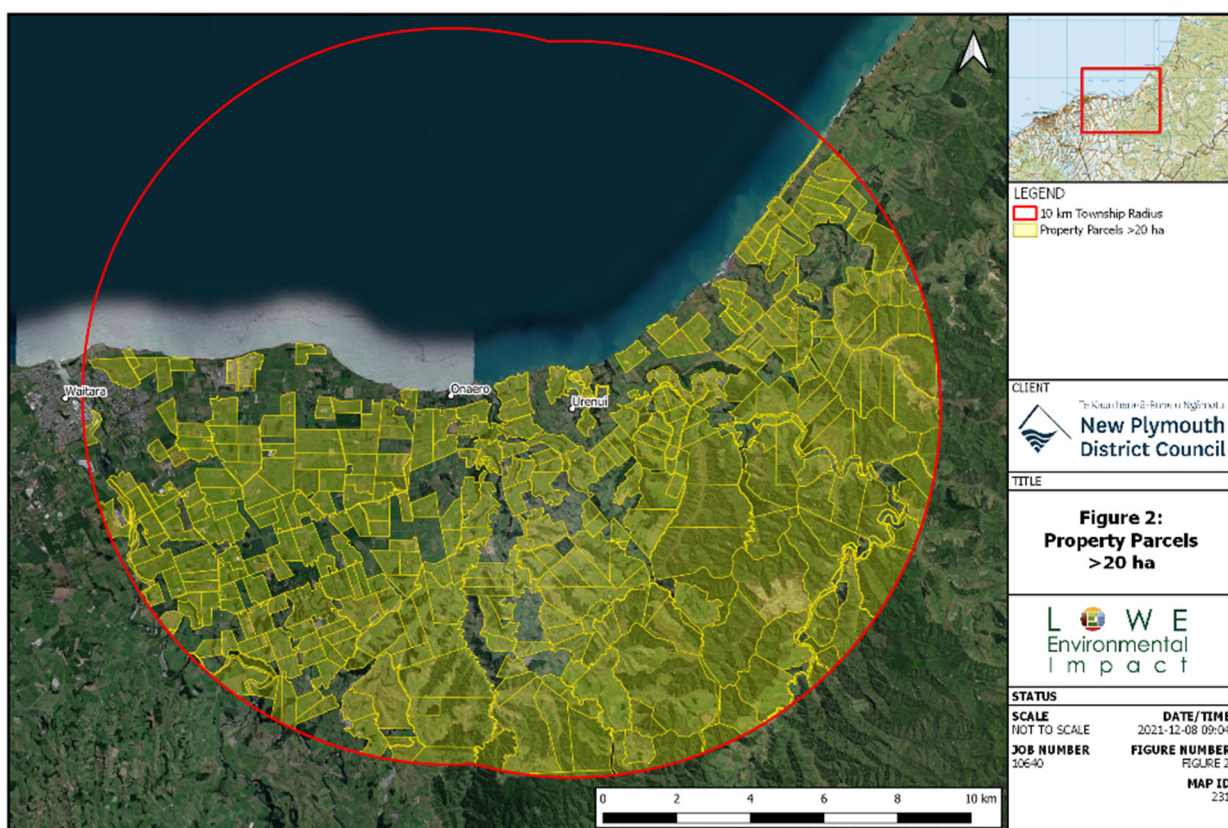
Figure 4.2: Properties Greater than 20 ha in Size

Figure 4.2 (larger version as Appendix A, Figure 2) shows land parcels in the Investigation Area >20ha in area. Further work would be needed to determine which parcels are in the same ownership so that the size of contiguous land areas can be identified.

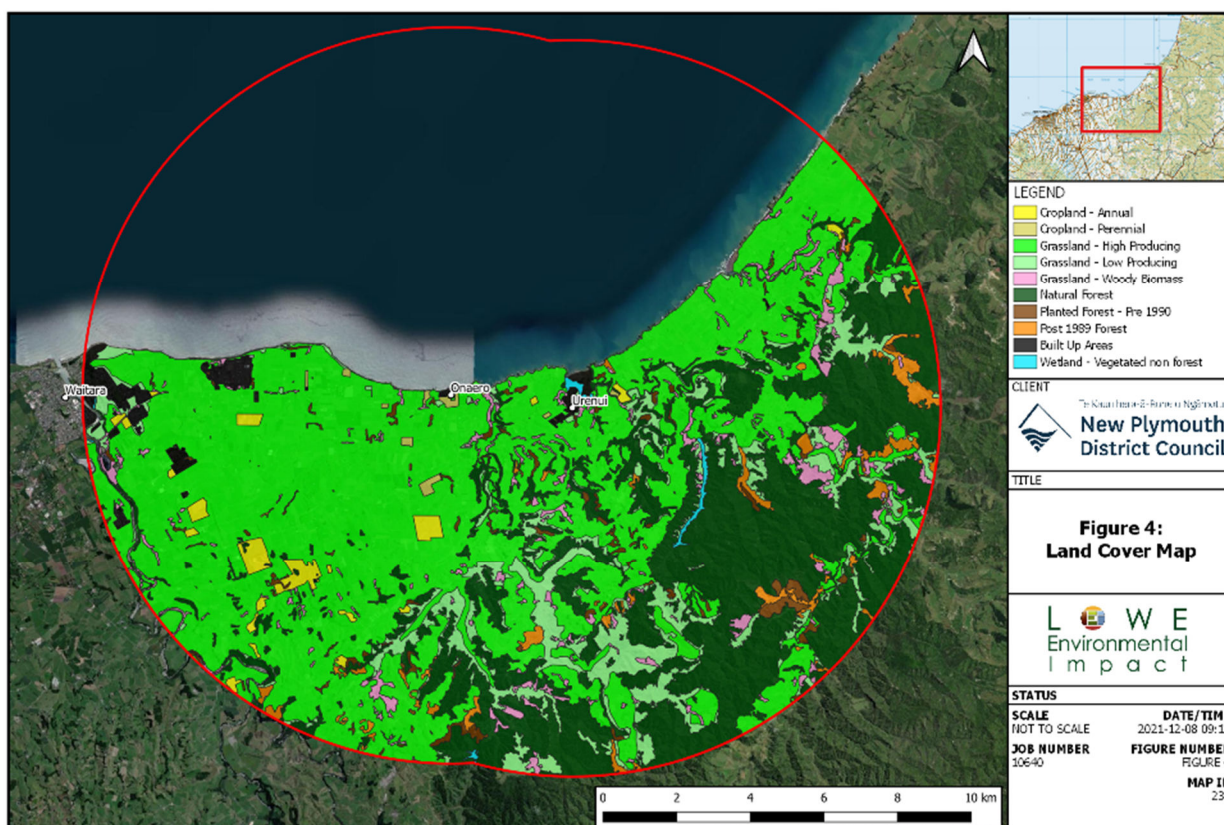
Figure 6.1: Land Cover Map

The land cover type and land management practices adopted on any site are another indicator of the site’s ability to remove nutrients applied in wastewater. Sites in the Investigation Area have been identified but not scored as LUC class was the most appropriate way to determine nutrient uptake. The approximate areas in each land use are given in Table 6.2. Figure 6.1 (larger as Figure 4, Appendix A) represents the current land use within the 10 km Investigation Area. Current land use data was retrieved using the LUCAS land use map from the Ministry for the Environment.

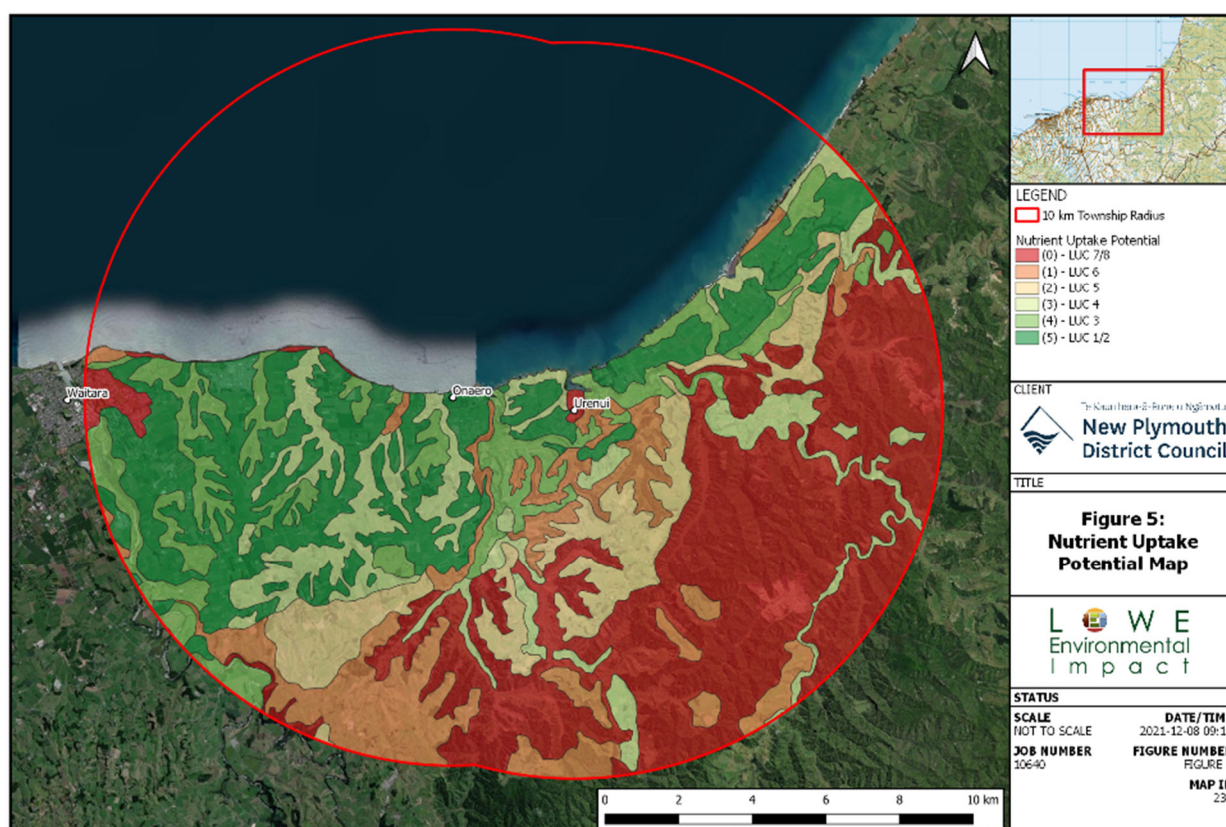
Figure 7.1: Nutrient Uptake Potential

Figure 7.1 (larger as Appendix A, Figure 5) shows nutrient uptake potential based on LUC.

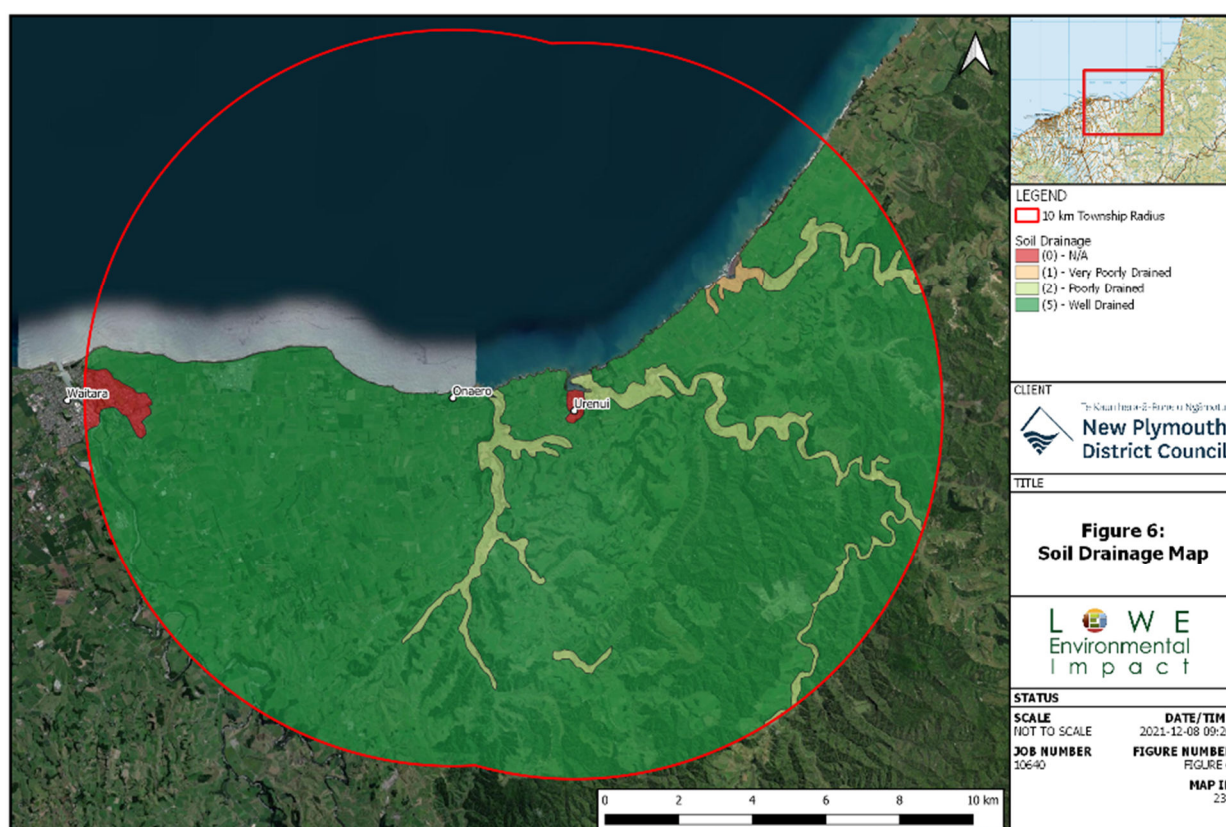
Figure 7.2: Surface soil drainage

Figure 7.2 (larger as Figure 6, Appendix A) shows soil drainage of the surface soil within the Investigation Area.

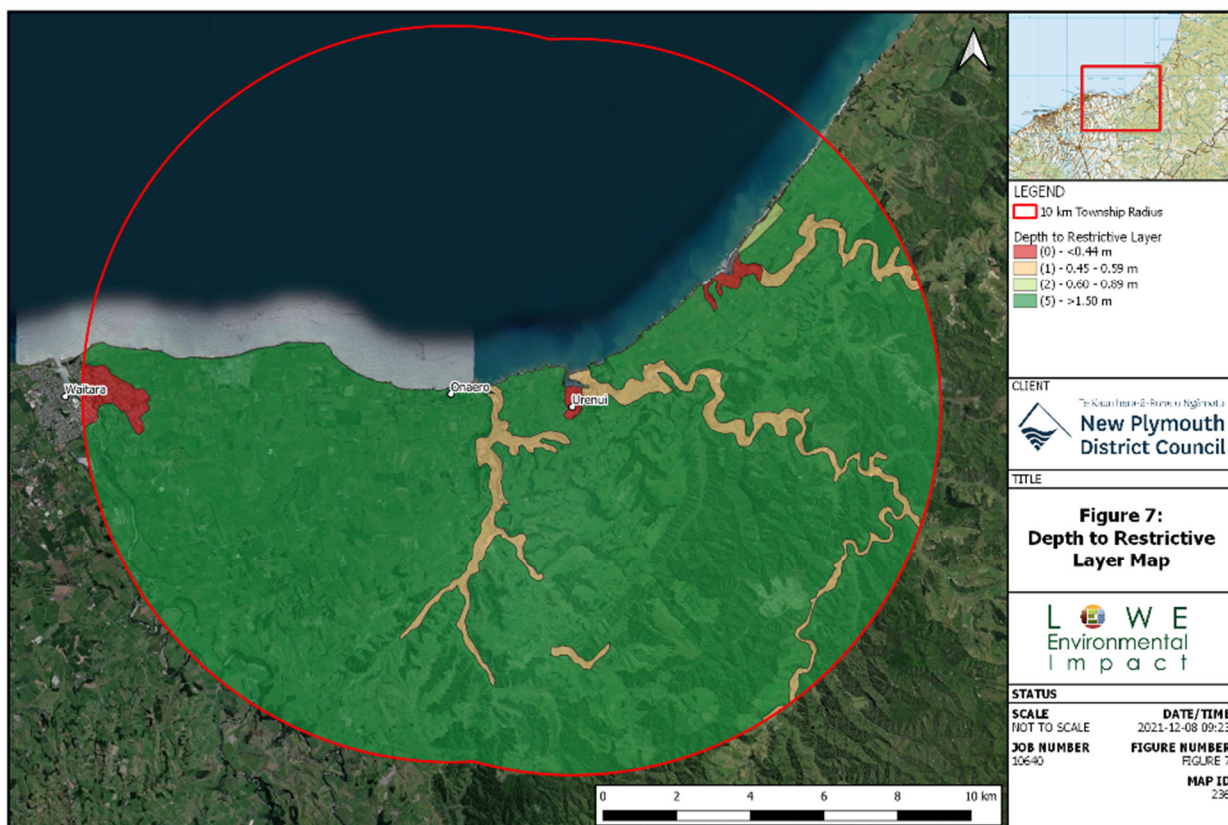
Figure 7.3: Soil Depth to Slowly Permeable Layer

Figure 7.3 (larger as Figure 7, Appendix A) shows soil depth to a slowly permeable horizon. This may be related to the soil drainage, permeability and to the depth available for root exploration or aerobic treatment of applied wastewater.

Around 94 % of the Investigation Area has no observed restriction within at least 1.5 m from the soil surface. These areas occur across the entirety of the Investigation Area outside of the Onaero, Urenui and Mimi River channels.

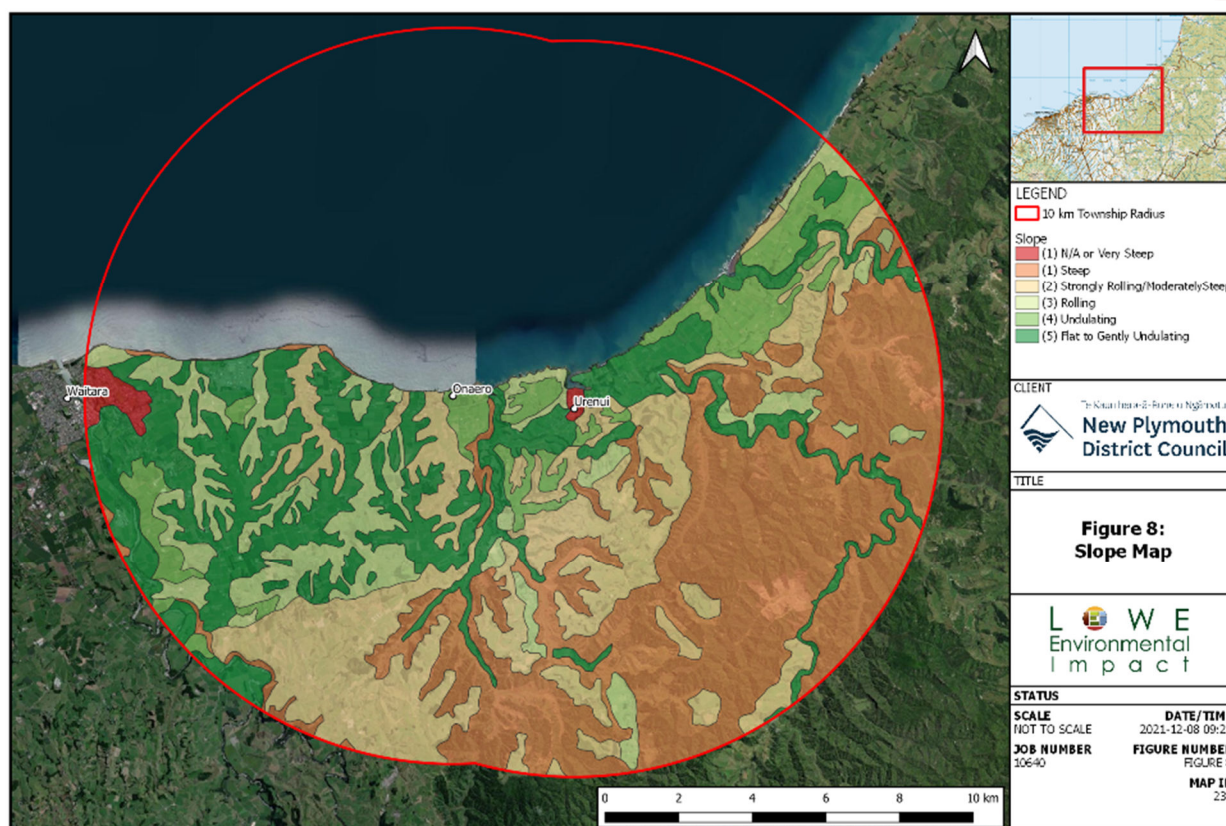
Figure 7.4: Slope

Figure 7.4 (larger as Figure 8, Appendix A) slope within the Investigation area.

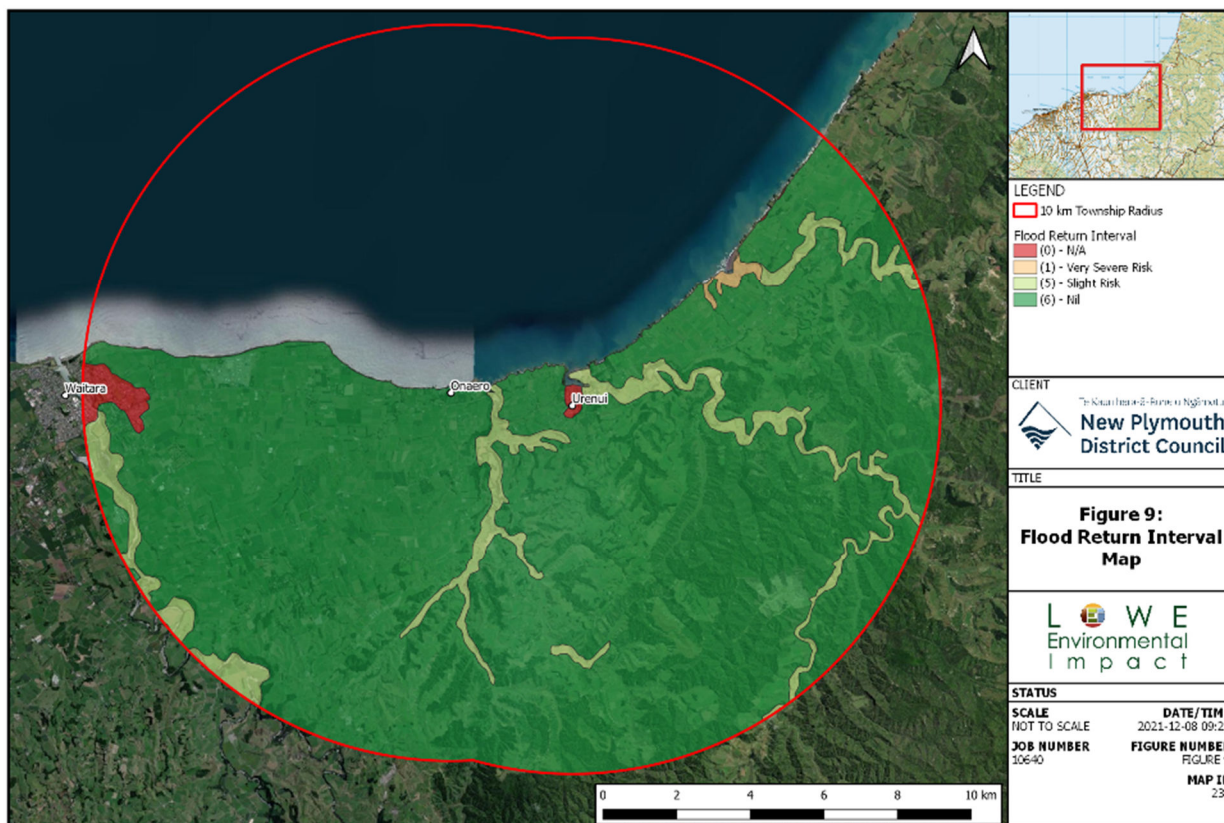
Figure 7.5: Flood Return

Figure 7.5 (larger as Figure 9, Appendix A) shows the flooding risk in the Investigation Area as indicated by the flood return interval.

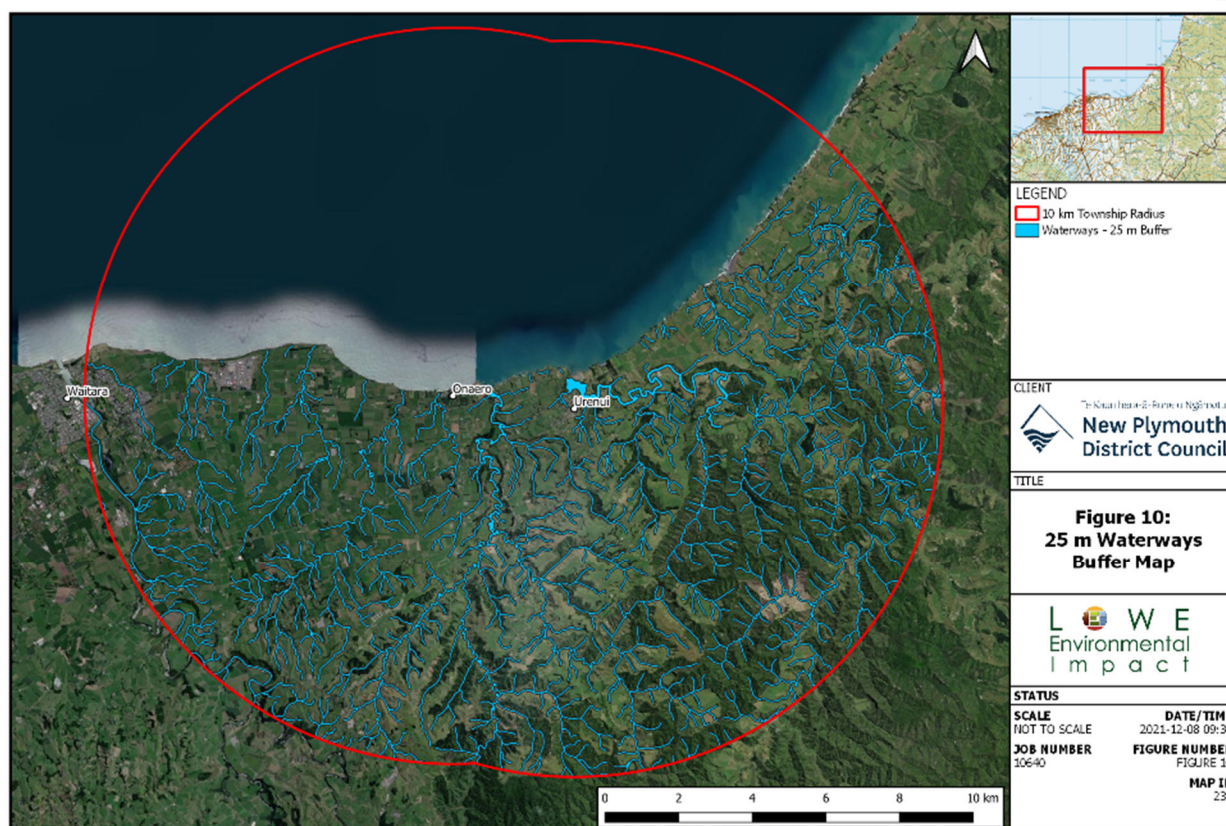
Figure 7.6: Riparian buffers

Within the 10 km radius Investigation Area there is an extensive network of streams which transport surface water to the main rivers or directly to the coast themselves. The more dissected an area is, the more disruption to irrigation infrastructure and the greater the total area needed. No ranking has been applied to this parameter. Figure 7.6 (larger as Figure 10, Appendix A) shows the extent of riparian buffer zones within the Investigation Area.

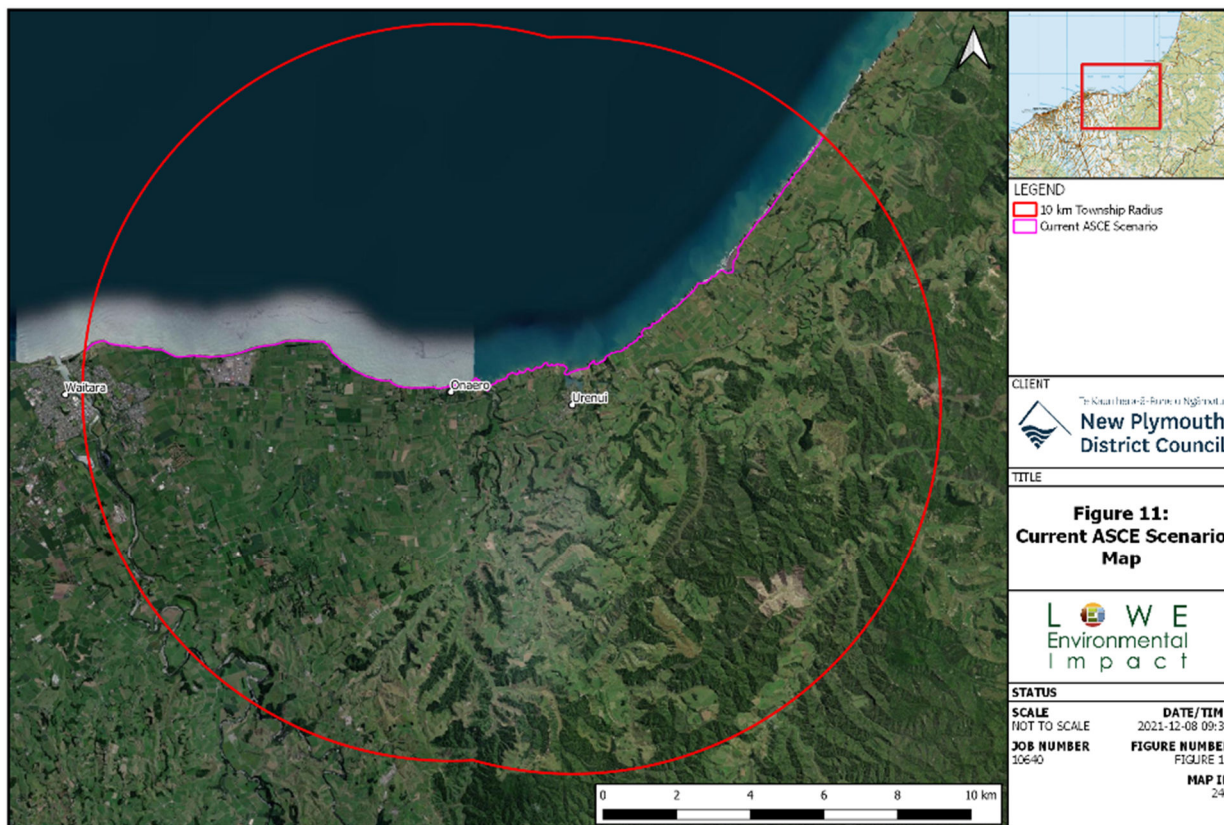
Figure 7.7: ASCE (after T&T, 2019)

Figure 7.7 (larger as Figure 11, Appendix A) represents the current Areas which may be Susceptible to Coastal Erosion (ASCE). Investigations around coastal erosion within the Taranaki region has been done by Tonkin + Taylor (2019) whereby a line representing the current ASCE has been derived. For this investigation, this line delineates the seaward extent of the Investigation Area, where no land has been included seaward of this line. Approximately 100 ha of land has been excluded from the Investigation Area that is seaward of this boundary.

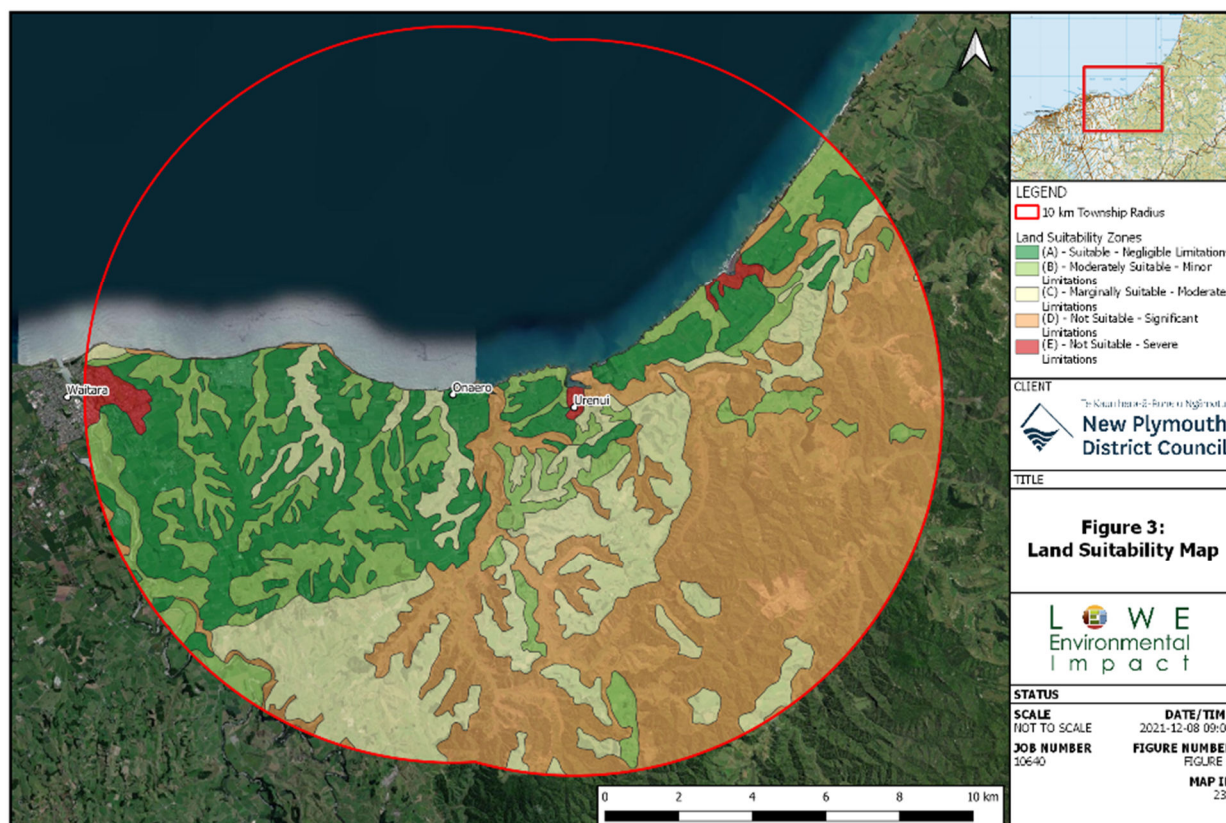
Figure 8.1: Land Suitability

As described in Section 5.4 above, parameter scores can be combined to create zones representing land suitability within the Investigation Area for land application of wastewater. Figure 8.1 (larger as Figure 3, Appendix A) shows these aggregated zones. Table 8.1 summarises the land area for each zone within the Investigation Area.

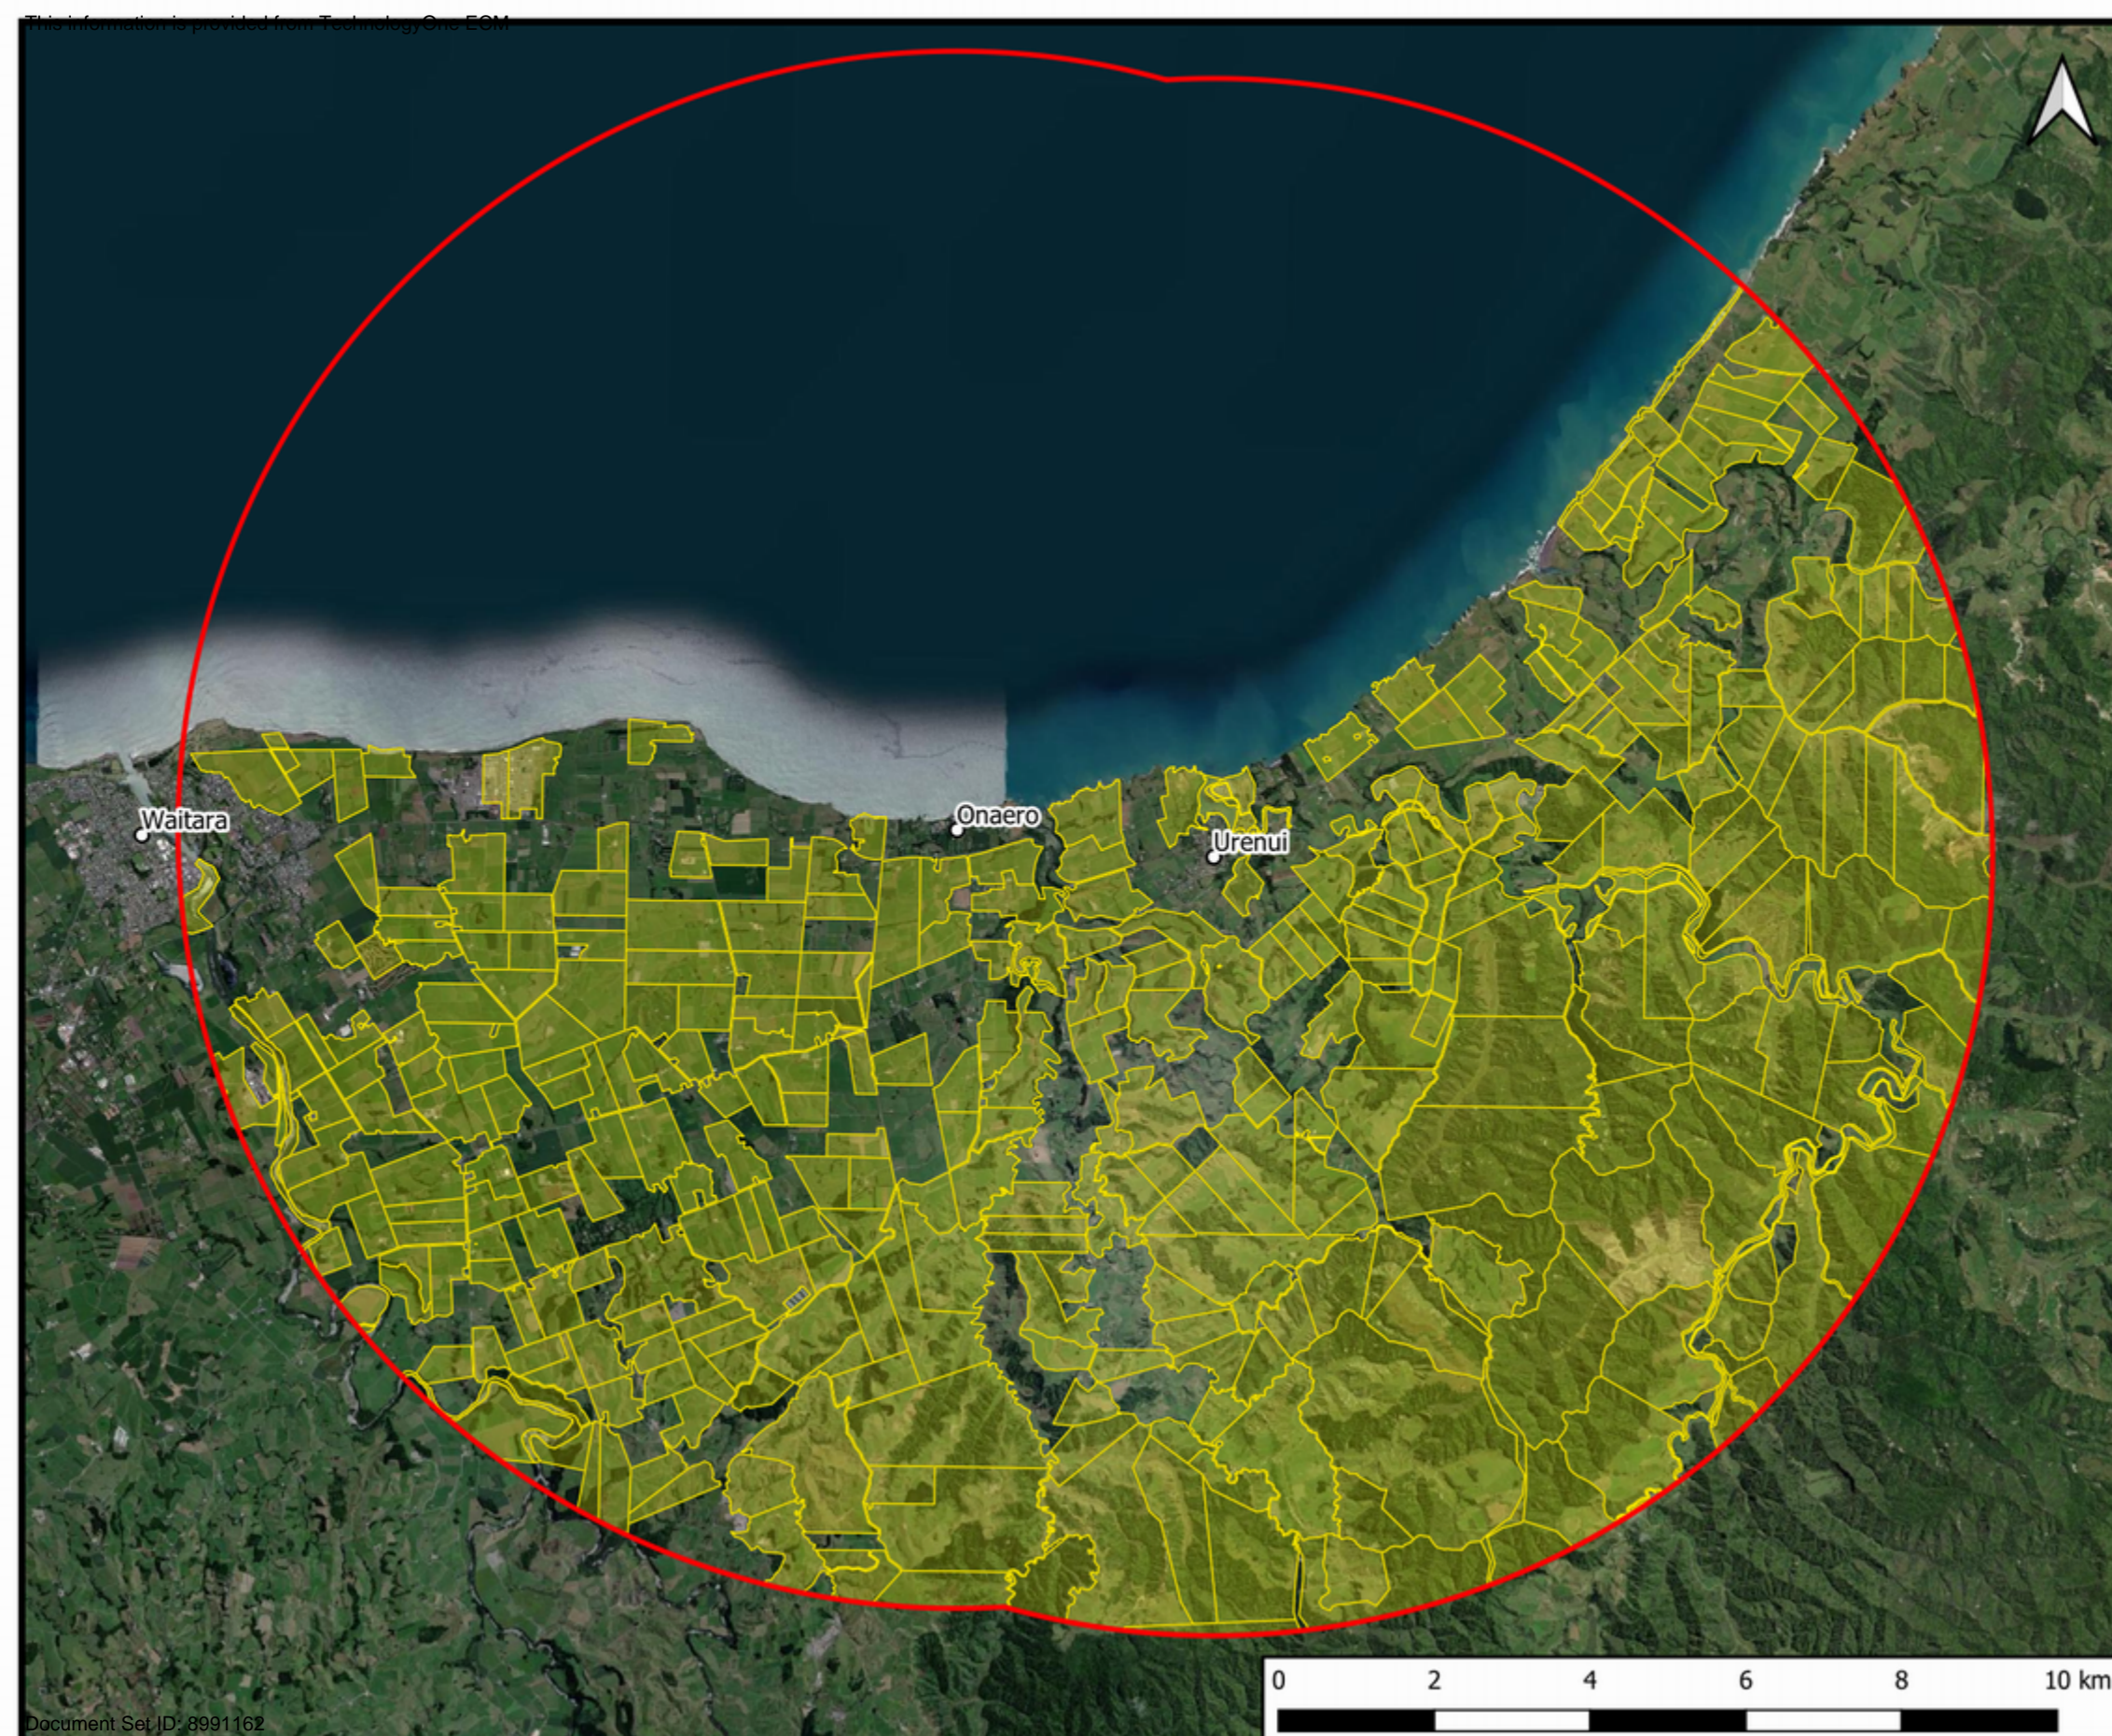
SCALE NOT TO SCALE	DATE/TIME 2021-10-26 14:58
JOB NUMBER 10640	FIGURE NUMBER FIGURE 2
	MAP ID 231

- 10 km Township Radius
- Property Parcels >20 ha
