Urenui and Onaero Wastewater Treatment Plant - Assessment of Alternative Sites

Prepared for New Plymouth District Council
Prepared by Beca Limited

19 January 2024

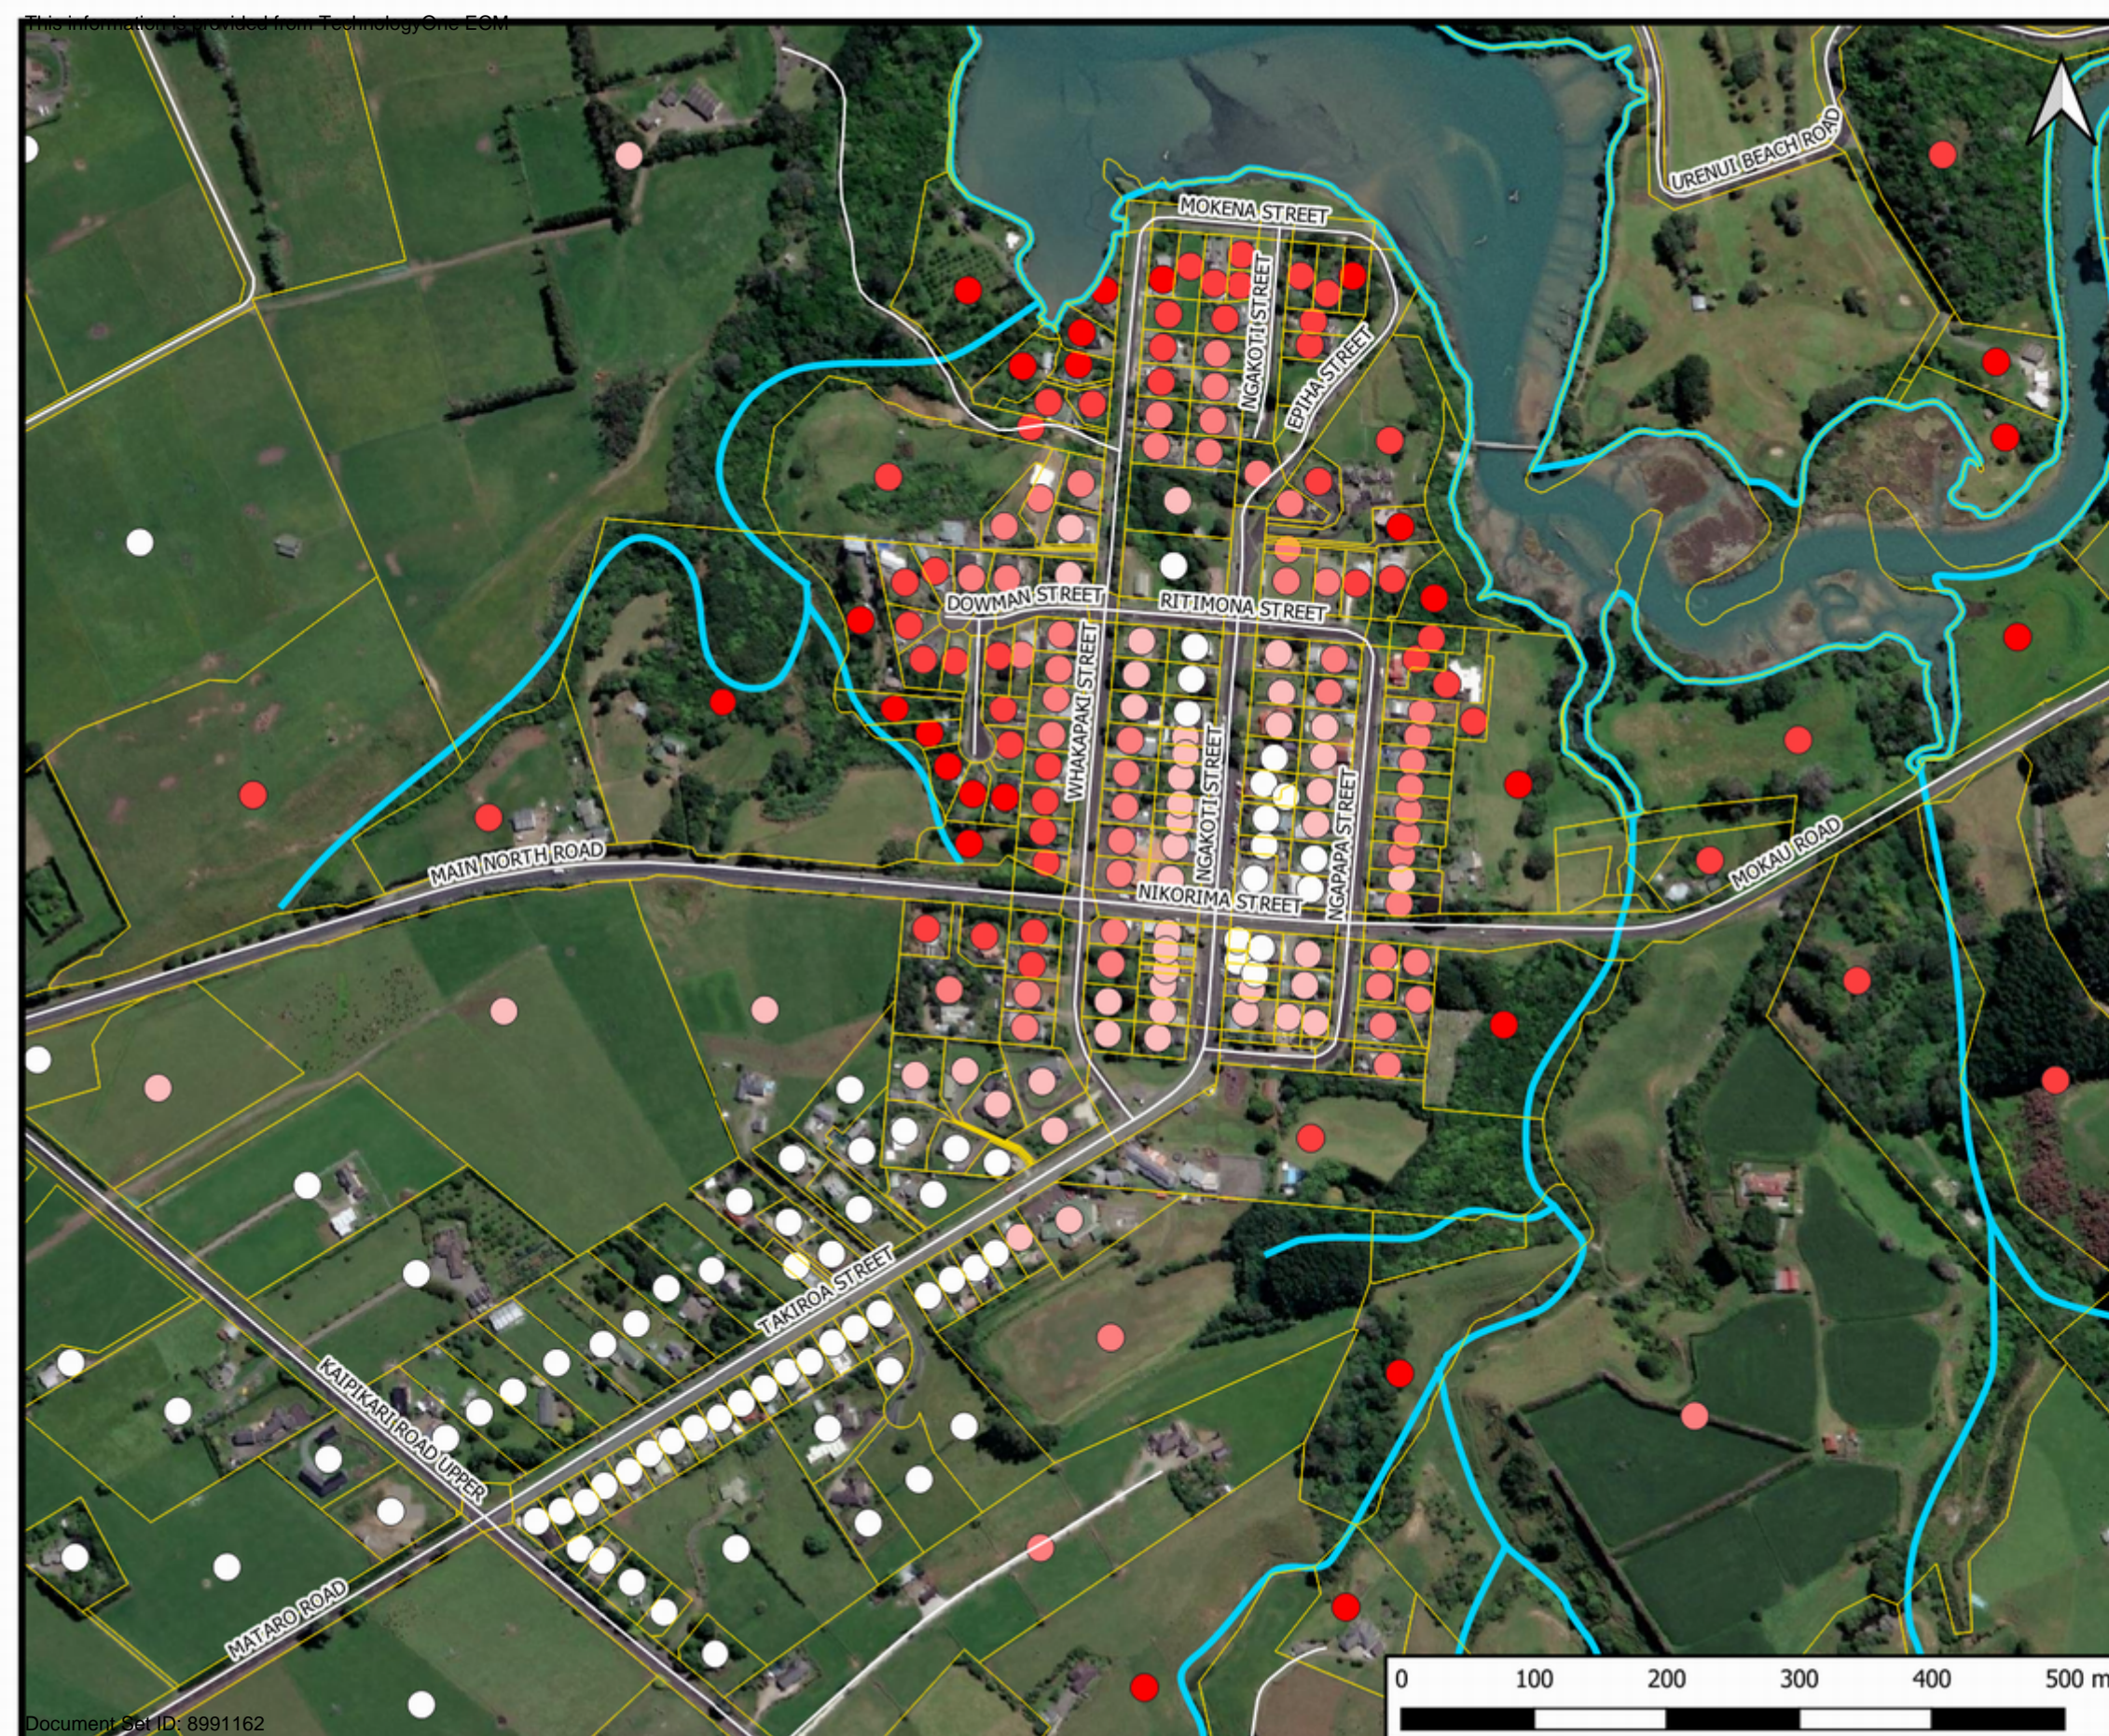
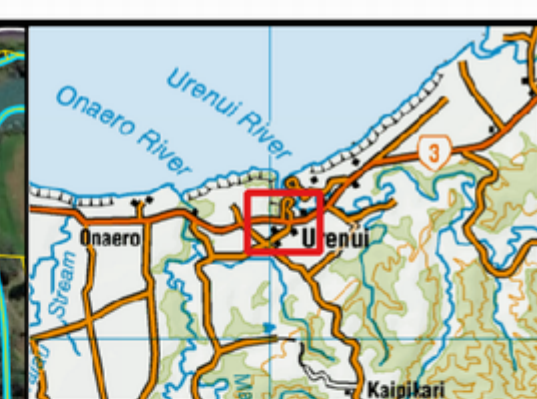
SCALE	DATE/TIME
NOT TO SCALE	2021-10-28 15:17
JOB NUMBER	FIGURE NUMBER
10640	FIGURE 12
	MAP ID
	241

Septic Discharge Suitability

Figures 3.1 and 3.2 (and Figures 12 and 13, Appendix A) show the suitability for a new septic tank discharge for sites within Urenui and Onaero. There are areas near the centre and south of Urenui which are likely to be suitable for septic tank discharge. This is due to larger distance to surface water paths, and to lesser overlap with upgradient plumes from other discharges.

The values given in Table 3.1 have been used to create a risk based on proximity to receptor (typically surface water paths). Figures 3.1 and 3.2 (and Figures 12 and 13, Appendix A) show the suitability for a new septic tank discharge for sites within Urenui and Onaero. No information on the location, design, and construction of existing septic tanks and discharge fields was able to be reviewed for this investigation. There is potential that a large proportion of systems in operation in the two towns do not meet current design standards. This assessment does not apply to systems which do not meet current standards. Replacement of aged systems may be considered.

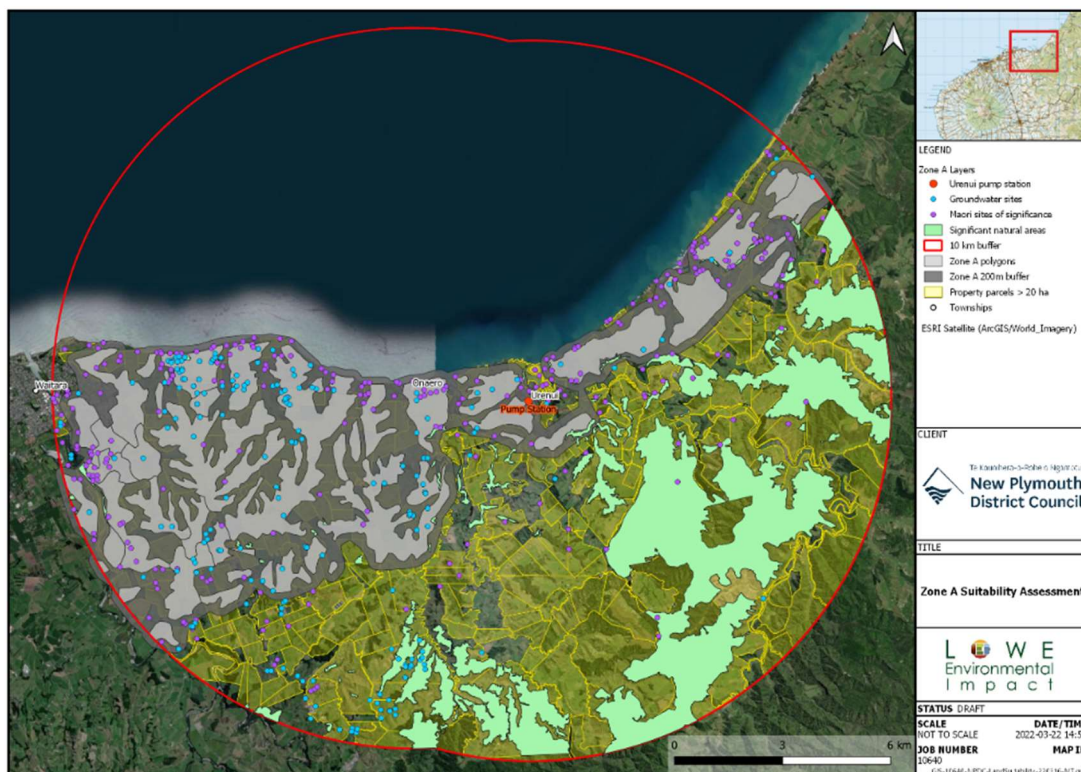
Figure B: 10 km Radius Around Urenui and Onaero

Figure B shows the distribution of Zone A land (grey) with a buffer of 200 m (dark grey). This area has been nominated for further investigation.

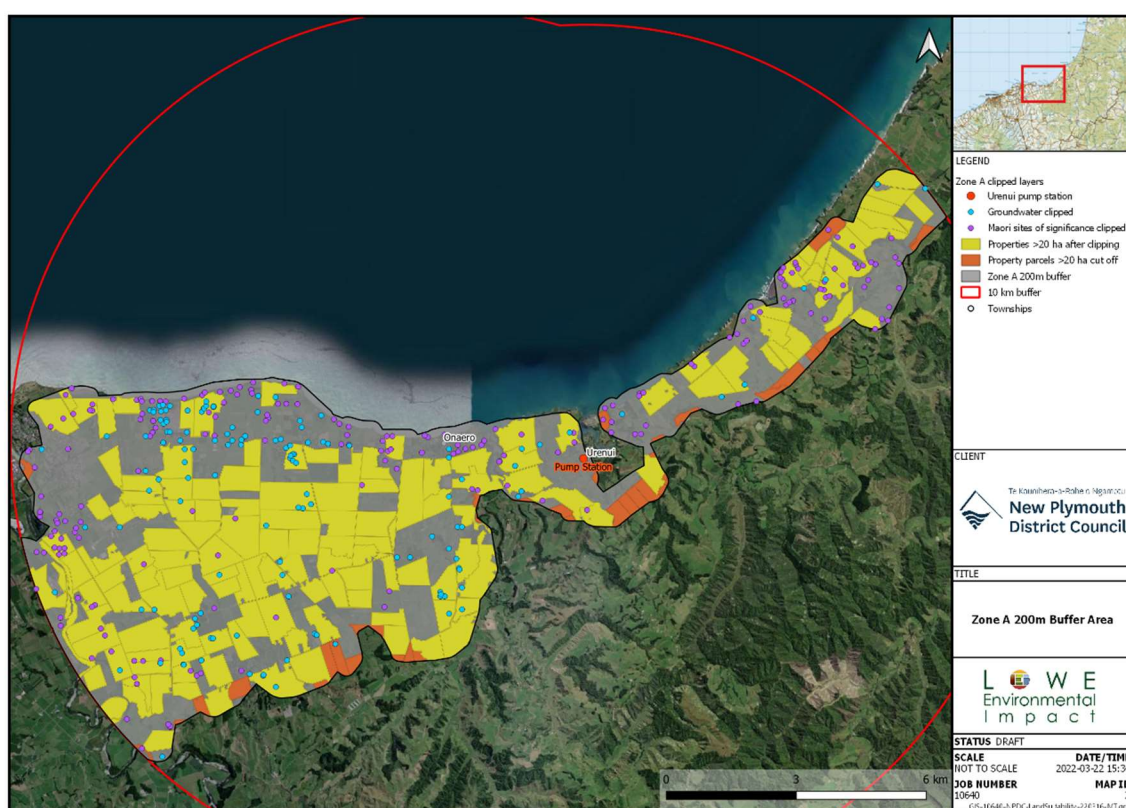
Figure C: Zone A Clipped Extent

The result of these layers is Figure C, where everything outside of the Zone A plus 200 m buffer has been removed. In this map, property parcels have been filtered to only include properties which are greater than 20 hectares in area so as to allow for buffers from the features identified in Figure B and from property boundaries and dwellings. The yellow polygons indicate properties greater than 20 hectares, grey polygons less than 20 hectares, and orange polygons which were greater than 20 hectares but have been clipped by the Zone A extent so may still want to be considered.

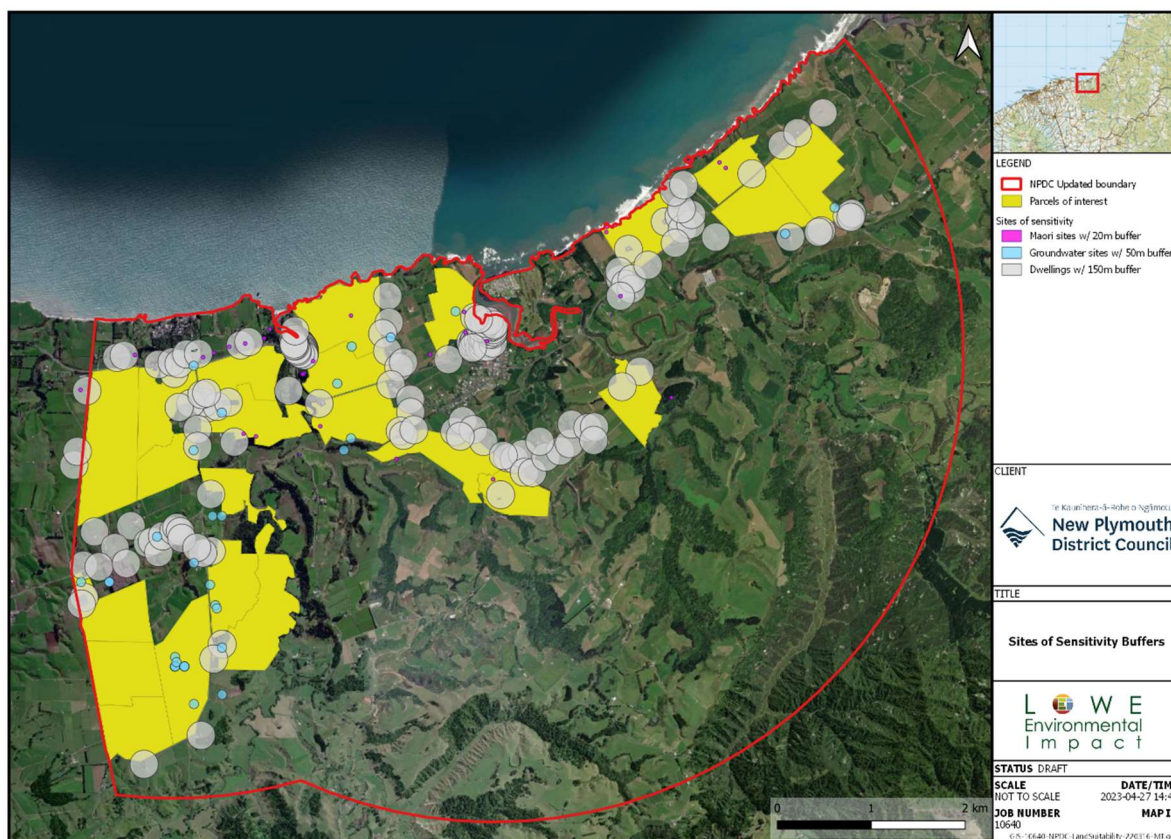
Figure E: Sites of Sensitivity: Māori significance, Groundwater Bores, and Dwellings

Buffer zones have been applied to the Māori sites of significance (20 m), groundwater bores (50 m), and dwellings (150 m). It should be noted that the Māori sites of significance are presented on this map as points but it is understood that site extents may incorporate a larger area. As discussed at a workshop (29 April 2022) with Marlene Benson for Ngāti Mutunga, an initially suitable buffer around sites of significance to Ngāti Mutunga is 200 m. It is intended that this parameter is re-examined in the event that a property near to a site of significance is identified for further investigation.

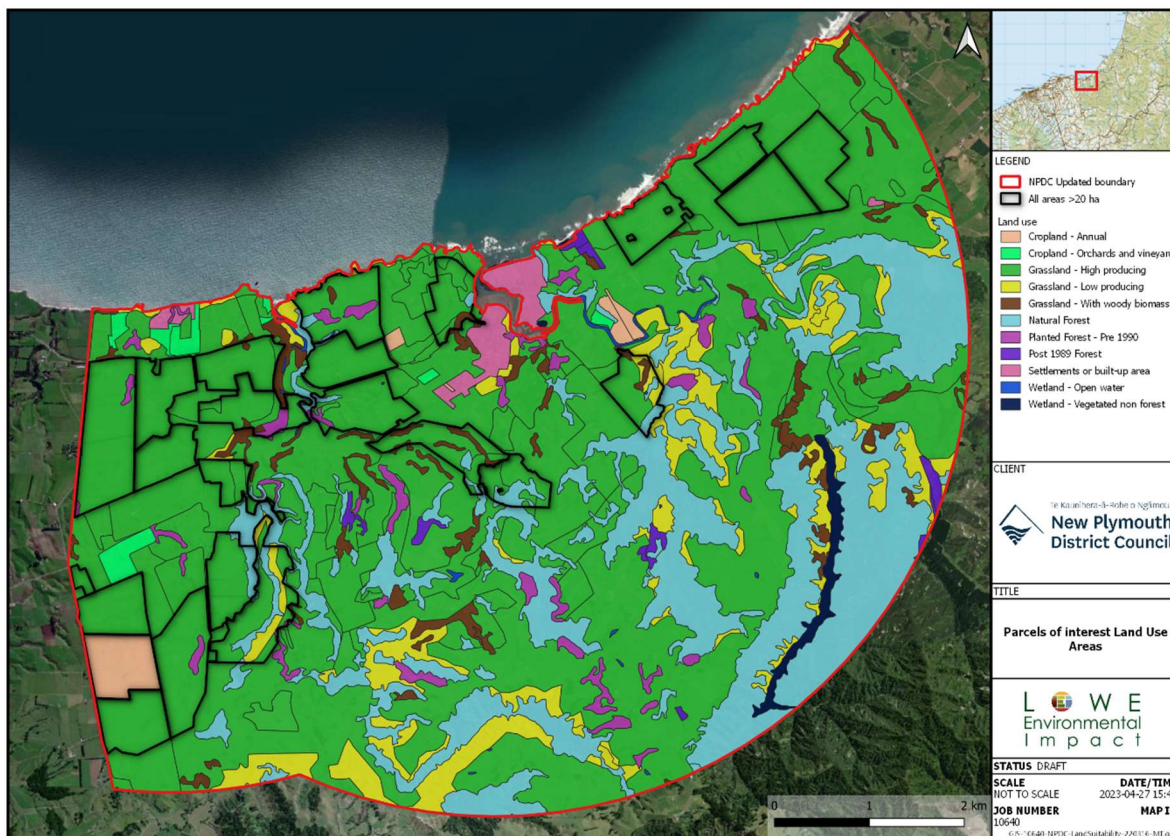
Figure F: Land Use Type for all Areas Greater than 20 Hectares

dairy farming region of Taranaki. From a land treatment perspective, this land naturally lends itself to wastewater treatment as it is predominantly low sloping land and supports a dual purpose land use if grazing or cut and carry was desired. From a cultural and industry perspective, areas supporting dairy or food production may not be appropriate for wastewater land treatment. There are also some areas of 'Natural Forest' and 'Planted Forest – Pre 1990' which are less suited to wastewater treatment.

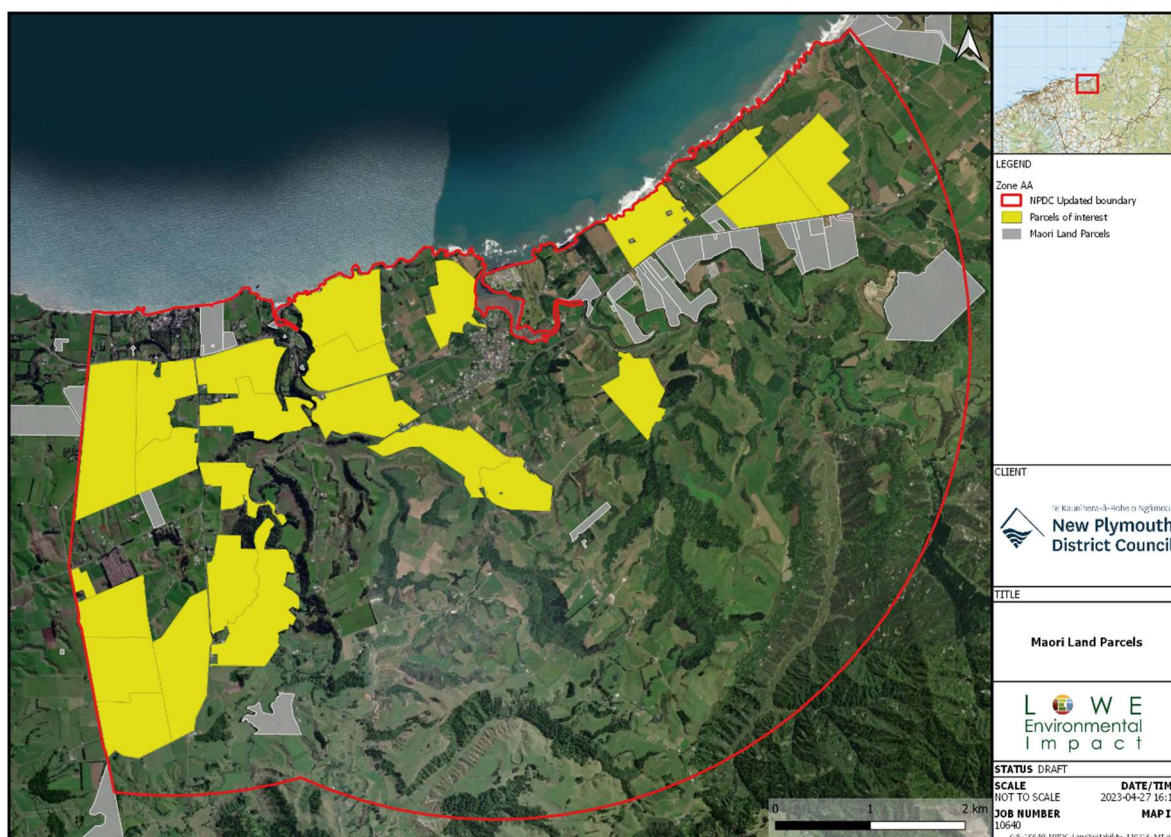
Figure G: Māori Land Parcels (in grey)

An assessment of Māori land parcels was undertaken based on the data from Māori Land Online database. These are parcels under the jurisdiction of the Māori Land Court and are primarily Māori customary land, Māori freehold land and may also include Crown and other land set aside for treaty settlements. Figure G overlays the Māori land parcels against the Zone Aa land parcels of interest. Based on this figure, there are no land parcels of interest that intersect any of the Māori land parcels.

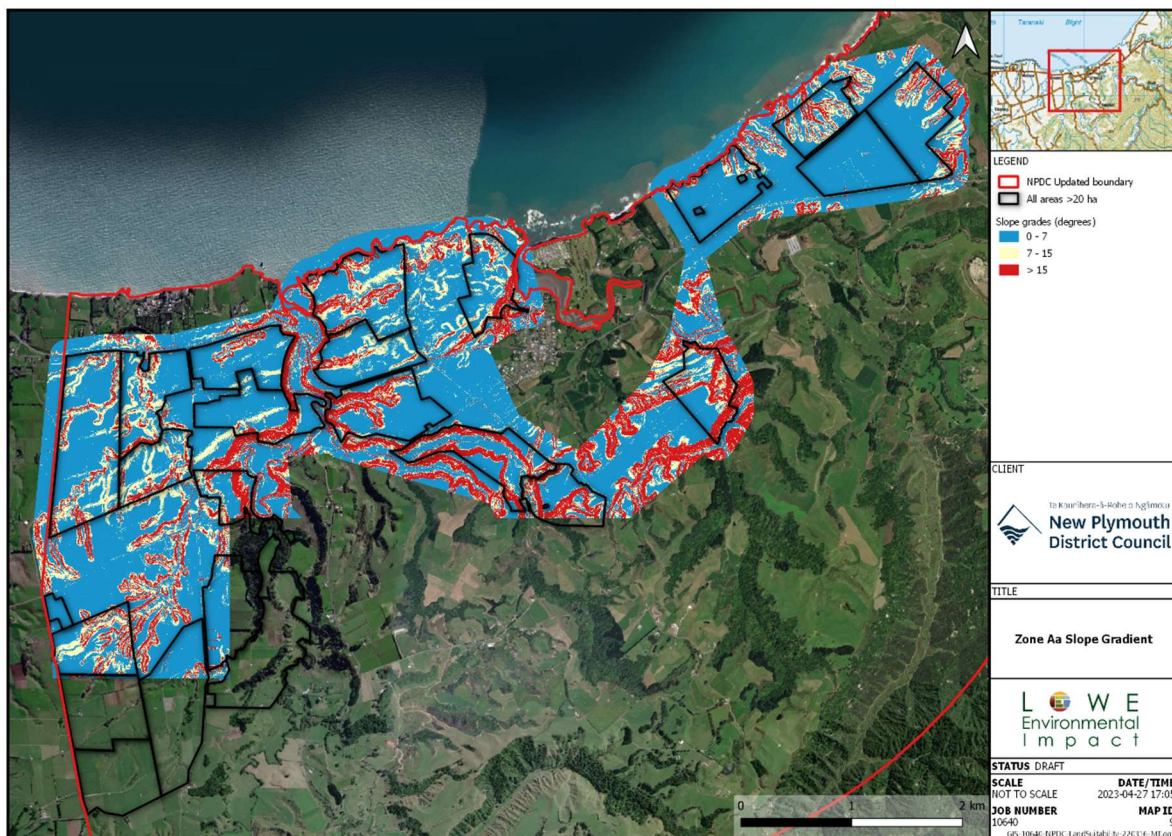
Figure H: Slope Gradients for Zone Aa. Blue 0 – 7°, Yellow 7 - 15°, Red Greater Than 15°

Overlaying the sensitive areas, current land use, land in Māori ownership and slopes less than 7° enabled the likely area within each property that is available to be irrigated to be evaluated (Figure I). Following this analysis, 14 properties remained (Property ID 1, 2, 6, 7, 9, 14, 15, 16, 17, 19, 20, 21, 22, 23). Property 17 (1028 Main North Road) was subsequently excluded due to the irrigable area on the property being discontinuous and correspondingly, impractical for an irrigation system to be setup on. This left 13 properties for further consideration.

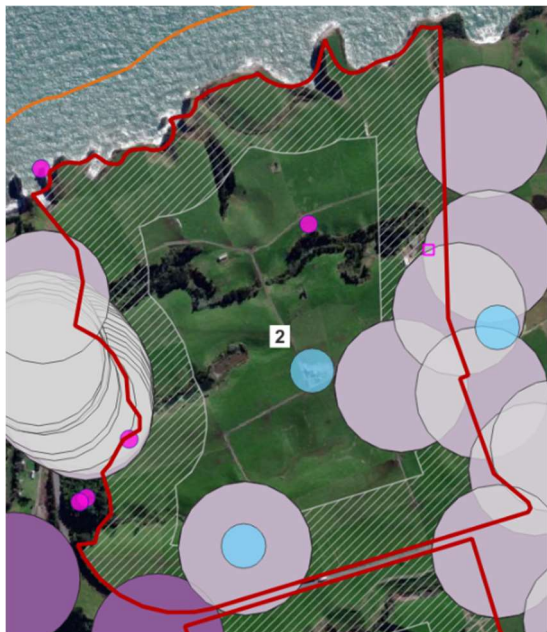
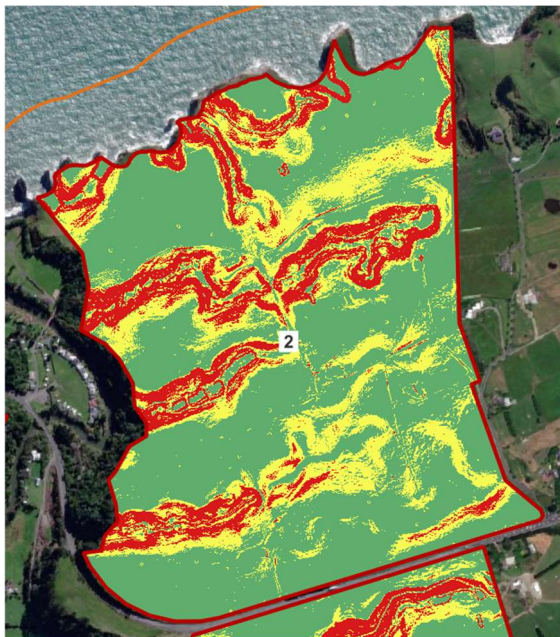
Site 2 - 1237 Main North Road, URENUI

Figures for each site are shown which identify buffers around key features as previously discussed. The hatched buffer shown to the property boundary extends 150 m and is an exclusion area for locating the treatment plant but does not apply to the land application. The second figure for each site shows the slope across each property. Slopes of less than 7° (green) are preferred for both land application of wastewater and for sighting of a treatment plant and associated infrastructure.

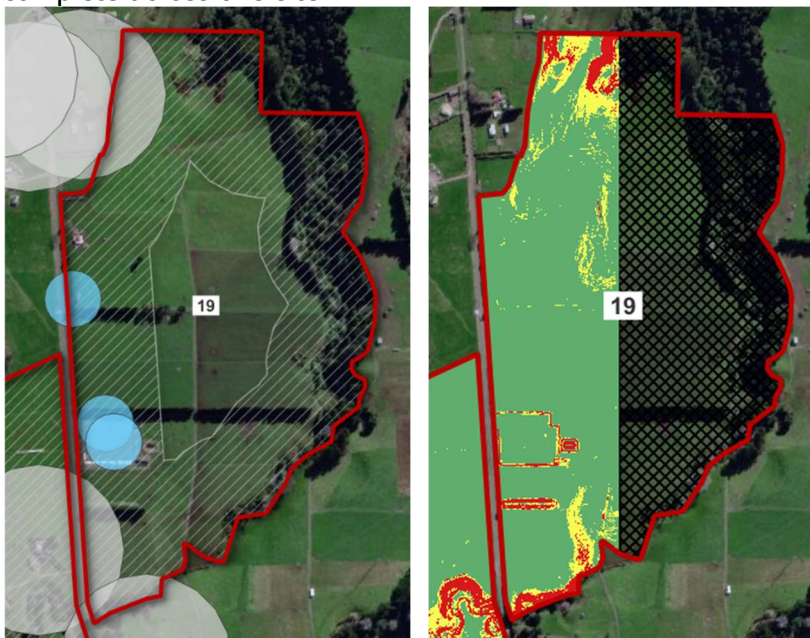
Site 19 - 397 Ohanga Road, ONAERO, URENUI

Lidar data is incomplete across this site.

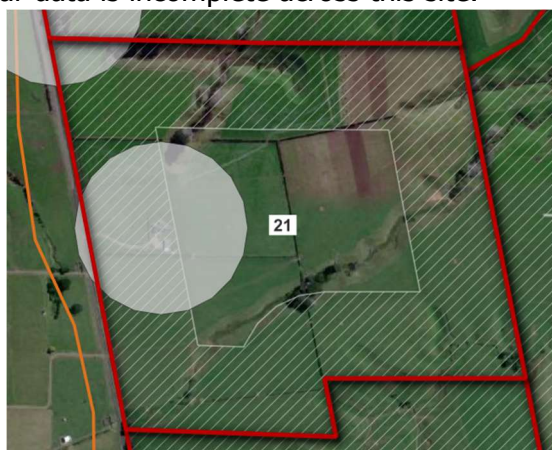
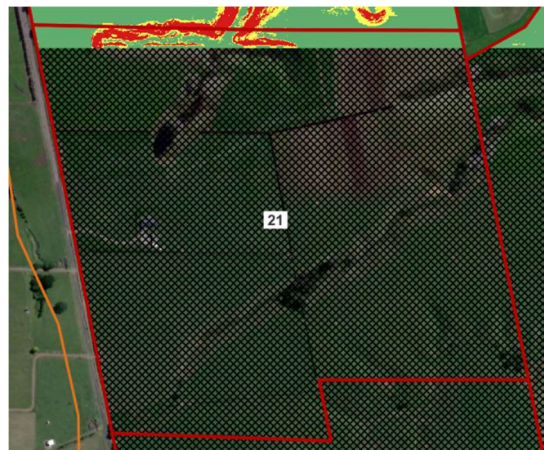
Site 21 - 363 Waiiau Road

Lidar data is incomplete across this site.

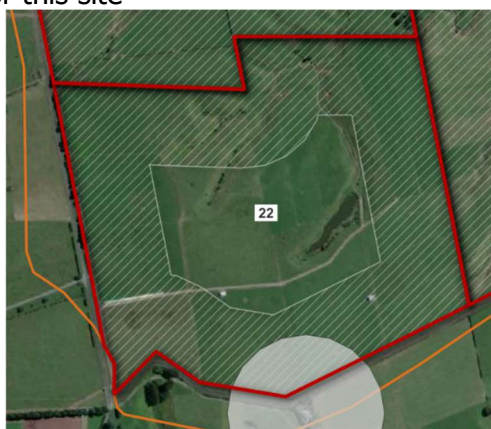
Site 22 - 138 Ohanga Road

No lidar data is available for this site

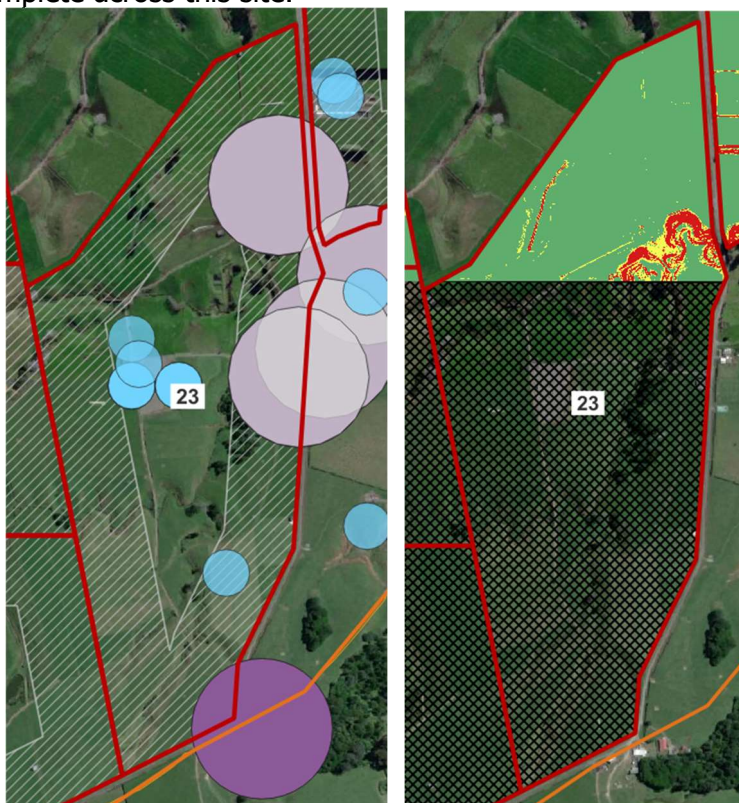
Site 23 - 284 Ohanga Road

Lidar data is incomplete across this site.

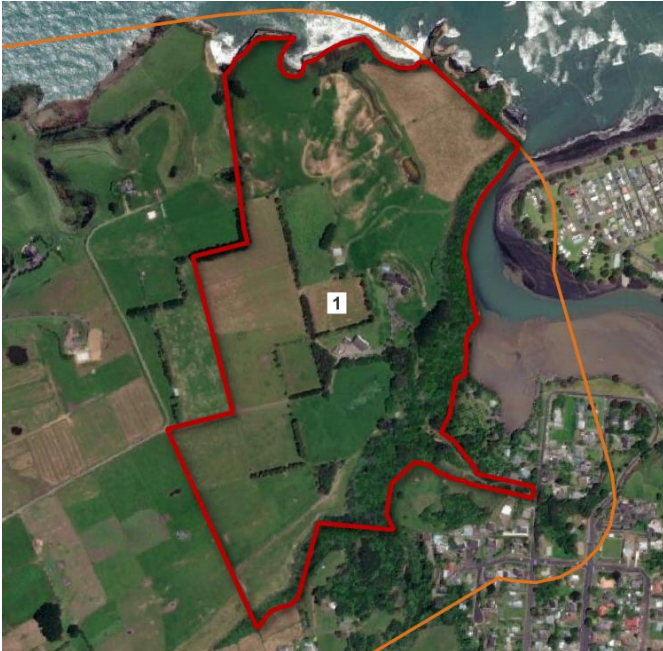
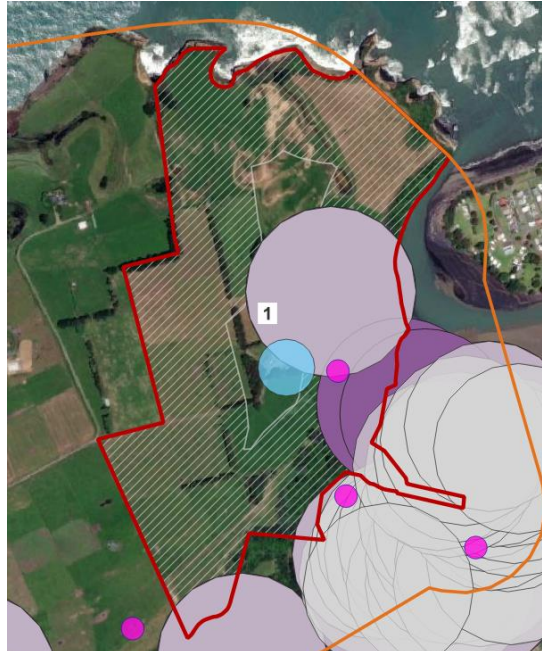
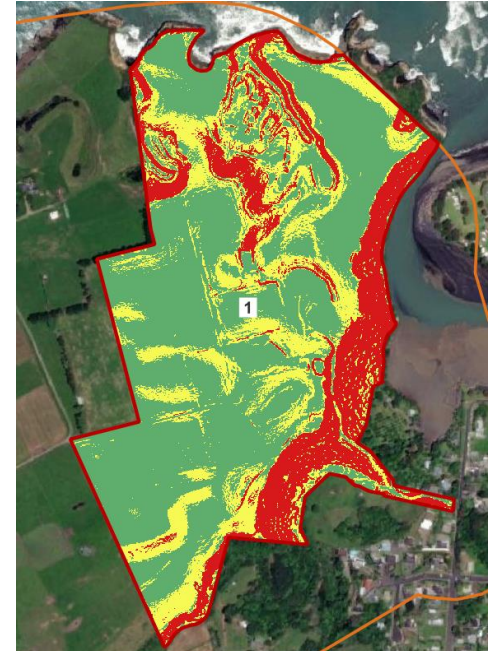
OPTION 1

AERIAL IMAGE	BUFFER EXCLUSIONS	SLOPE
  Property boundary	  Dwellings – 150m	  Slope (degrees) ≤ 7.0
	  Dwellings (updated) – 150m	  7.0 - 15.0
	  Groundwater sites – 50m	  > 15.0
	  Maori sites of significance – 20m	
	  Odour buffer for WWTP – 150m from property boundary

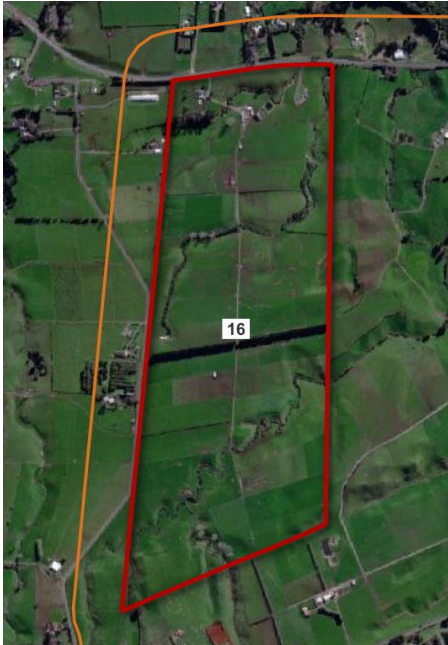
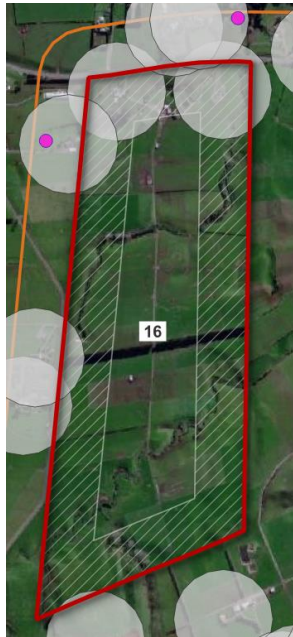
OPTION 16

AERIAL IMAGE	BUFFER EXCLUSIONS	SLOPE
  Property boundary	  Dwellings – 150m	  Slope (degrees) ≤ 7.0
	  Dwellings (updated) – 150m	  7.0 - 15.0
	  Groundwater sites – 50m	  > 15.0
	  Maori sites of significance – 20m	
	  Odour buffer for WWTP – 150m from property boundary

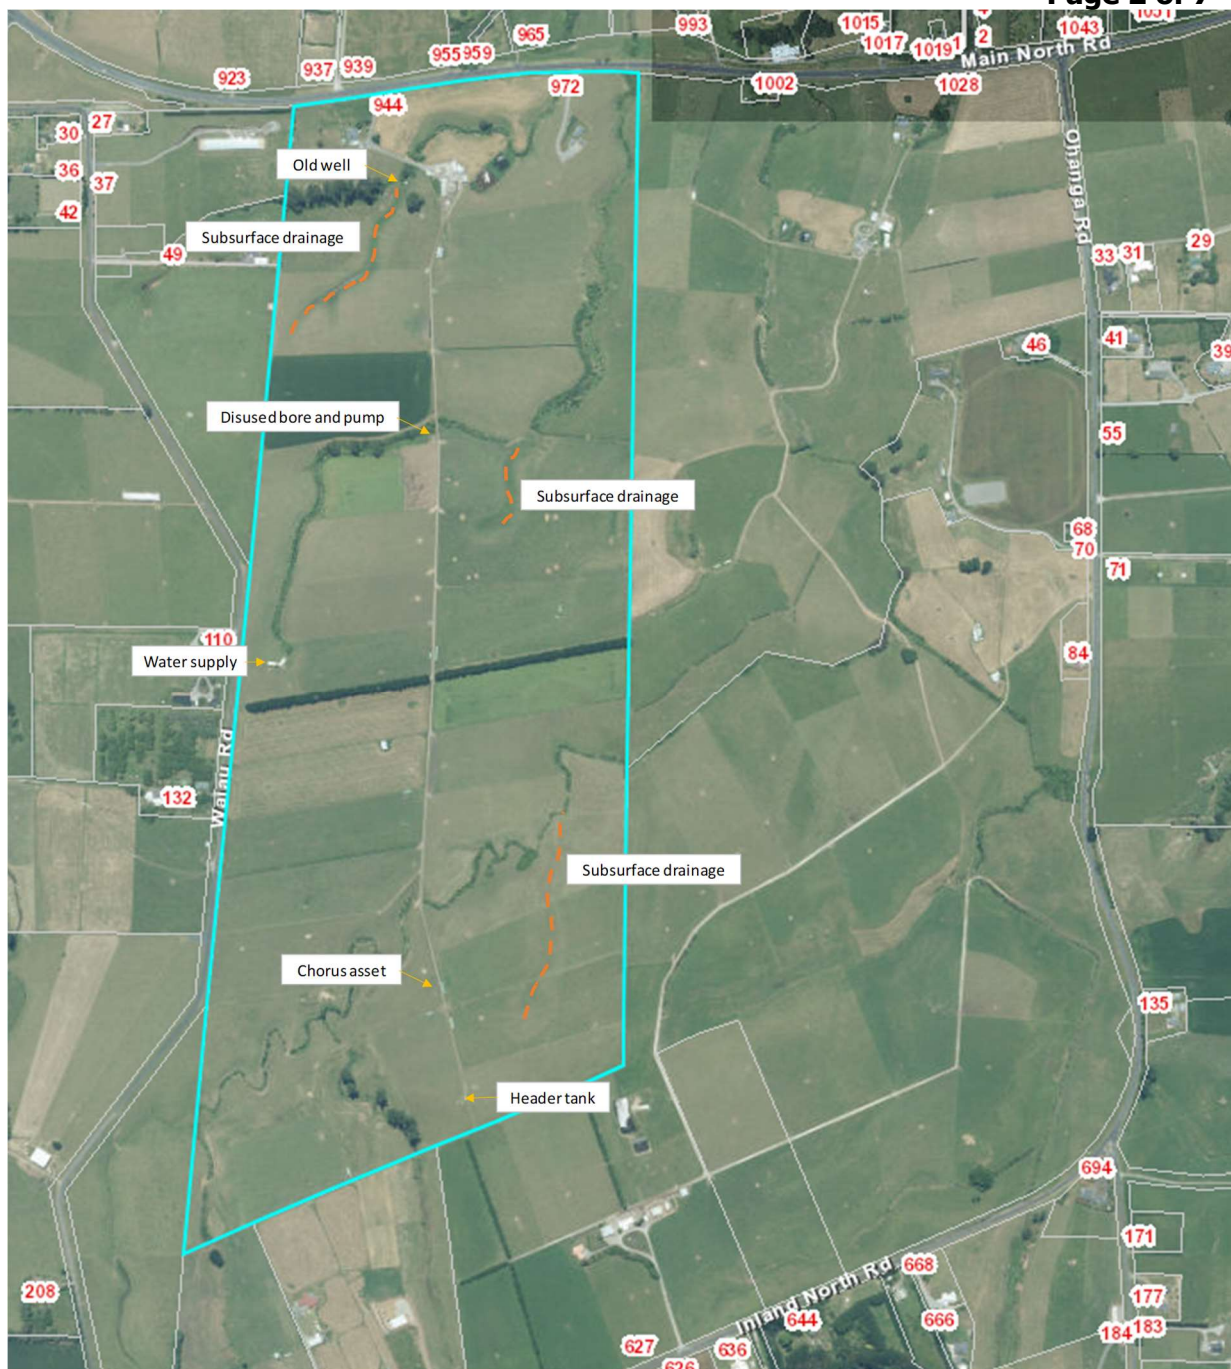
Figure 1: 944 Main North Road, Site Layout

Figure 1 shows an aerial view of the property. Access is via Main North Road leading past the main house to the dairy shed (Figure 2). Additional site access is available along Waiiau Road, on the property's western boundary.

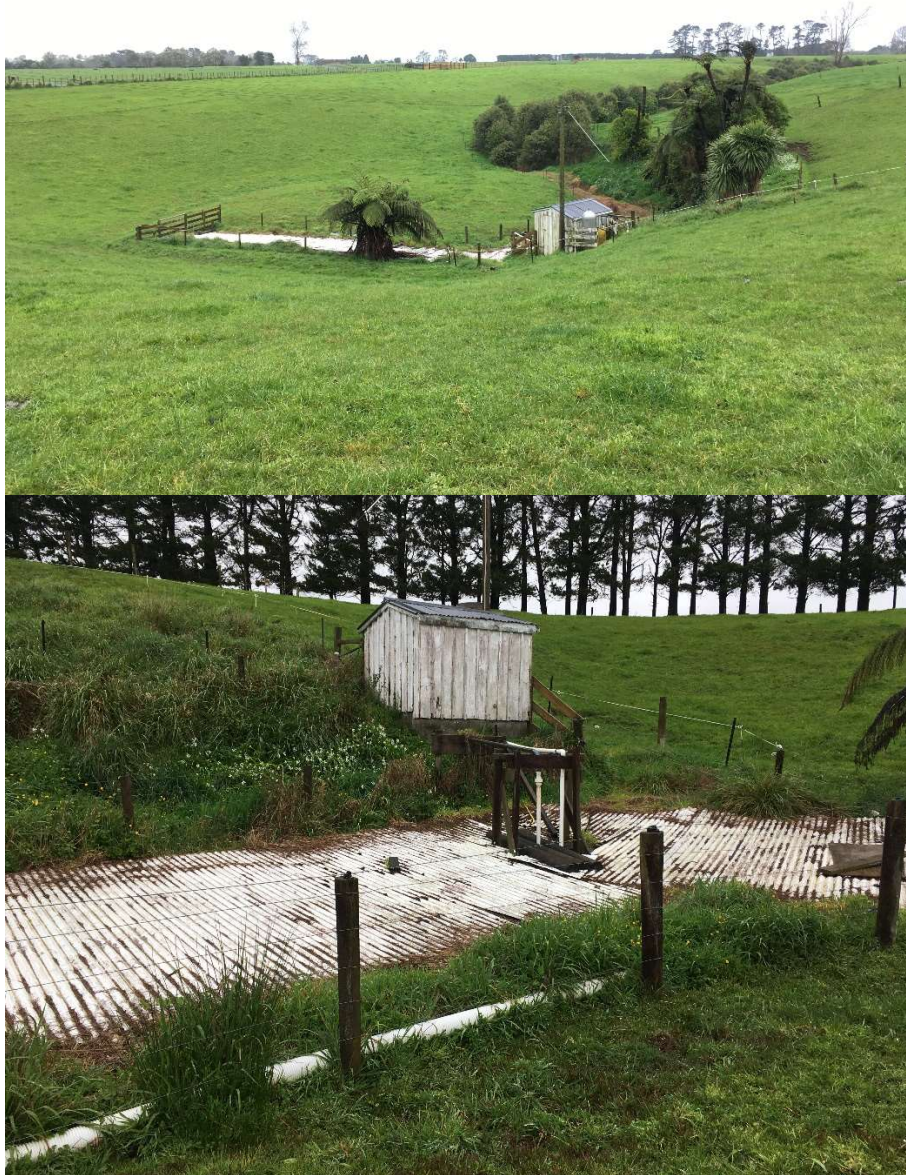
Figure 3: Water supply dam

The main water supply is understood to be from a spring located in the central, western portion of the site. The spring is dammed and covered (Figure 3). Water is transferred to a tank (likely 20,000 L PE) located near to the back (south) boundary of the site and gravity fed along the race.

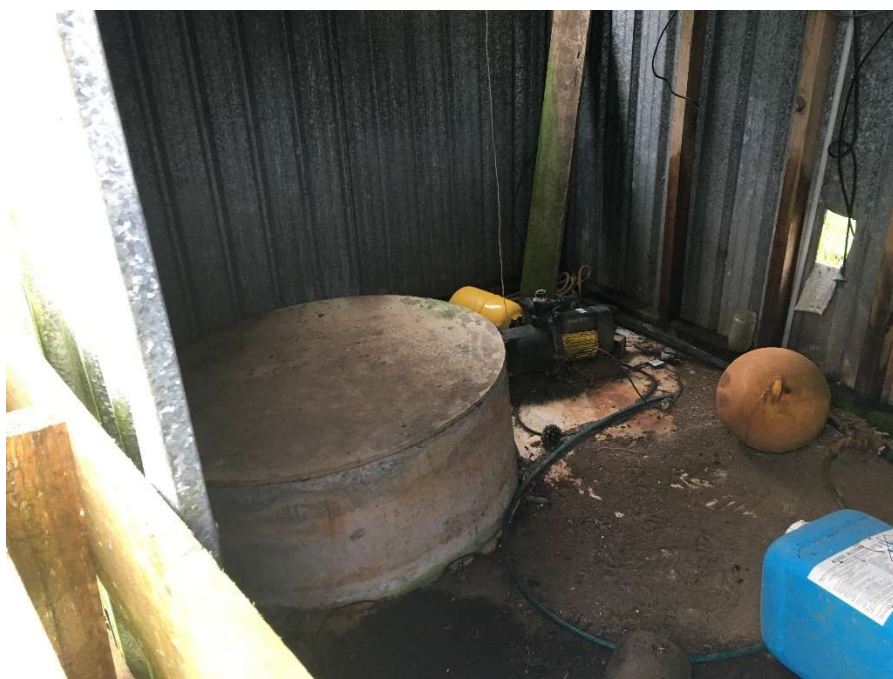
Figure 4: Old well

A well is located around 50 m west of the dairy shed. This supply is not believed to be in use. Water was observed at approximately 2.0 m depth below ground level in the well (Figure 4).

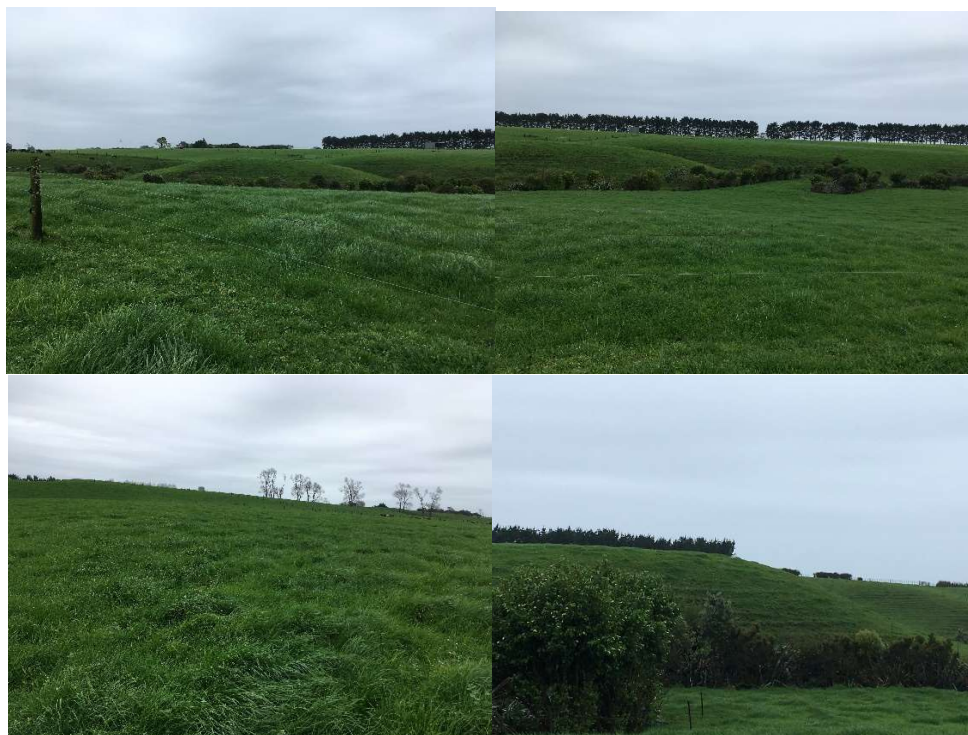
Figure 5: Site topography

The property is dominated by flat to gently rolling terrain, sloping generally towards the north (towards the coast). This surface has been dissected by waterways resulting in rolling to steep sided gullies. Figure 5 shows the topography of the property.

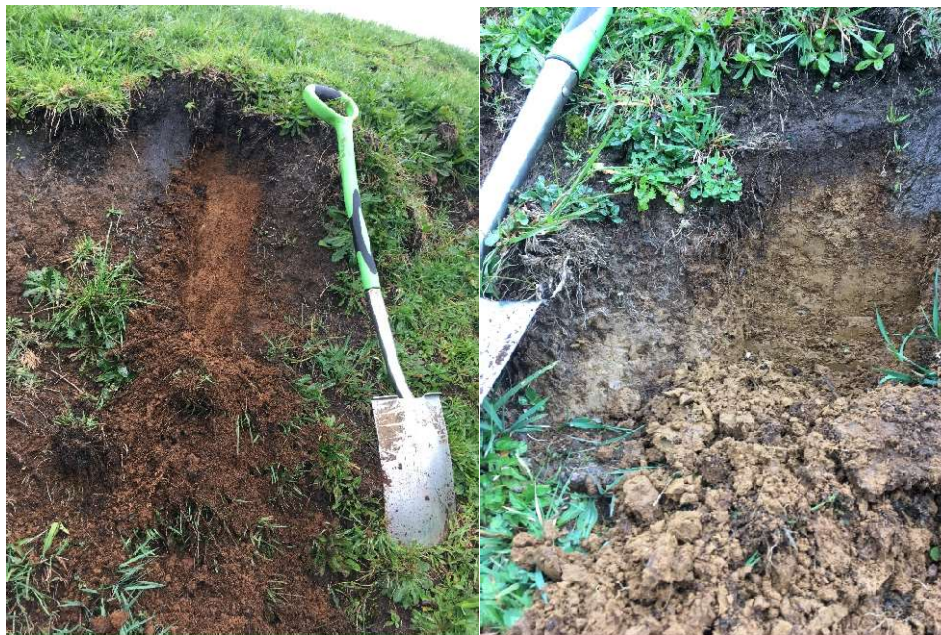
Figure 1: New Plymouth black loam soils (left), Whangamomona complex soil (right)

New Plymouth black loam soils correspond to land use capability class (LUC) 1 and are considered resilient, fertile and have a high capacity to retain phosphorus. These soils are well suited to irrigation and can receive some irrigation year round. The available water capacity is in the order of 10-30 %, indicating that irrigation is unlikely to cause excessive leaching. Whangamomona complex soils at the site correspond to LUC 3 and are well suited to irrigation with appropriate management controls.

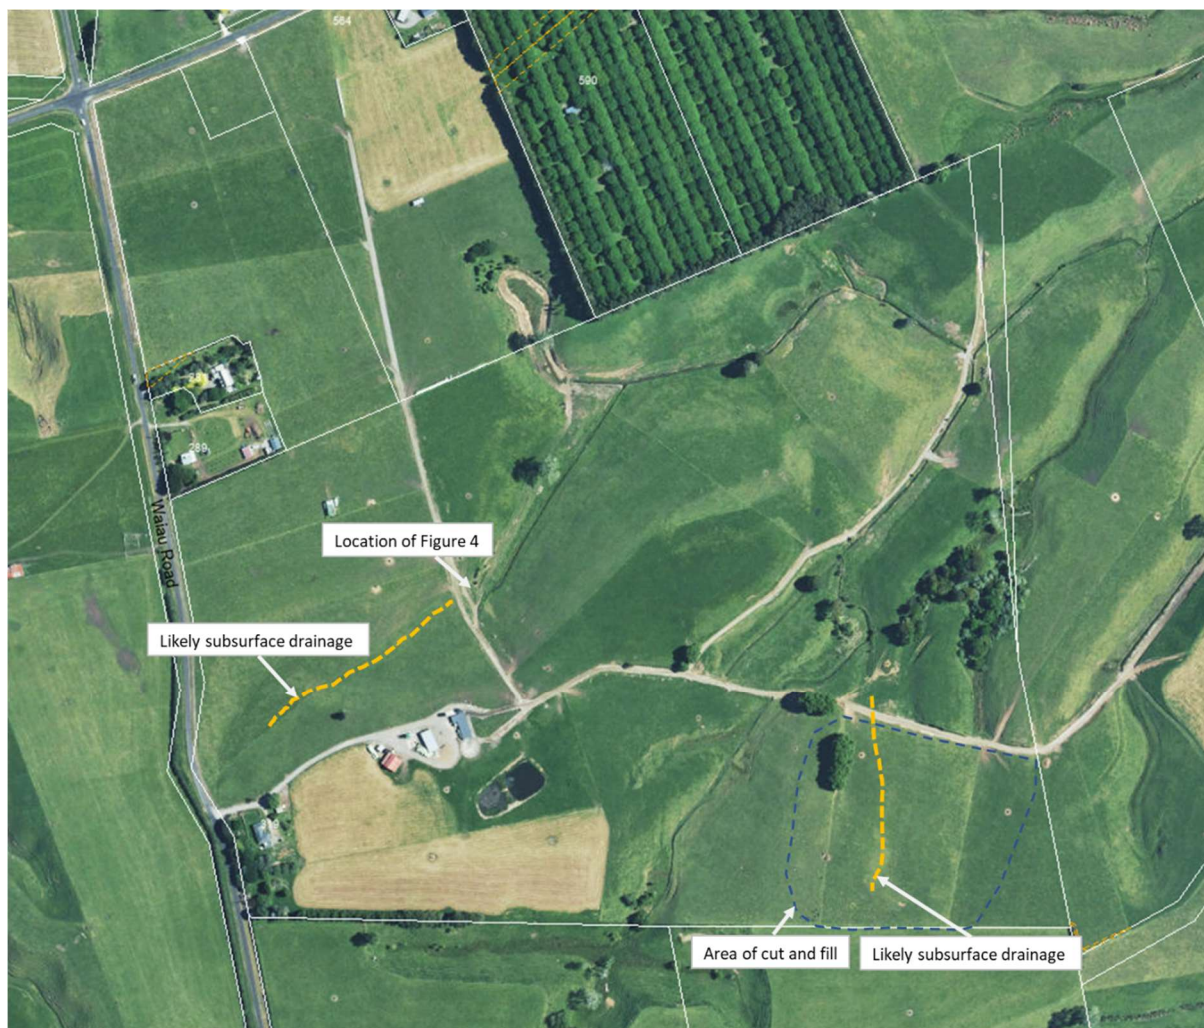
Figure 1: Site layout

Figure 1 shows an aerial image of the property layout and key features.

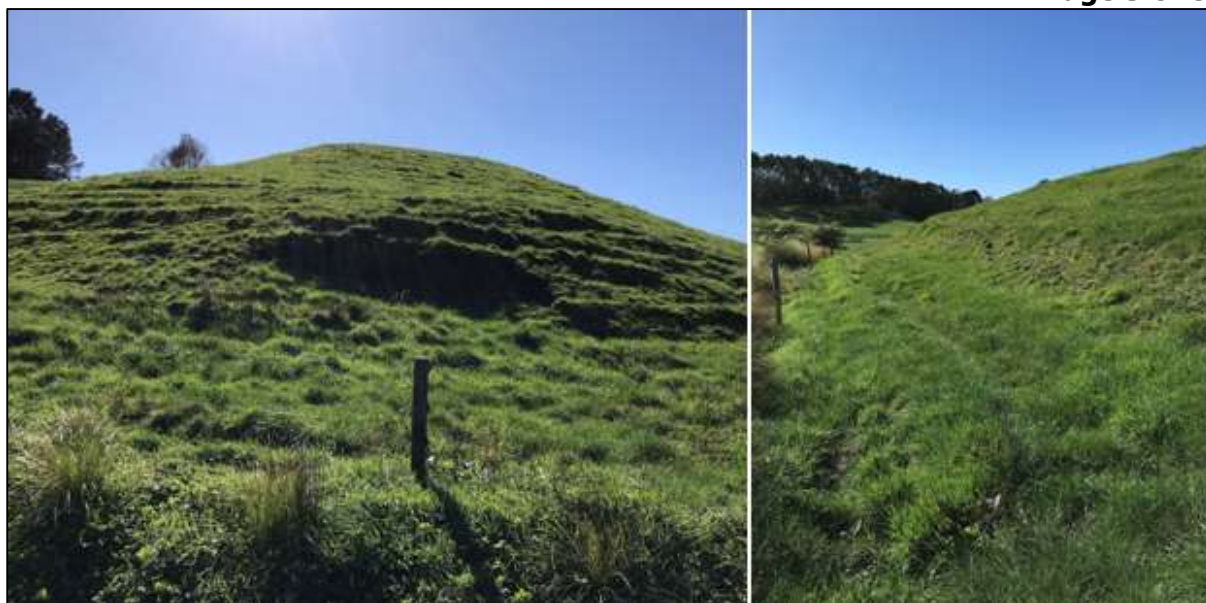
Figure 2: Examples of the steeper topography.

The variation in topography will reduce the suitable options for irrigation as, for instance, a centre pivot or travelling irrigator would not travel across steep and irregularly shaped areas. The application depth to rolling terrain would need to be much lower than the application rates on the flat areas to ensure the chances of runoff are mitigated and to avoid exacerbating erosion.
