Urenui and Onaero Wastewater Treatment Plant - Assessment of Alternative Sites

Prepared for New Plymouth District Council
Prepared by Beca Limited

19 January 2024

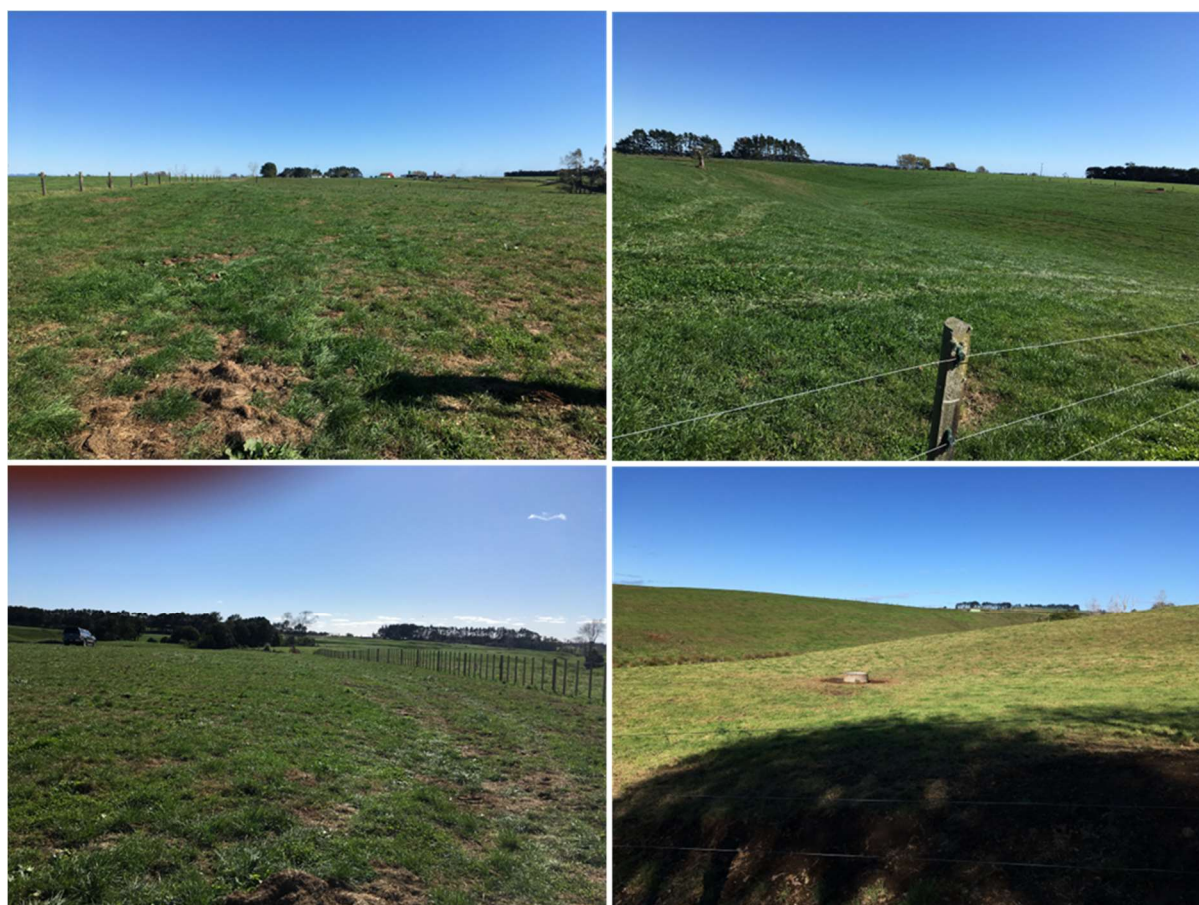
Figure 3: General site landforms and topography

The desktop assessment (letter dated 10 May 2022) considered the property likely to be flat to gently rolling. However upon our visit, it was clear that the topography of the property included flat to gently rolling (Figure 3), but was also rolling and in some areas, would be considered easy hill (Figure 2). Slips were observed on some steeper slopes, in particular, close to watercourses.

Land around and including tracks, gates and troughs (Figure 3) was in good condition and showed minor tendency to pug and become muddy due to high traffic (animal or vehicle) under wet conditions (Figure 8).

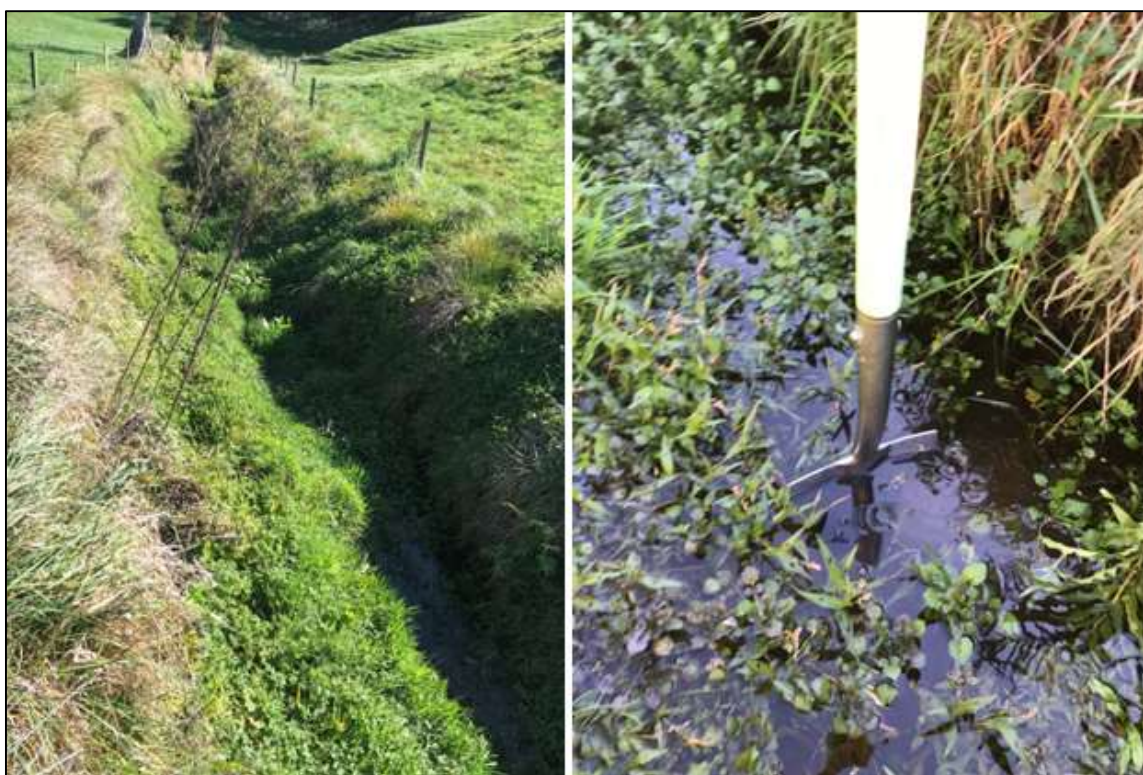
Figure 3: Typical characteristics of the waterways at the property.

At the time of the site walkover, the waterways had stagnant or slow moving water in most parts, with the occasional running water due to the gradient of the waterways. The waterways were mostly filled with weed of various plant species. The size of the waterways varied from 1-1.5 m from bank to bank and approximately 20 – 30 cm in water depth. A detailed description will be provided by Riverwise Consulting.

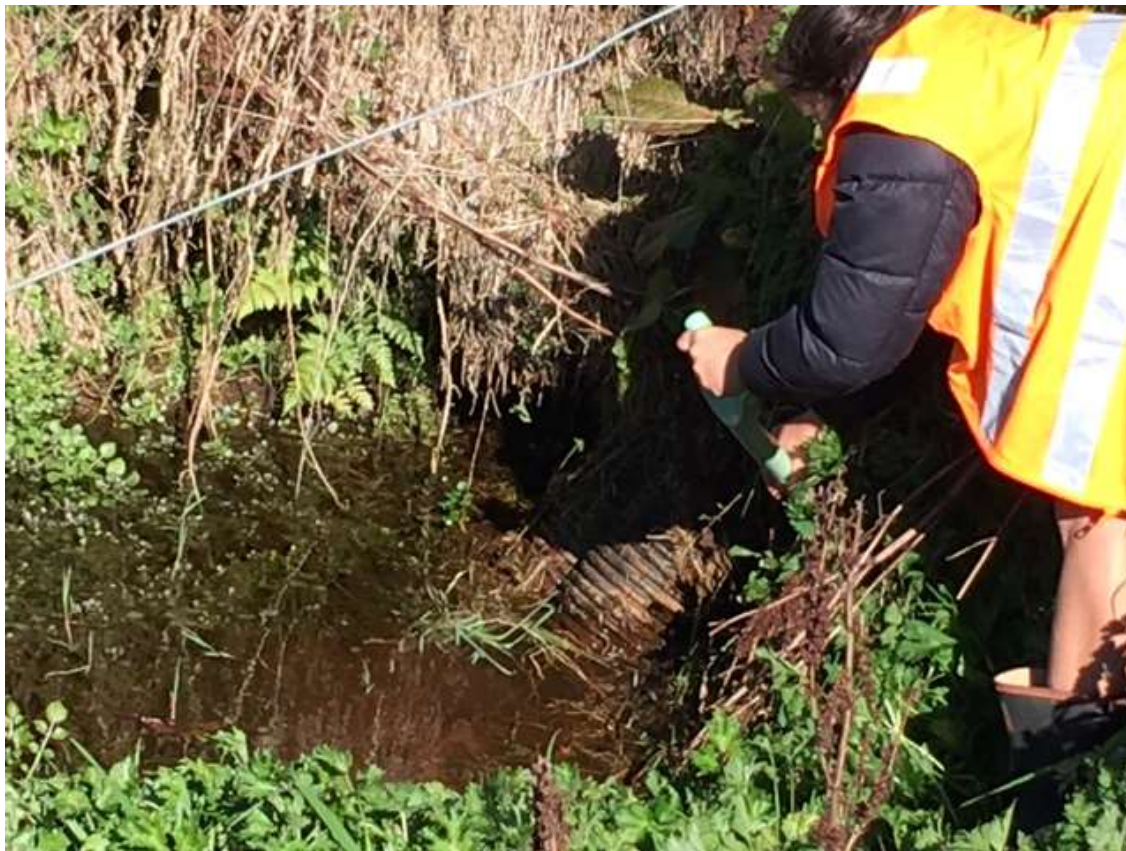
Figure 4: Drainage coil discharging to waterway

As noted above, flow paths have been extensively modified across the site by infilling and straightening. Drainage pipe observed at the head of a waterway can be seen in Figure 4. See attached map for the location of that site.

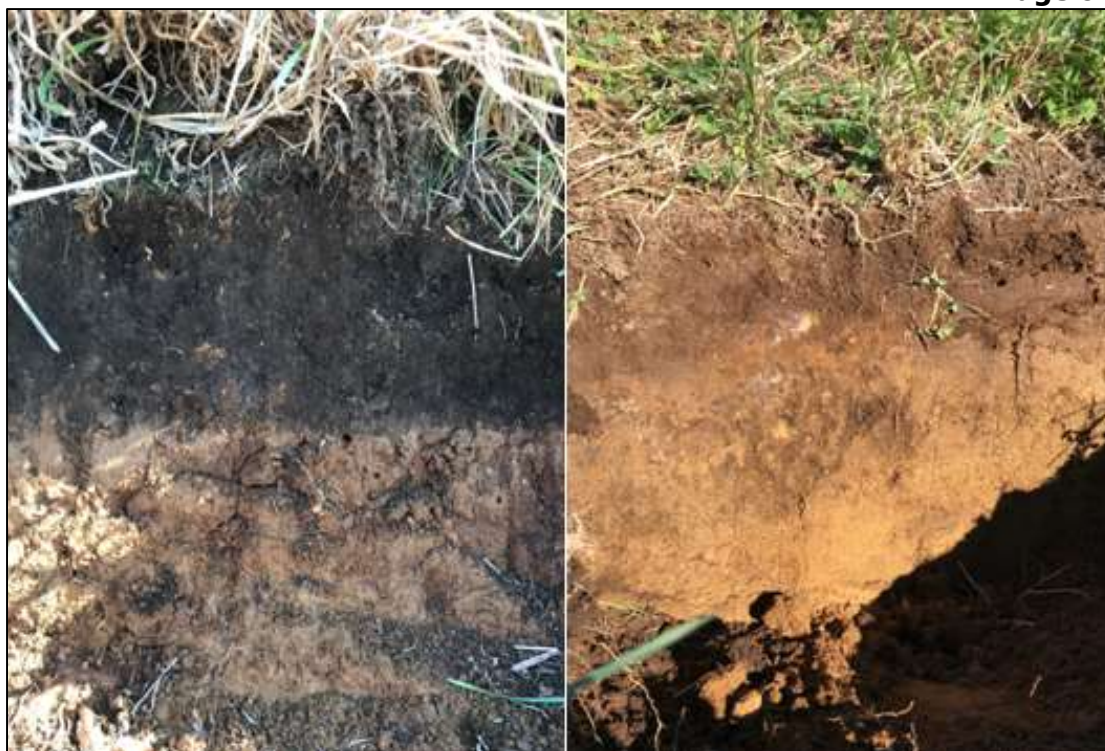
Figure 6: New Plymouth Black Loam Soils. Photos taken at 319 Waiau Road.

The soils at 319 Waiiau Road were confirmed to be New Plymouth Black Loam Soils. These soils are considered resilient, fertile and have a high capacity to retain phosphorus. The available water capacity for the site is in the order of 10-30 %, indicating that irrigation is unlikely to cause excessive leaching. Photos of soil from the property are shown below in Figure 6.

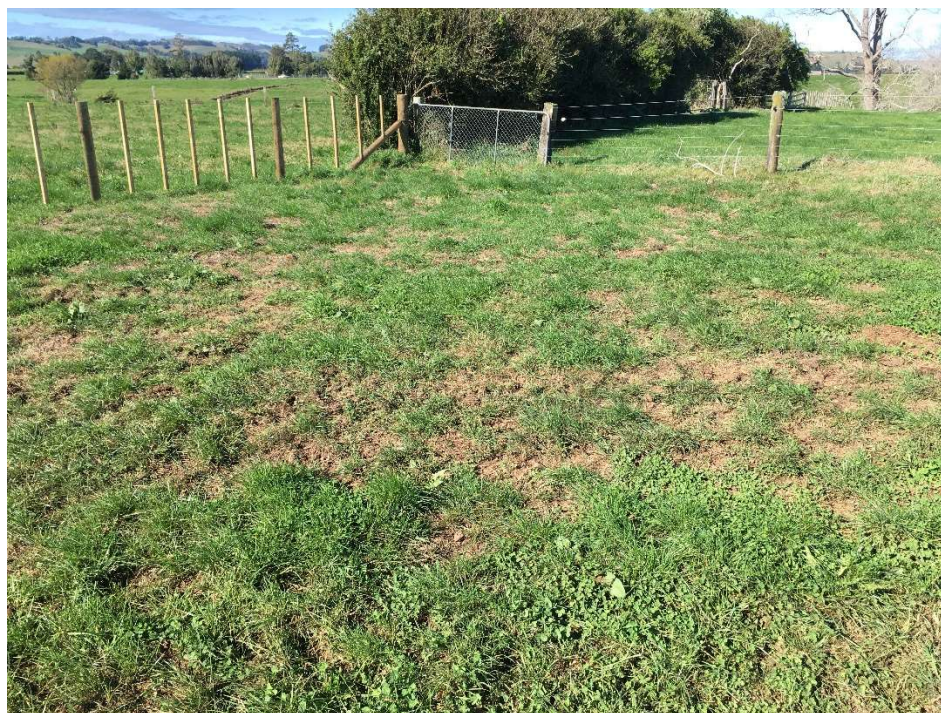
Figure 7: Late summer/autumn pasture regrowth

The land condition was generally good, with signs of late summer dryness resulting in pasture dieback and fresh growth visible following recent rainfall (Figure 7). This indicates that the sites productive capacity would be increased by irrigation. This results in an increased removal of both water and nutrients than currently occurs.
